# Lightning Direct Effects Handbook

Revision Letter	Date Released	Report Number	Author	Additional Notes
Initial Release	11/03/2022	22-51512-RTR52865	Rebeka Khajehpour & Alyssa Gonzalez	NIAR KART R52865 Spliced Lightning Strike Protection on Thermoplastic Composites

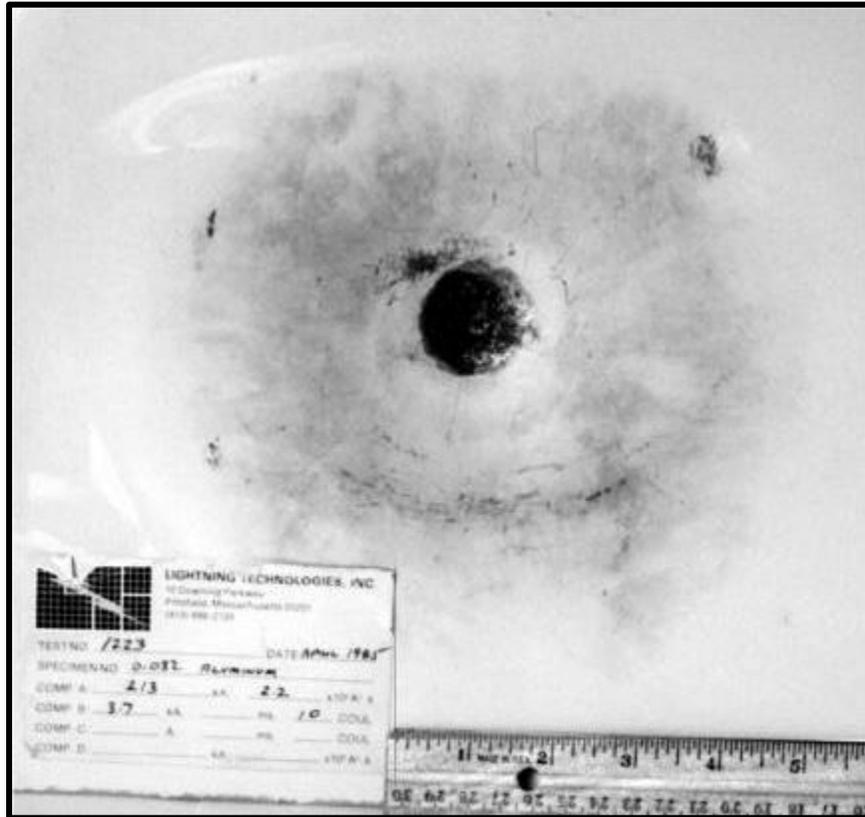
Table 6-3 lists typical test results. A *Zone 2A* strike of 5 ms dwell time (*Components D and B* only) will generally melt through a panel less than 0.080 inches thick. Even the 0.080 panels may show resolidified metal on the interior surface. Figure 6-4 through Figure 6-6 show typical damage to aluminum skins caused by *Zone 1A* and *1B* test currents.

Figure 6-4: Aluminum Panel (0.032" thick)  
 Darkened area is a 2" in diameter dent to a depth of 1", no melt-through

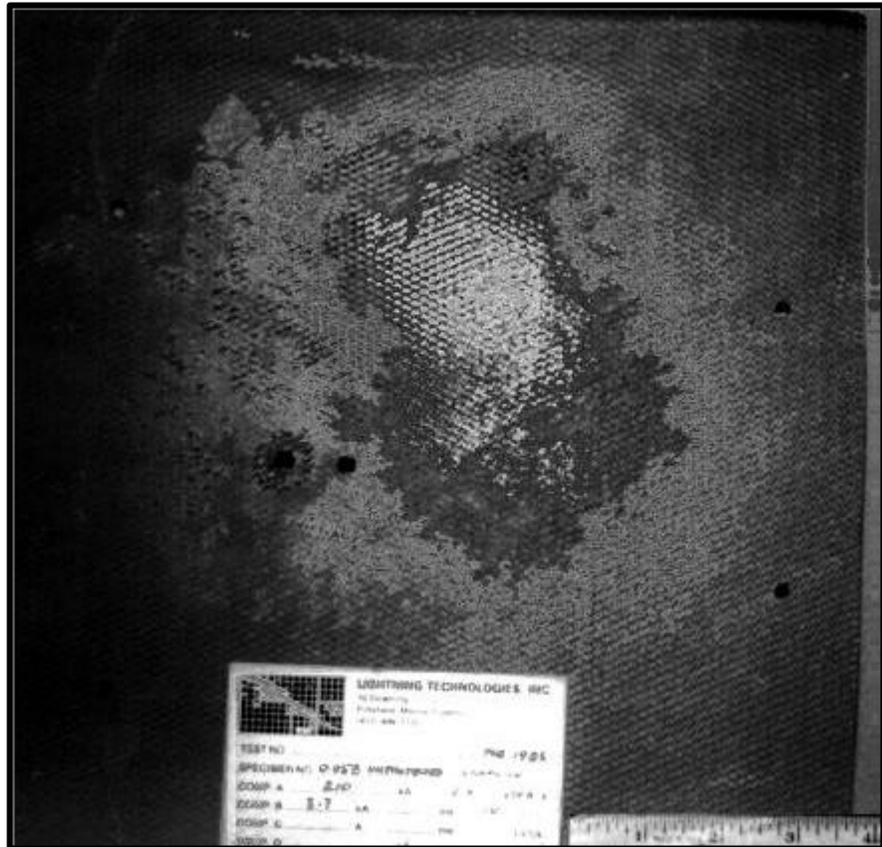
Figure 6-7: Unprotected and unpainted CFC panel subjected to a Zone 1A strike

Figure 6-7: Unprotected and unpainted CFC panel subjected to a Zone 1A strike illustrates the effects of non-conductive surface treatments on the CFC laminate. This is a typical illustration of the importance of allowing the arc root of the lightning channel an opportunity to spread out over a larger region. Although an unpainted carbon structure is not realistic, the importance of keeping surface treatments to a minimum thickness, even on protected composites, are important in minimizing damage.

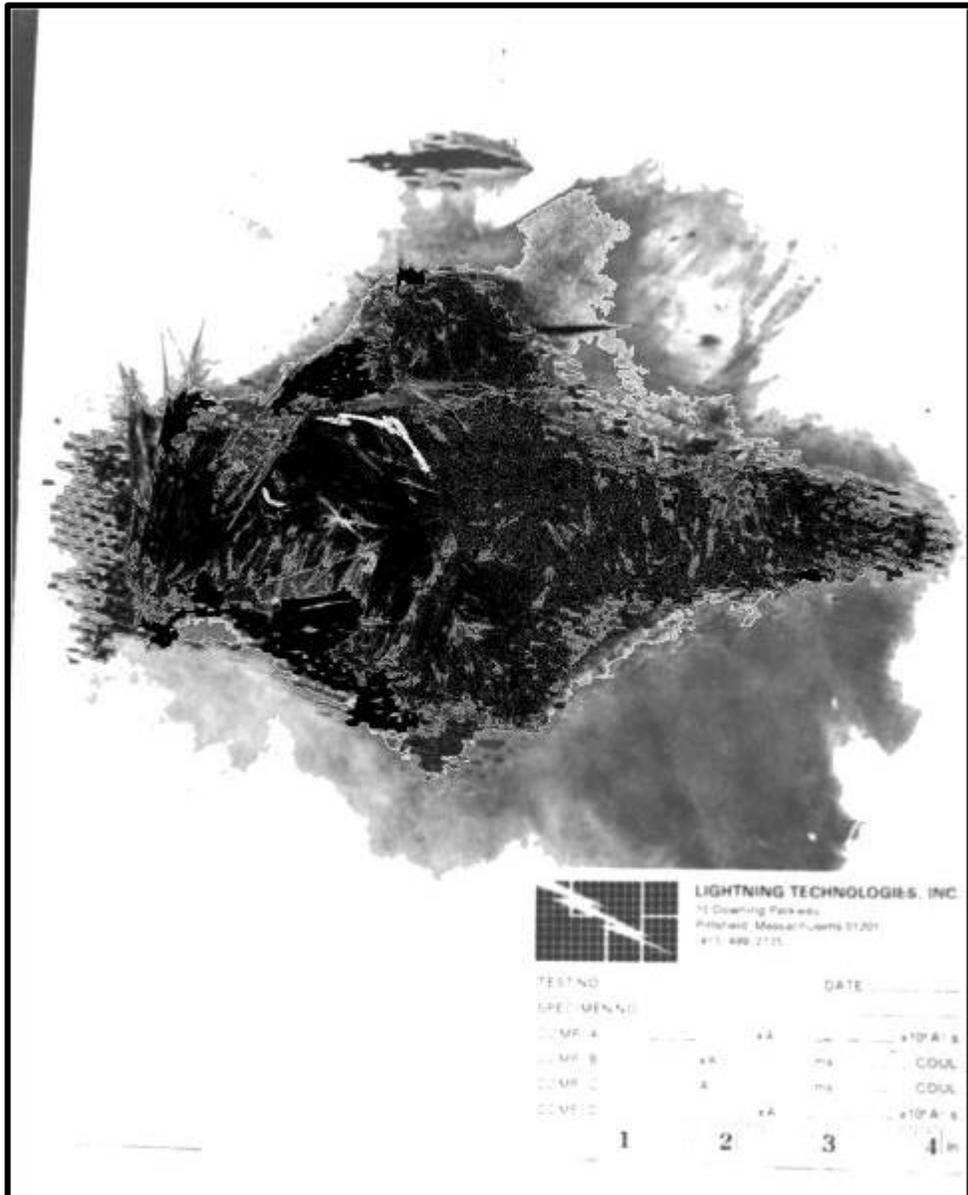
Zone 1A - Painted: Figure 6-8 shows the results of a Zone 1A lightning strike to a 0.040 in. thick painted CFC panel. The laminate was damaged over a region of 30 to 40 square inches of the laminate. The laminate was also punctured on the back side of the panel.

Figure 6-8: Zone 1A strike to a painted exterior surface unprotected 4 ply 0.052 in. CFC laminate of woven cloth plies

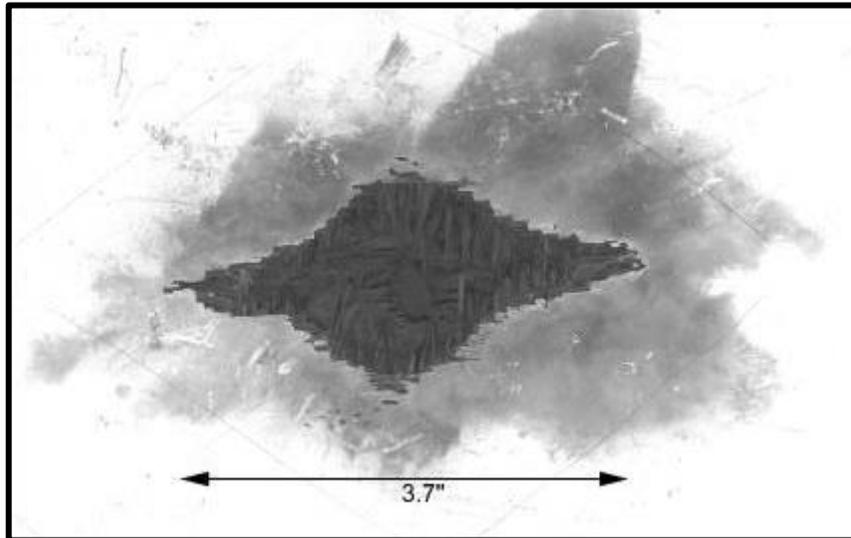
Zone 2A - Painted: Figure 6-9 shows the results of a Zone 2A lightning attachment to an unprotected 0.040" thick painted CFC panel. The laminate was damaged over a region of 3 square inches. The inner ply laminate was also fractured over the approximate same area as the exterior surface, although the resin was not pyrolyzed on this ply.

Figure 6-9: Zone 2A strike to exterior surface  
unprotected 4 ply 0.052 in. thick laminate of woven cloth plies

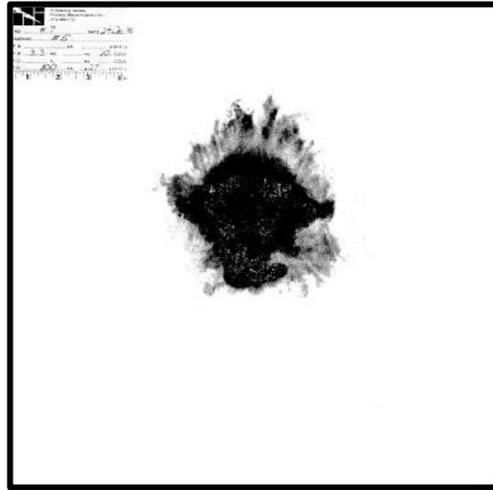
Figure 6-32: 0.029 ECF protected Panel, Zone 2A

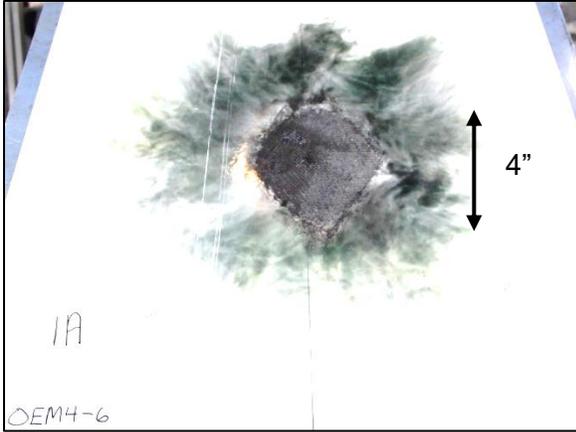
Figure 6-37: 0.029 ECF, Zone 1A, outer

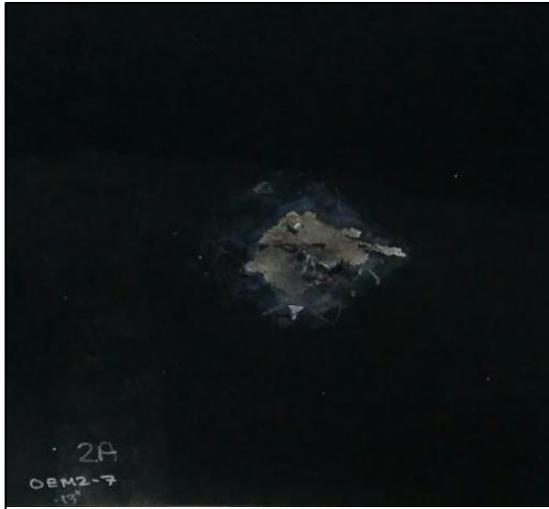
Figure 6-49: Single, Unitape, ECF  
12 mils of paint

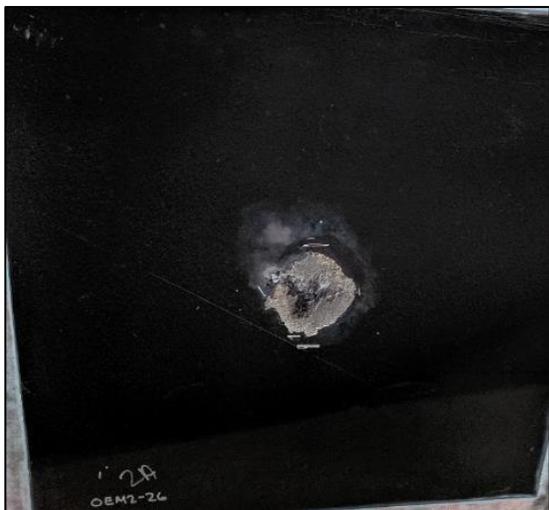
Figure 6-53: Full, Uni, ECF,  
12 mils of paint

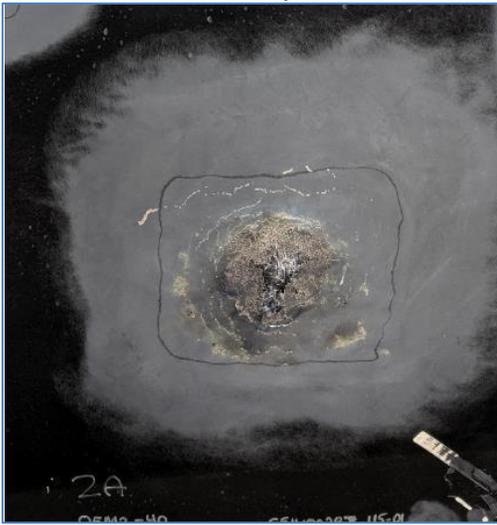
Figure 6-58: Full, Woven, Film  
7 mils of paint

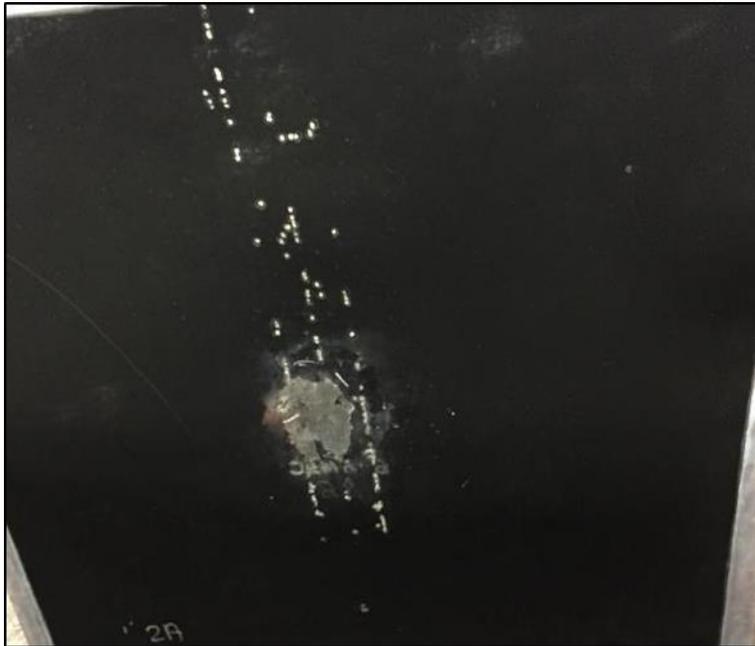
Spliced panels often display damage along the lightning protection seam lines where there is a discontinuity of the current path and higher contact resistance, as seen in Figure 6-59. Visual inspection suggests that this may result in a redistribution of damage rather than an increase in overall damage. Testing at higher, Zone 1A lightning strike level would be necessary to determine whether this phenomenon would result in greater damage in comparison to full panels without splices.

Figure 6-59: Butt and Splice Panel with Seam Damage

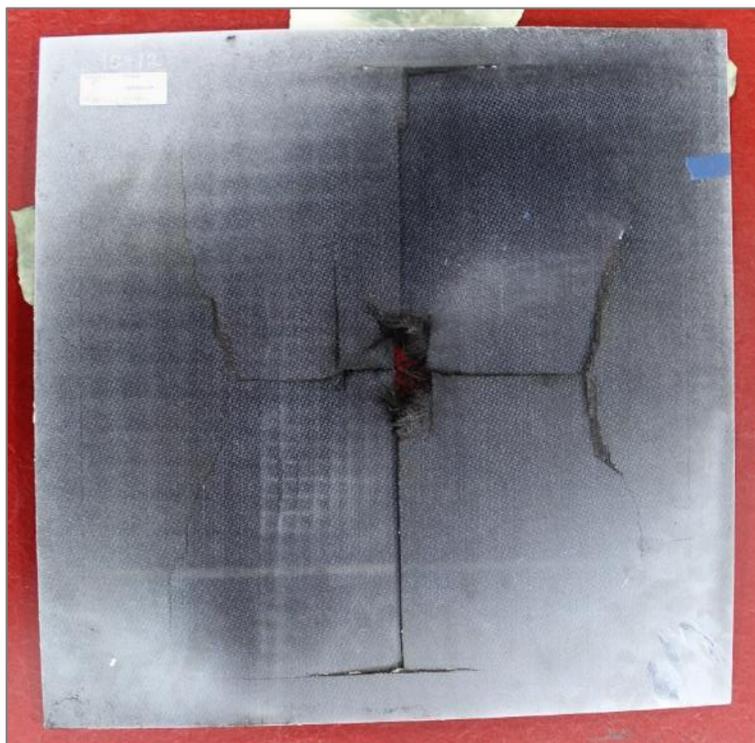
Figure 6-61: 5THCU1, Zone 1A

The 5THCU1 and 5THCU2 panels both split along the 0° and 90° directions, which can be seen in Figure 6-61 and Figure 6-62 below. The thin orthotropic layup seems not to have been able to withstand the acoustic shock; this is discussed more in the Fiber Arrangement section below. In the case of the thin unitape panels, the lighter weight of copper scored much lower based on the damage code. This could have been due to a split attachment point on the CU1 panel distributing the arc root energy. The lighter (142 gsm) ECF panel was tested again and, though there was a slight increase in damage on the retest, it was still significantly less than the panel with the heavier (195 gsm) ECF. This result is unexpected considering the additional mass of copper per unit area in CU2 should conduct current with less resistance, as well as requiring more energy to vaporize. This subject needs further investigation.

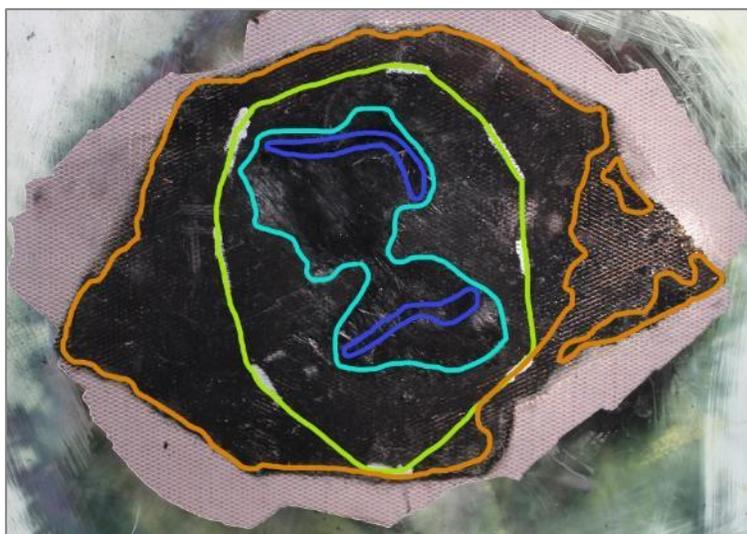
Figure 6-65: Composition of Damage and Repair Area, UTKCU2-1.

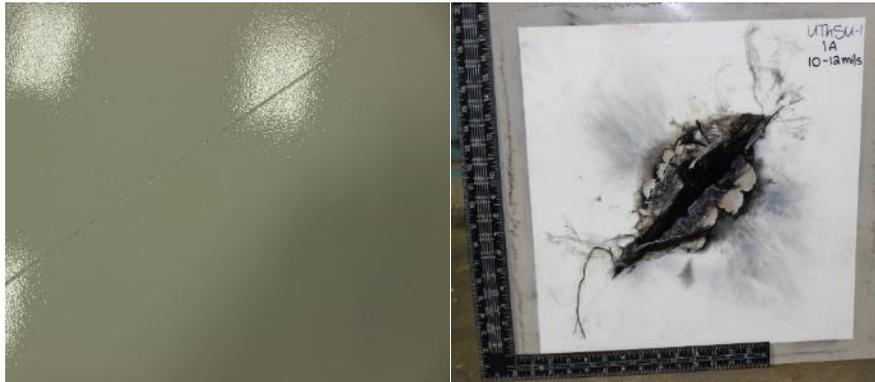
that the damage to the LSP did not go much further than the delamination area. The area of fiber breakage was considerably smaller than the delamination area.

Figure 6-66: UTHSU-1 Panel Defect (left) and Resulting Damage (right)

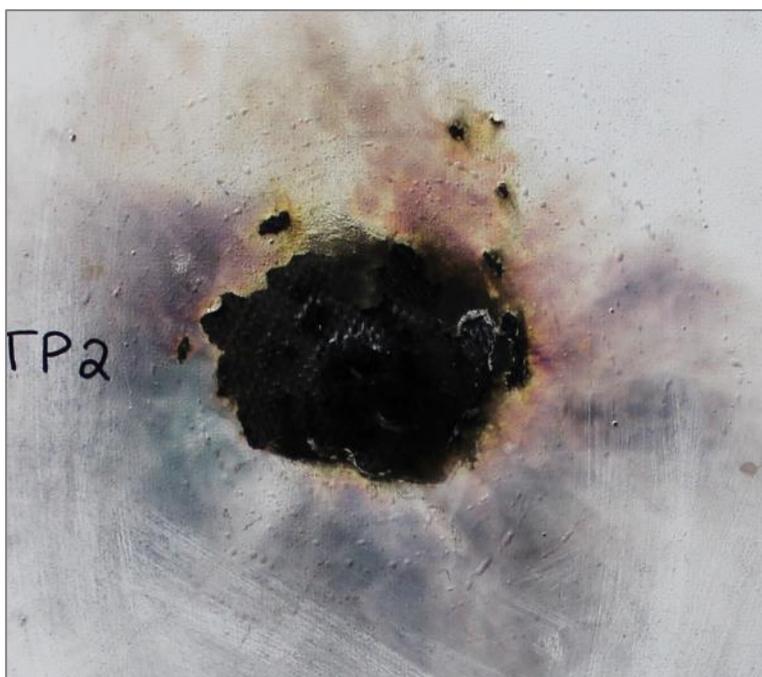
Thick panels with conductive spray performed well at the Zone 2A test level. The 5HS panels had no inside delamination. However, three of the four unitape test points had inside delamination ranging from 6.0 to 8.3 square inches, with evidence of polymer melting on the back of the panel. All of the conductive spray thin panels sustained extensive damage, scoring well over 64 on the damage codes, indicating the presence of a hole through the panel. The main difference between the Zone 1A and 2A strikes was the damage severity into the depth of the panel, and the ratio of the delamination area to the repair area. In the Zone 2A strikes, the repair and outer delamination areas were very similar while at Zone 1A the repair area was usually much larger than the delamination area, indicating that there was more LSP damage beyond the delamination area. The same concentric LSP damage shown in Figure 6-43 **Error! Reference source not found.** and Figure 6-45 of the conductive film TSC panels was seen on the TPC panels with the spray coating, but on a smaller scale (see Figure 6-68). This difference is likely due to the film versus spray-on nature of the LSP or the matrix material of the panel. More testing is required to determine the cause.

Figure 6-68: Concentric LSP damage of Conductive Spray

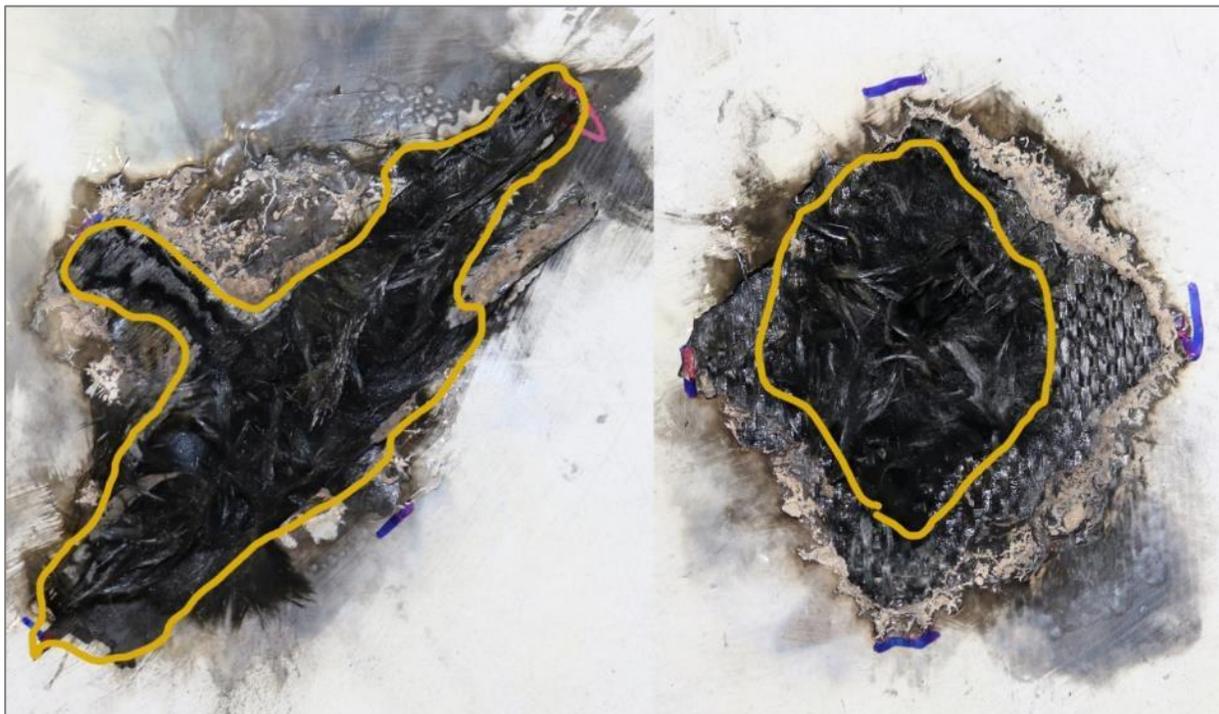
There is evidence that both fiber orientation and lightning strike protection play a role in the damage morphology. The influence of fiber orientation is most prominent in the test panels with no lightning strike protection. Shown on the left in Figure 6-72 is the unitape panel without LSP, with top layer fiber orientation of  $-45^\circ$ . The damage is elongated along the length of the fibers. A perpendicular protrusion of minor surface damage can also be seen extending out near the middle of the length of the main damage area. The 5HS panel shown on the right of Figure 6-72 displays a more symmetrical damage morphology in both fiber/resin damage and delamination, extending out along both the  $0^\circ$  and  $90^\circ$  fiber directions.

Figure 6-72: UTHNP (left) and 5THNP (right).  
Orange outline represents fiber and resin damage area (outer hole).

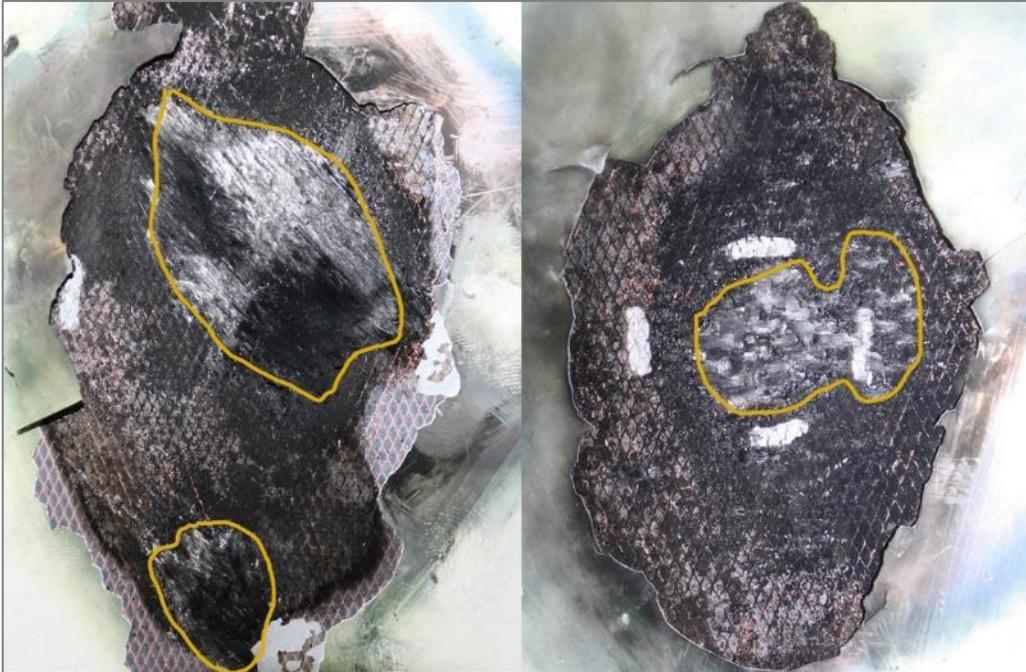
The ECF protected panels are shown in Figure 6-73 with the unitape top layer at  $45^\circ$ , and 5HS woven with top ply orientation at  $0^\circ$  and  $90^\circ$ . In the ECF unitape, the influence of the conductivity of the copper layer reduces the elongation of the damage relative to the unprotected panels, yet the damage area is still longer along the length of the fibers. The second, smaller damage area in the unitape panel is likely a result of a split attachment point, which still displays a slight elongation along the fiber direction. The pattern of damage suggests that the more isotropic conductivity of the copper mesh distributes the energy over the surface of the laminate as intended, rather than conducting primarily through the fibers. The damage to the 5HS panel is oriented along the  $0^\circ$  and  $90^\circ$  directions. The delamination area is marked by a silver marker, and is only 15% greater in the  $90^\circ$  direction. The resin damage is almost completely symmetrical at the center of the delamination with minor surface resin damage to the immediate right, outside of the delamination boundary.

Figure 6-73: UTKCU1 (left) and 5TKCU1 (right).  
 Orange outline represents fiber and resin damage area (outer hole).

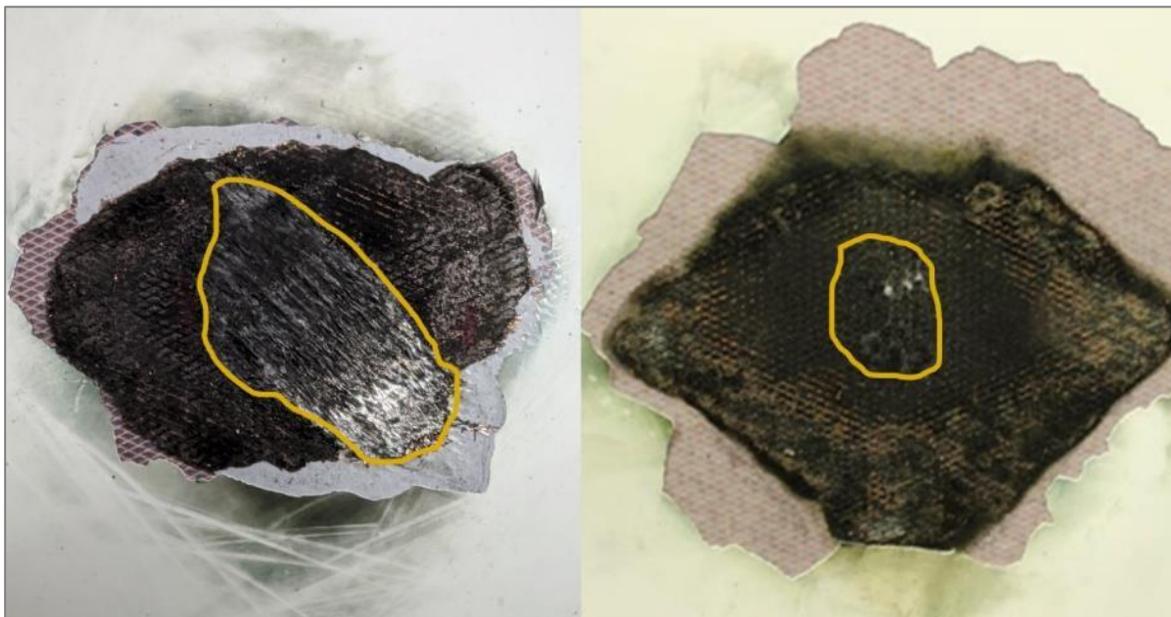
Figure 6-74 is another ECF protected panel with UTKCU2 and 5TKCU2. The unitape orange outlined resin damage area is again slightly elongated along the fiber direction, but not as severely as the unprotected panel. The orange outlined area of the 5HS panel is the damage to the resin and fiber which is again oriented along the 0° and 90° fiber directions and more symmetrical in proportion than its unitape counterpart. The outer hexagonal area is mainly LSP damage, illustrating the influence of the diamond shaped mesh on the distribution of the current energy.

Figure 6-74: UTKCU2 (left) and 5TKCU2 (right).  
 Orange outline represents fiber and resin damage area (outer hole).

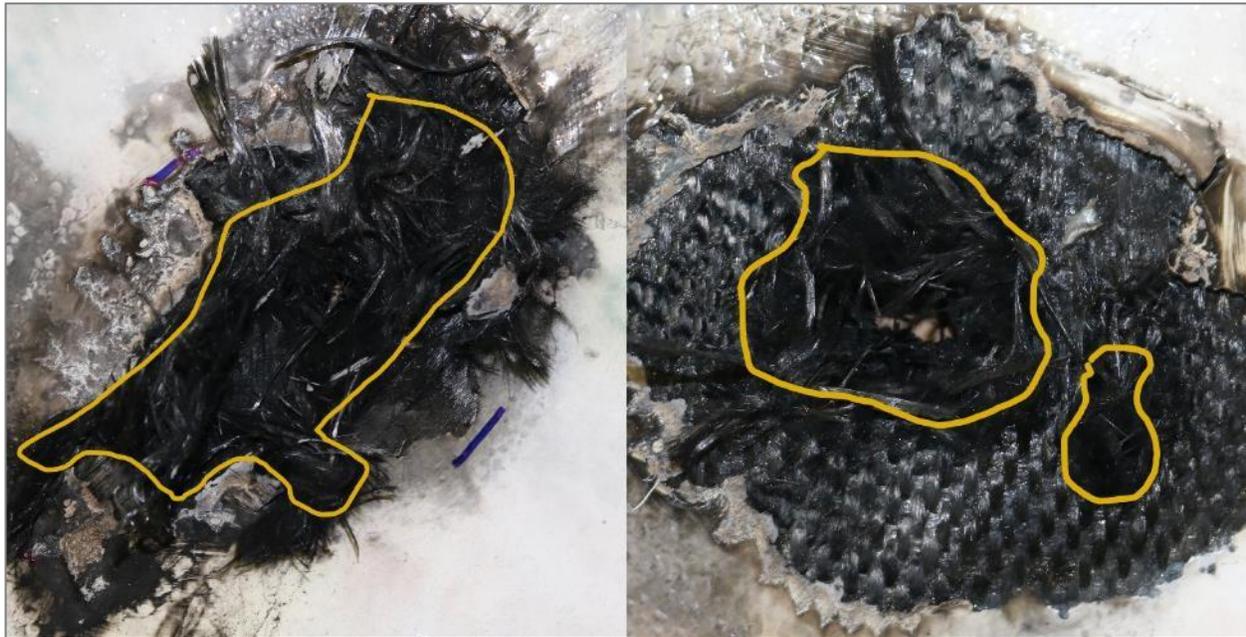
The UTHSU and 5THSU panels protected with conductive spray LSP are shown in Figure 6-75. The diagonal damage morphology can once again be seen on the unitape panel. The damage is less elongated than the unprotected panel yet more irregular in shape. The shape of the 5HS damage, while less elongated, is also more irregular in shape than either the copper LSP or no protection panels. This pattern of irregular shapes and multiple damage areas is not uncommon on conductive spray panels.

Figure 6-75: UTHSU (left) and 5THSU (right).  
Orange outline represents fiber and resin damage area (outer hole).

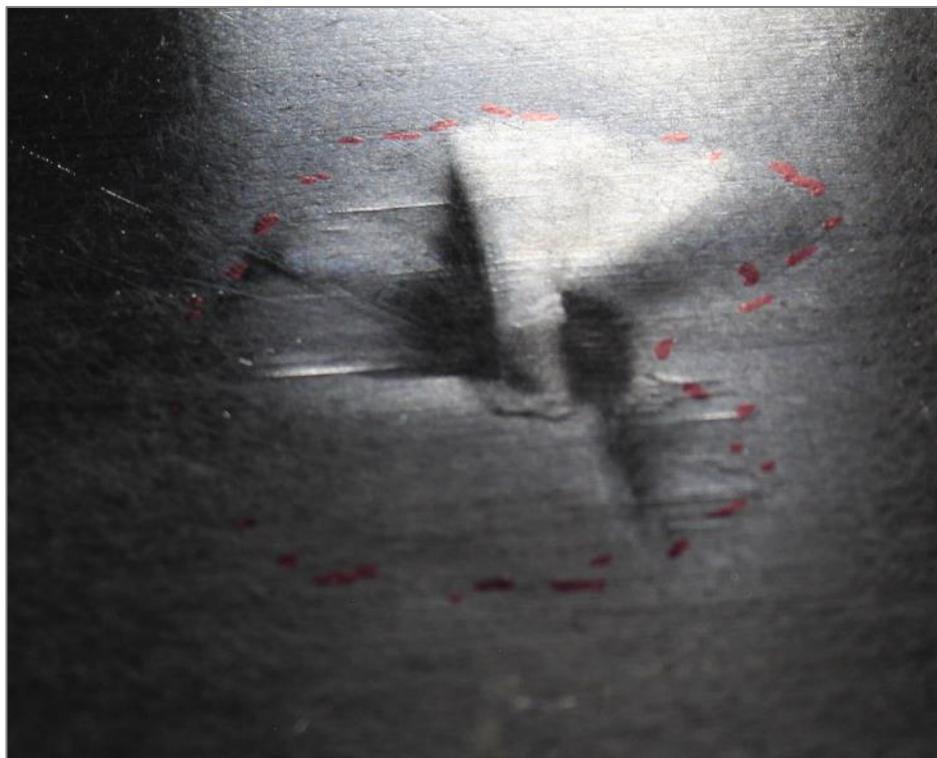
Figure 6-76: UTKSU-3 Test Point 2, Melting on Inside of Panel.  
The melting border, indicated by the dotted line, coincides with the delamination border.

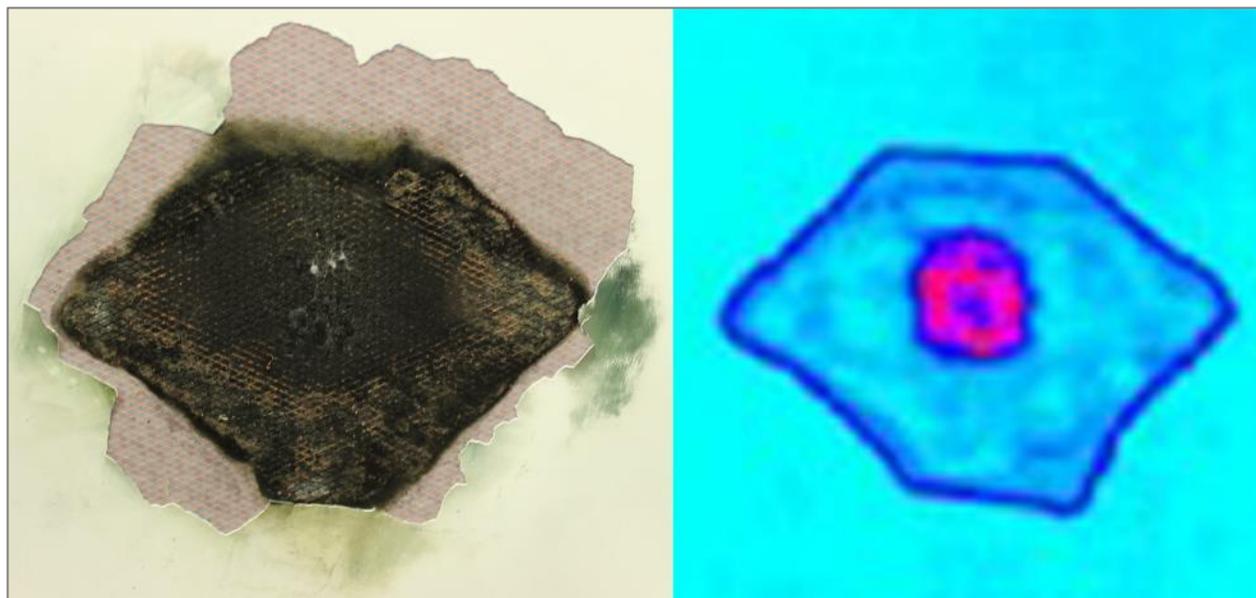
Figure 6-77: Damaged panel 5TKCU2-2 (left), pulse echo amplitude of PDZ (right)

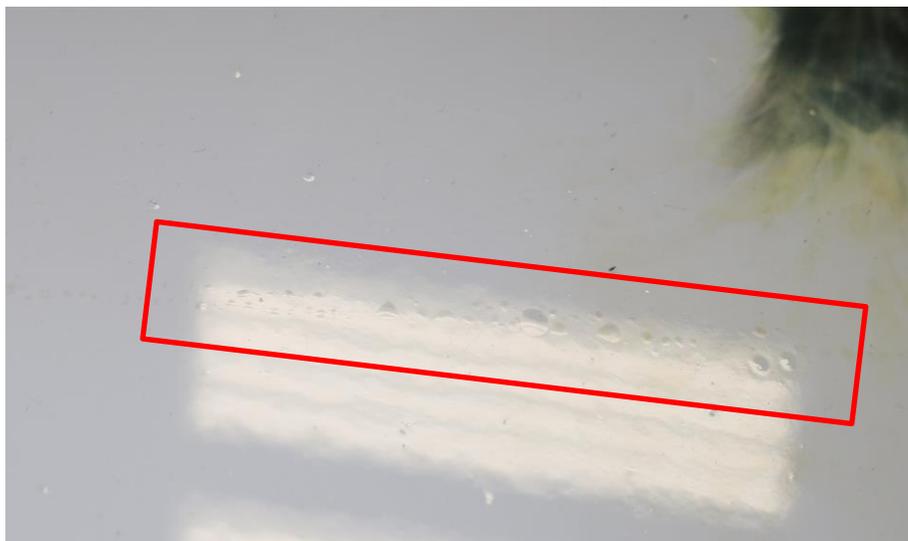
Figure 6-116: Paint Bubbling Above Splice on A1-73-2, Paint Intact

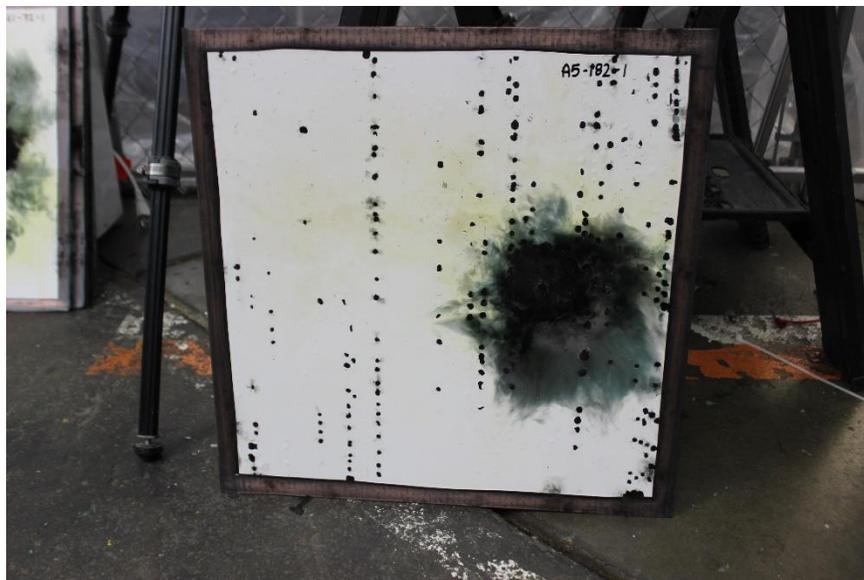
Figure 6-117: Paint Damage on A5-182-1 Panel Resulting from Lightning, Paint Ejected

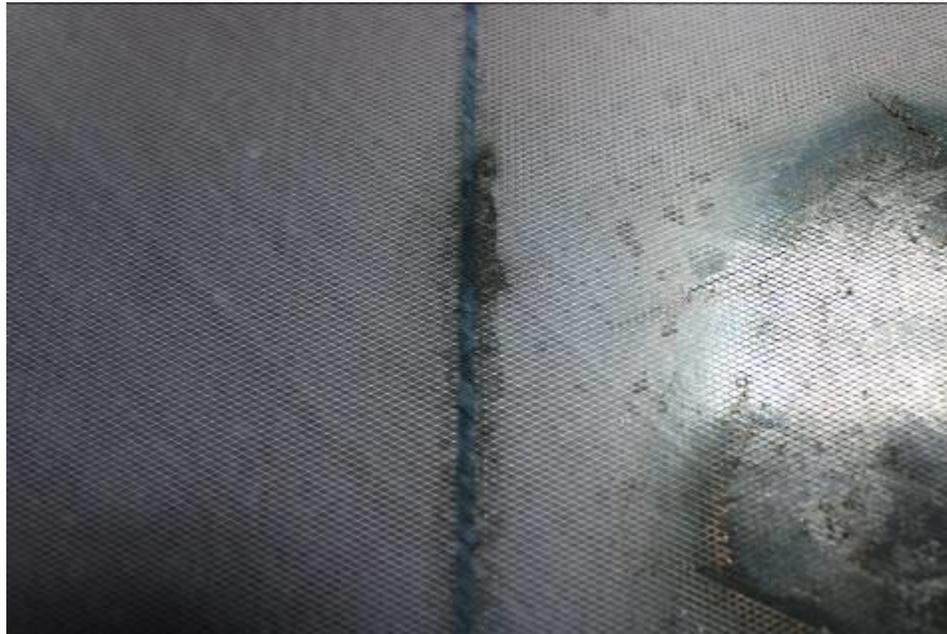
Figure 6-118: Damage to LSP at Splice Location, A1-73-1

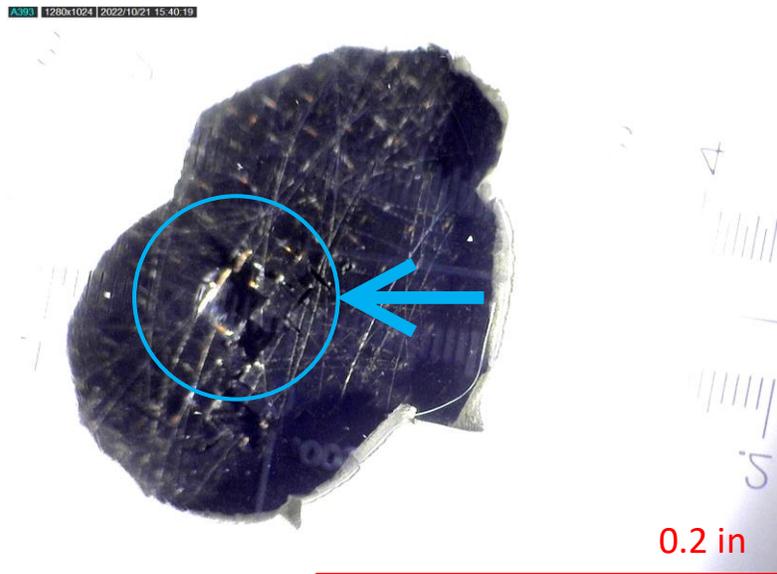
Figure 6-119: LSP Damage on the A5-182 Panels

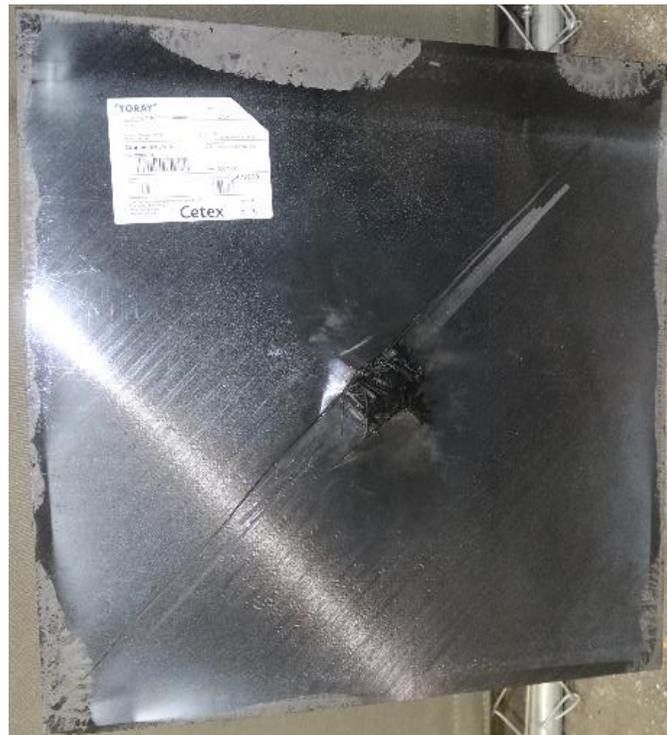
Figure 6-122: LGrZ1-2 Post-Test – Inside Damage Photo
