Aging Effects Evaluation of A Beechcraft Starship and a Decommissioned Boeing CRFP 737-200 Horizontal Stabilizer

To evaluate the aging effects of a (RH) graphite-epoxy horizontal stabilizer after 18 years of service (48000 flights, 2/3 of DSO)

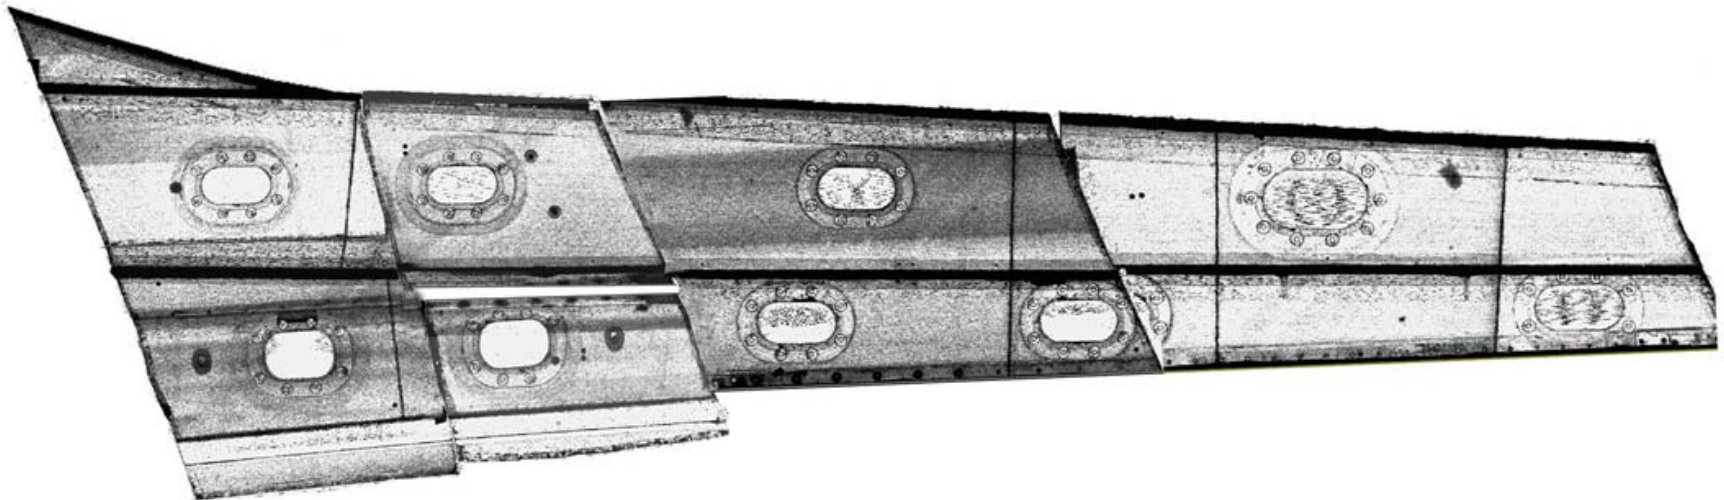
Preliminary TTU Non-Destructive inspection showed no evidence of flaws induced during manufacture or service in the skins

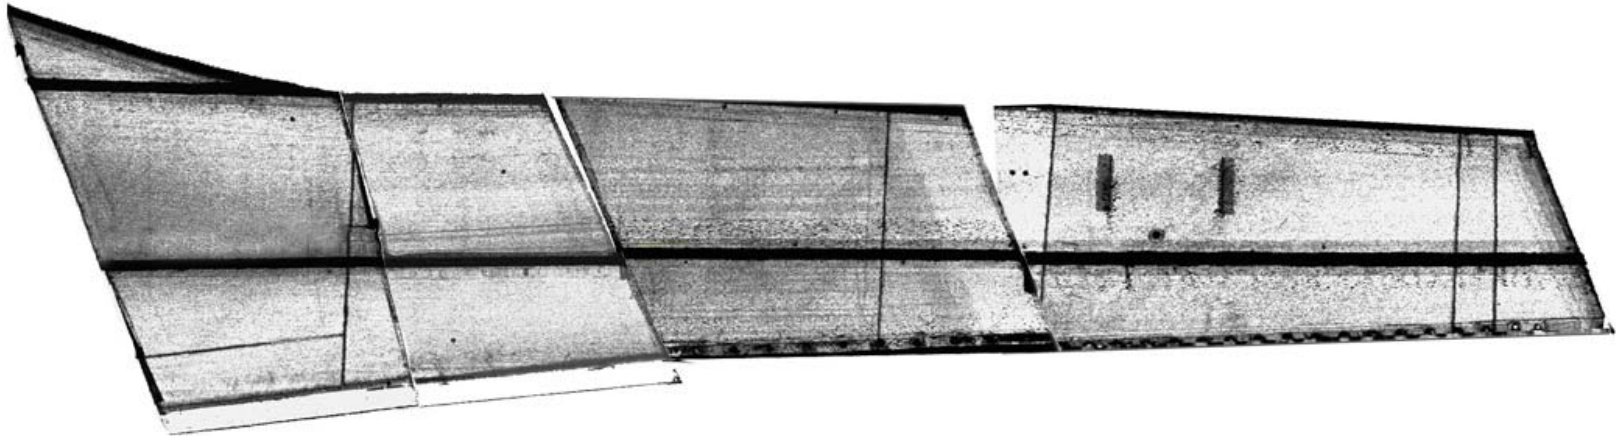
Preliminary TTU Non-Destructive inspection showed no evidence of flaws induced during manufacture or service in the skins

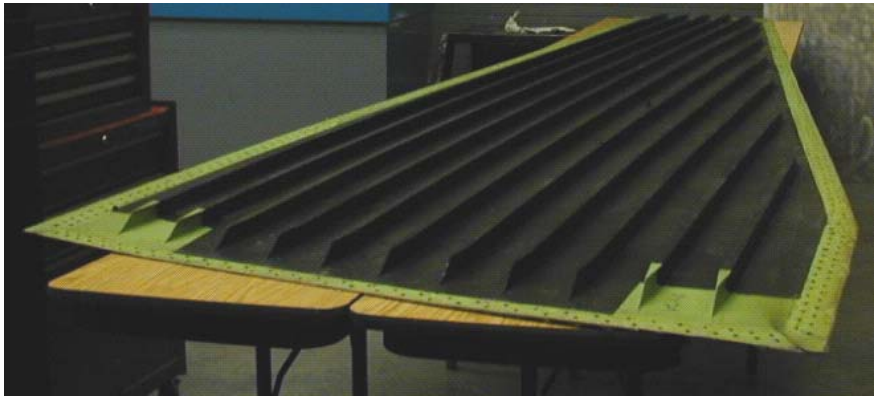
Upper Skin (RH)

- Structure held very well
- No evidence of pitting or corrosion as would be observed in a metal structure
- No residual strains compared to the LH

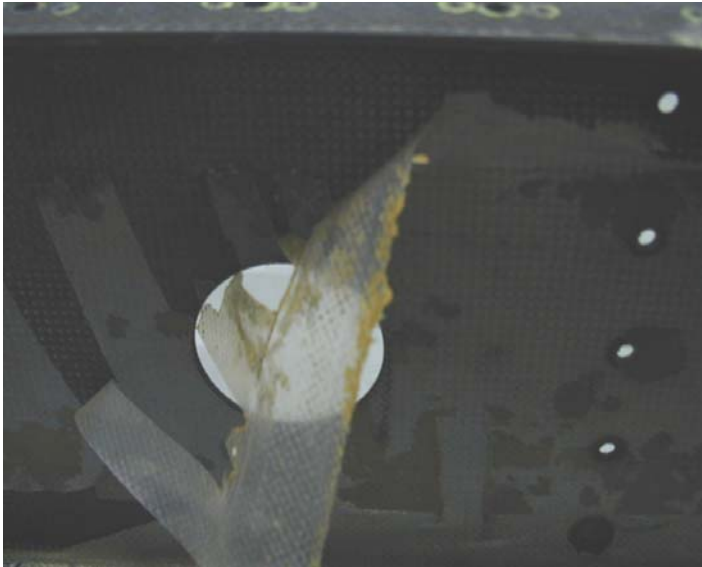
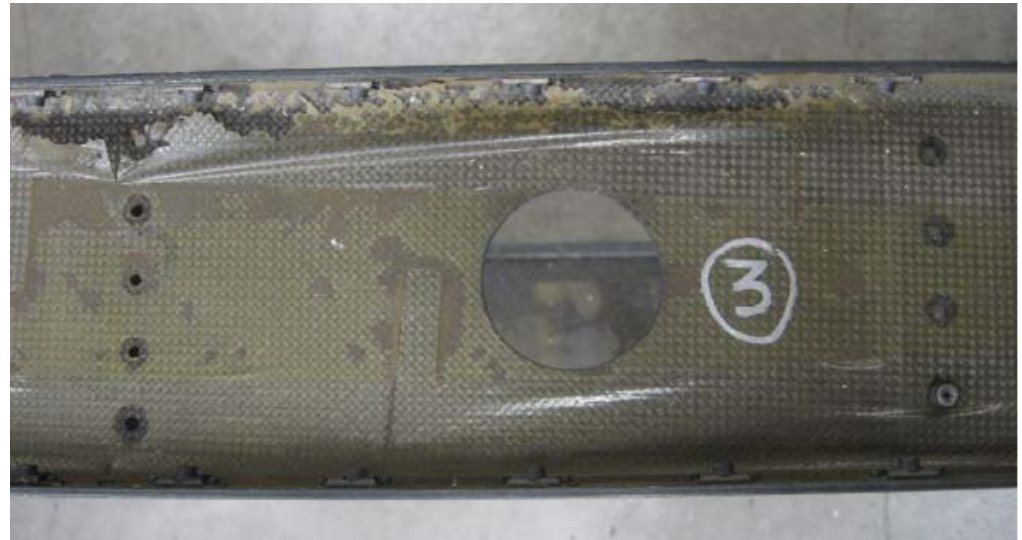
Degradation of Tedlar Moisture Barrier film

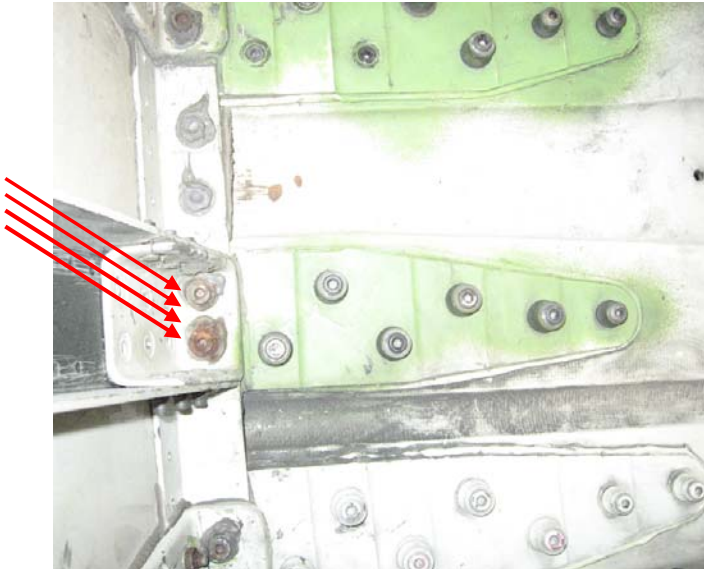
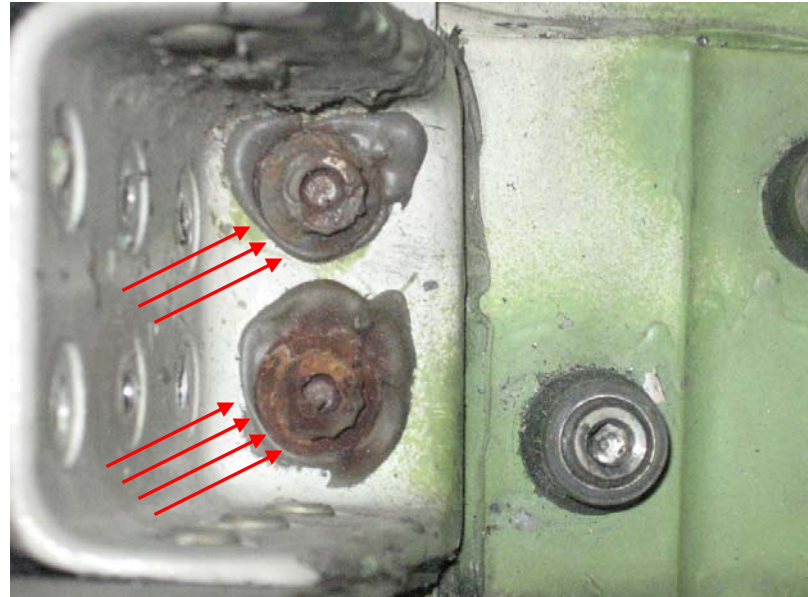
**A few corroded fasteners due
to sealant deterioration**

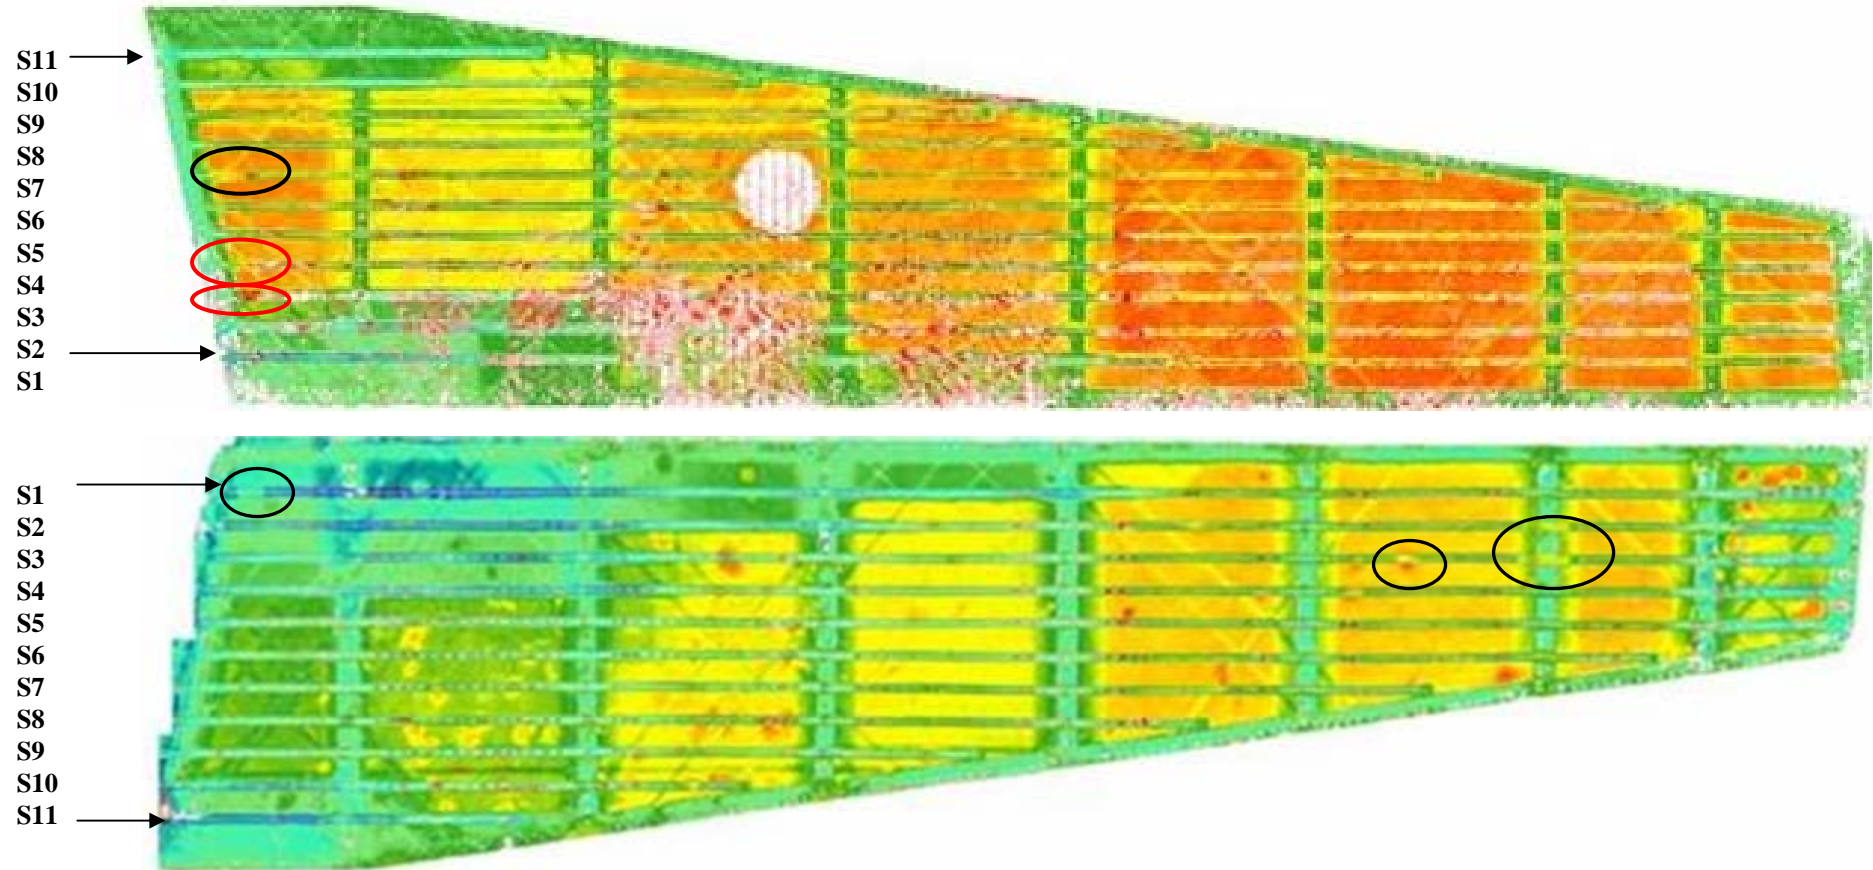
Rapidscan™ analysis (pulse echo time of flight data) of the R/H of the B737 stabilizer
(Courtesy of Sandia National Laboratories and NDT solutions ltd. UK)

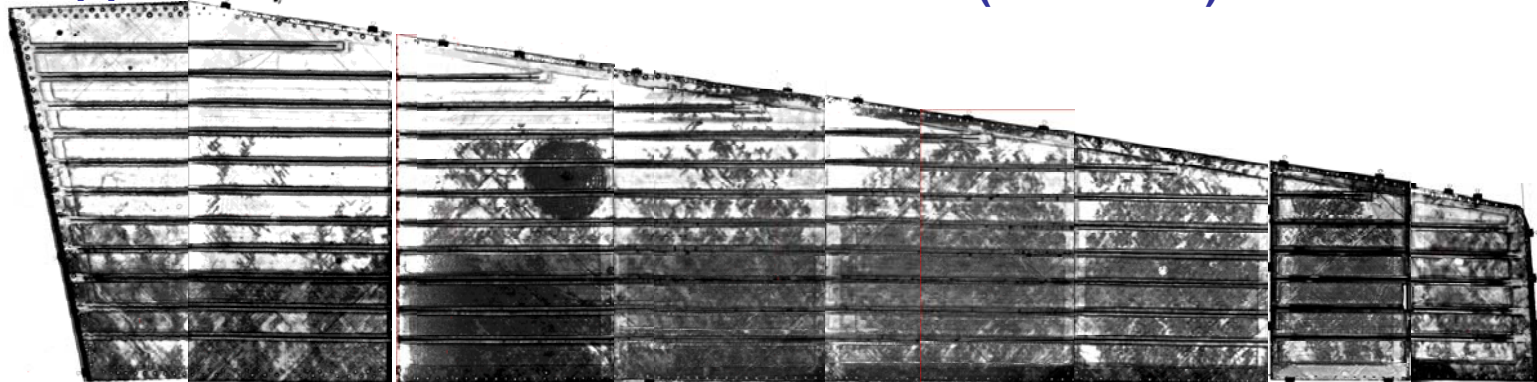
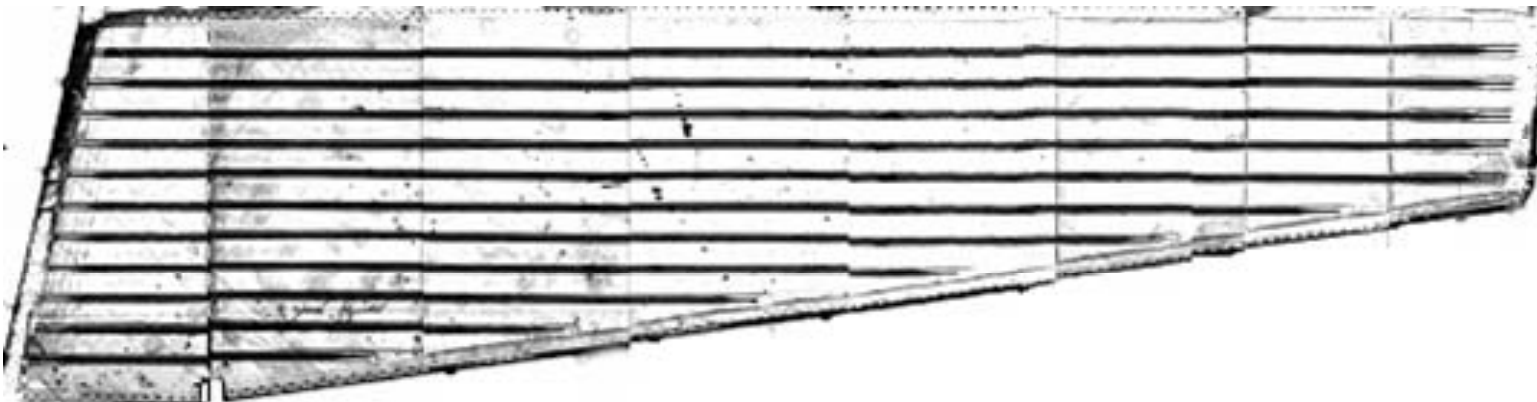
- NDI pulse echo inspection showed significant levels of porosity in the upper skin compared to the lower skin (tooling and process variability)
- Porosity levels have been quantified using image analysis/ physical tests
- Very porous repair between rib stations 2 and 3 (str 5 and 8)

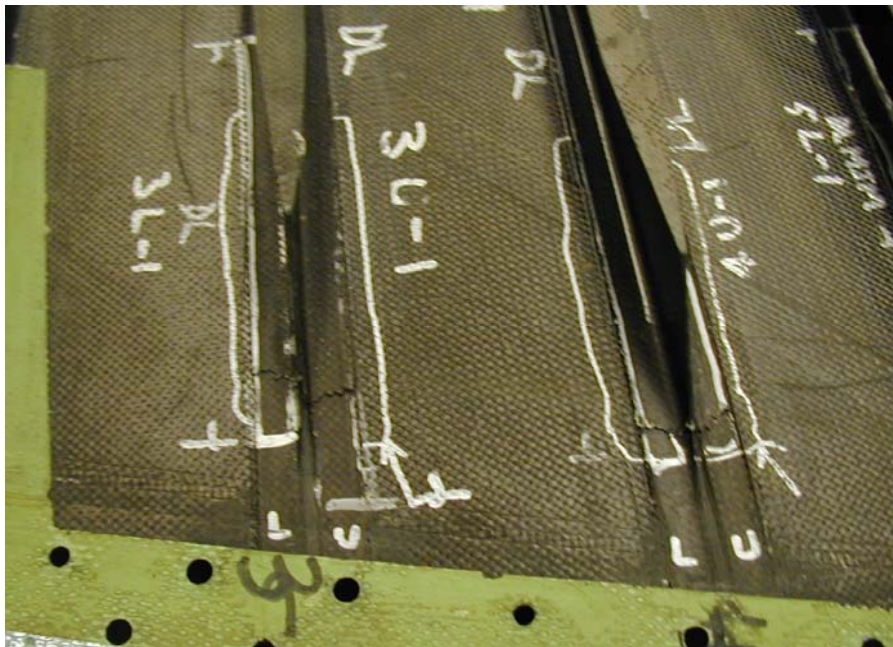
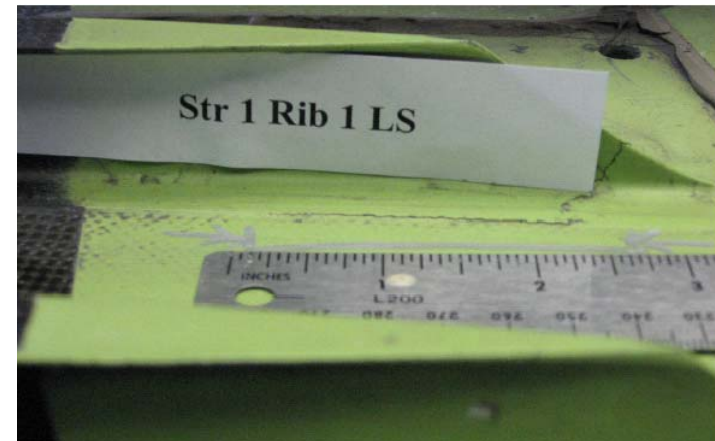
- DSO of 75000 flights
- Upper Skin Inboard delaminations at stringer runouts due to maintenance personnel walking on a no-step zone

Upper skin Inboard delaminations at stringer runouts

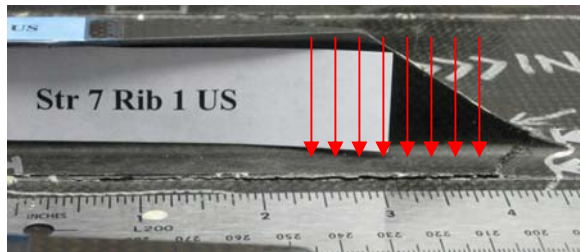
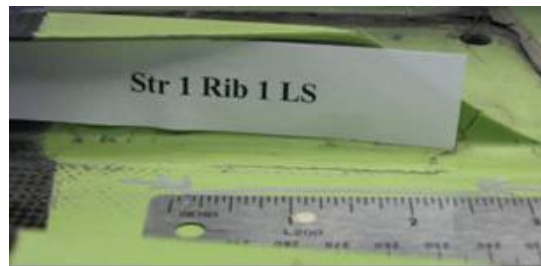
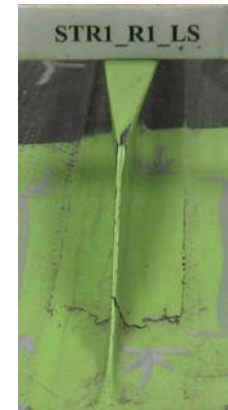
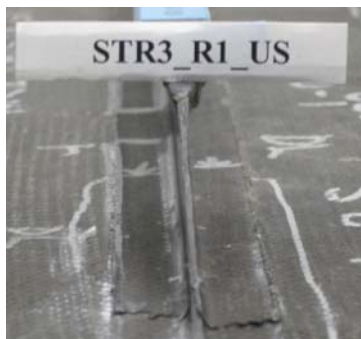
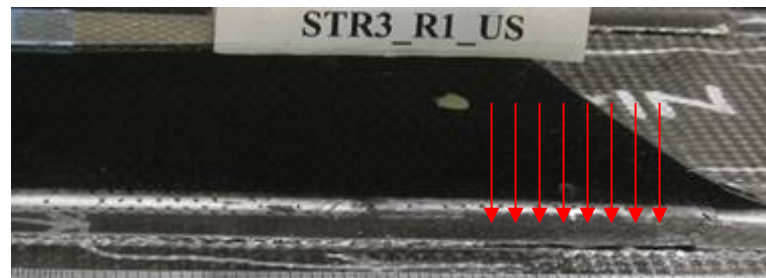
- Destructive evaluation has been conducted on sections of the stabilizer identified as disbonds from the NDI inspection to verify the existence of these delaminations. Destructive evaluation confirmed the results.

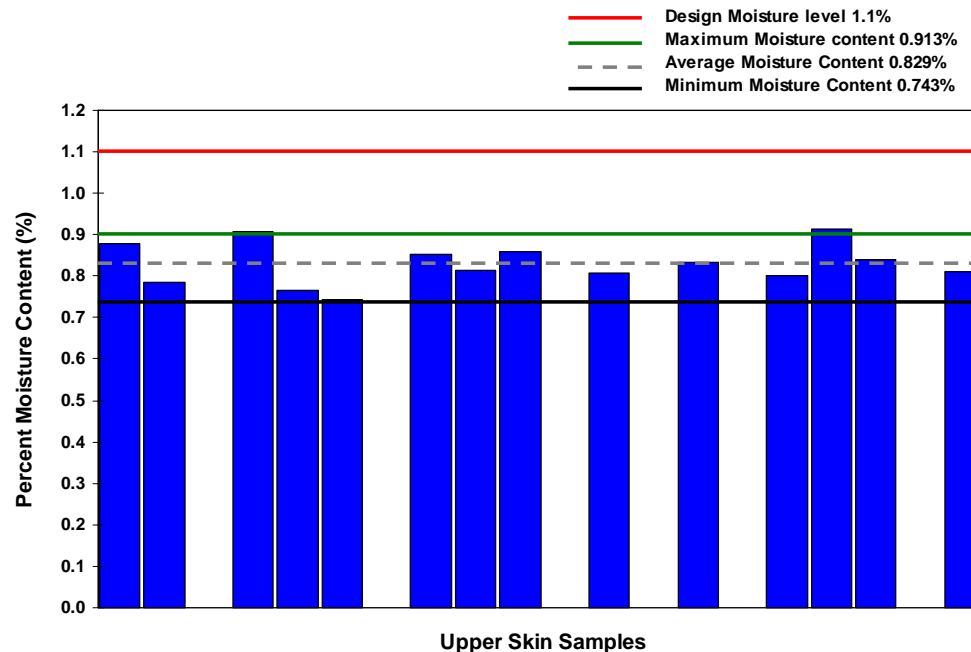
Moisture Distribution In the Upper Skin

- Moisture content in the aged structure has been quantified per ASTM D5229: specimens were extracted from different locations in the upper skin and lower skins of the stabilizer and have been dried to evaluate the moisture content of the structure.
- The results showed that the moisture content in the upper skin varied from 0.743 to 0.913% (design moisture level of 1.1%)

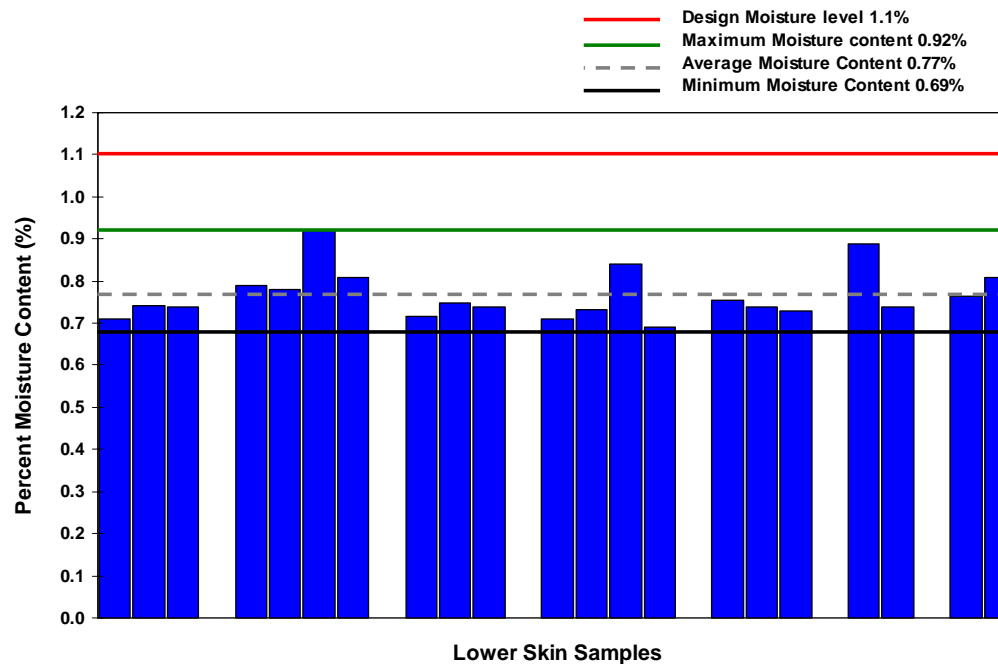
Moisture Distribution In the Lower Skin

- The moisture content in the lower skin varied from 0.69 to 0.92% (design moisture level of 1.1%)

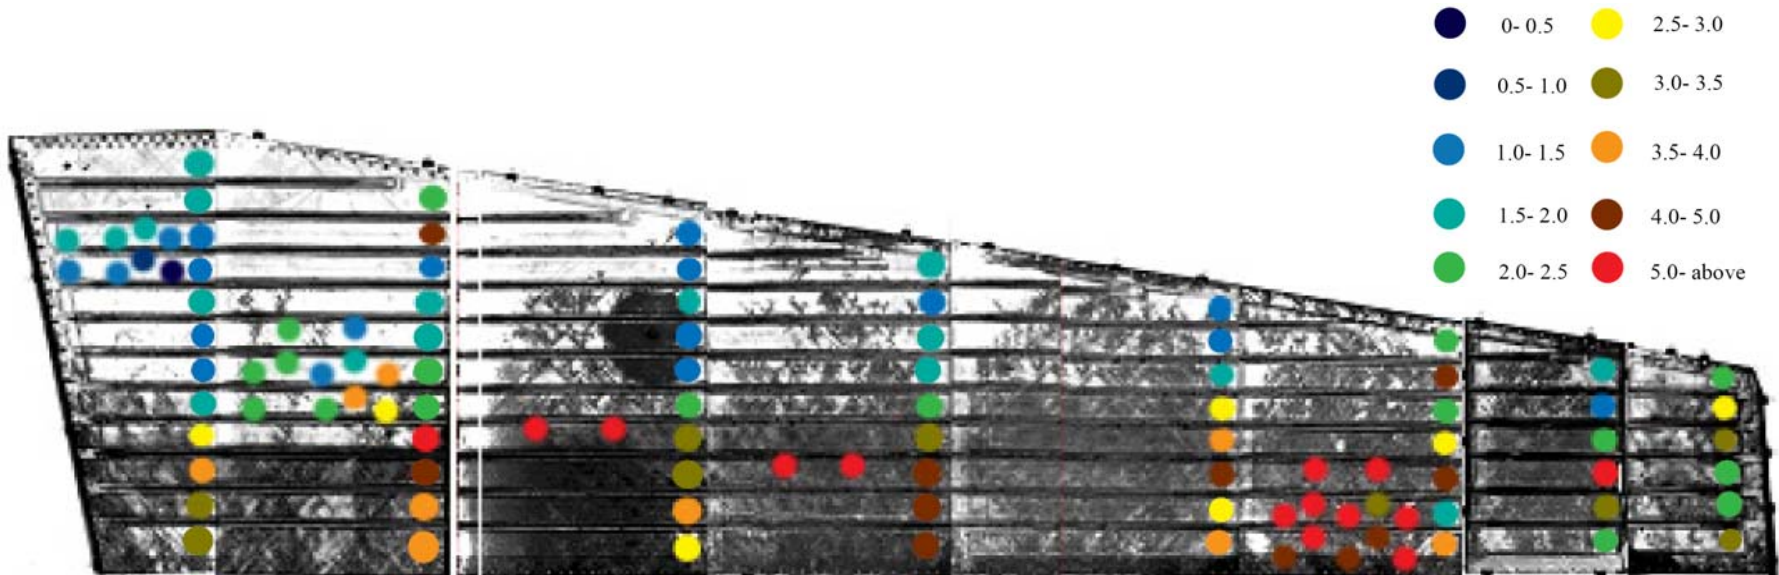
Upper Skin (Max void Content 7.26%)

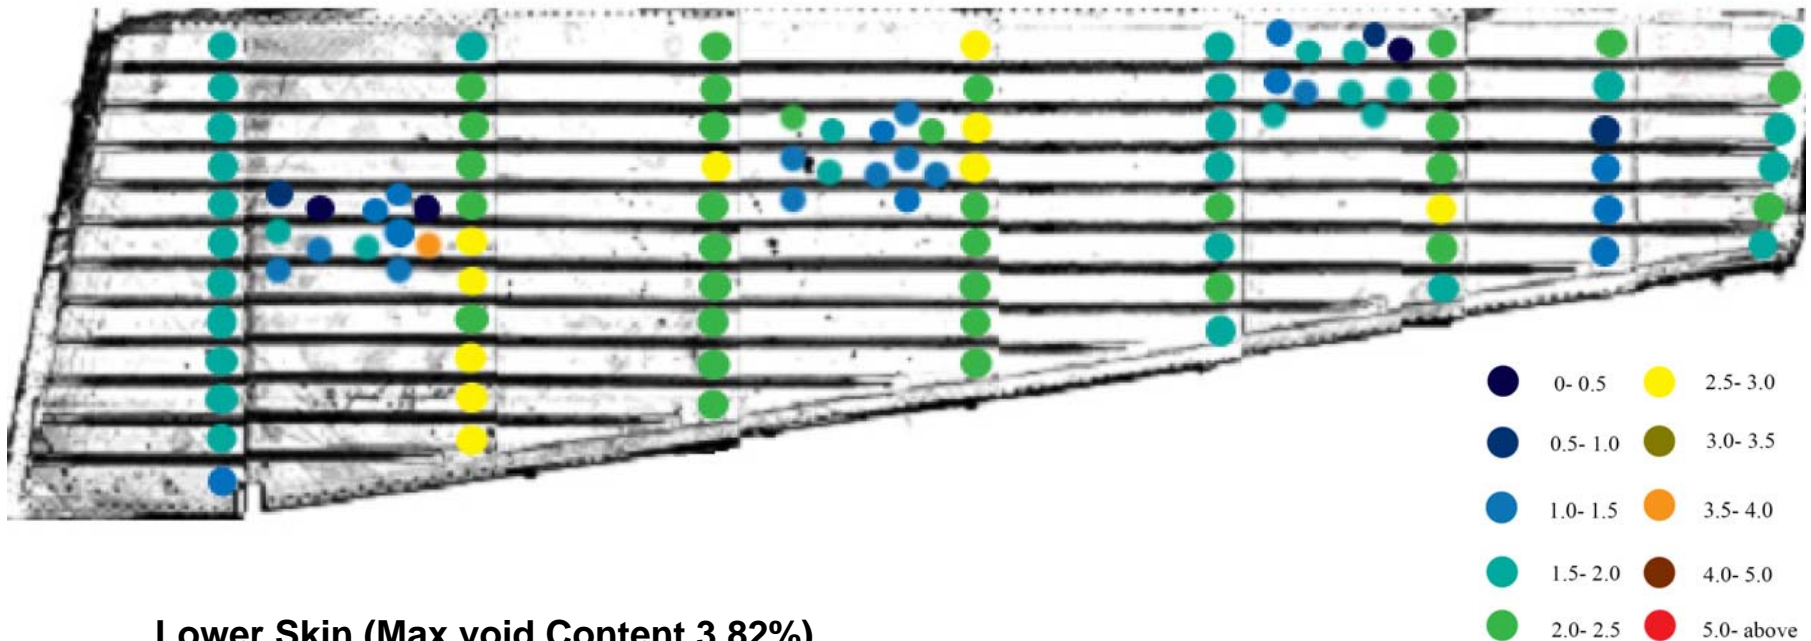
Lower Skin (Max void Content 3.82%)

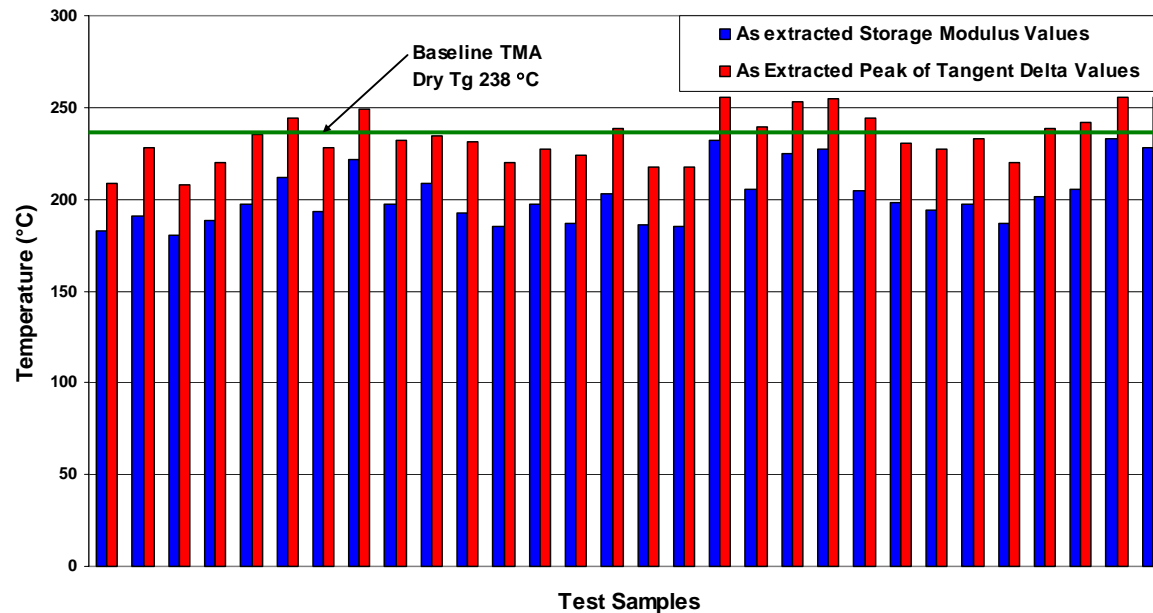
DMA Results for coupons excised from the upper skin of
the B-737 Horizontal Stabilizer (Boeing Method)

- Tg values consistent and comparable to LH Results (Courtesy the Boeing Co) average values for RH (201°C/233°C)
- DMA test parameters vary/ Tg obtained is a “wet” Tg (at least 0.69% moisture content)

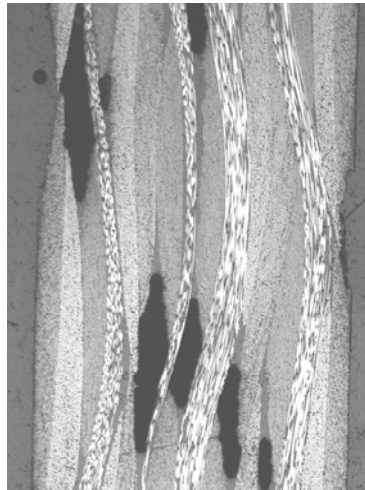
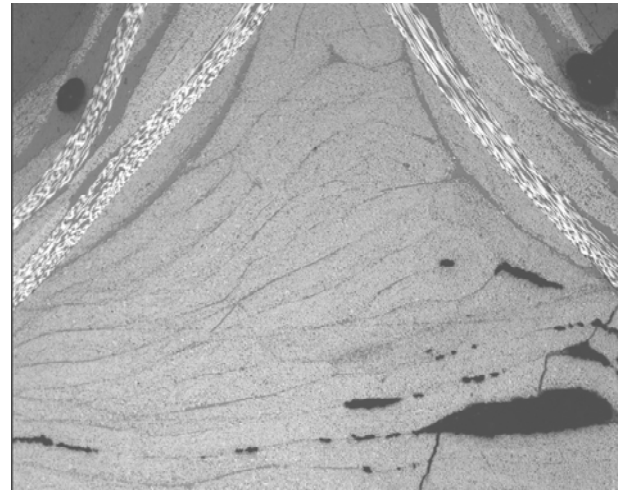
- Image analysis was performed to detect porosity/ micro-cracking and any evidence of aging in the structure.
- Both images show evidence of porosity embedded in the laminate. The flange cross section also shows evidence of microcracking initiating in the void areas.

**X-section of stringer 2, rib station 2 at a magnification of 50x
stringer web (left image) and flange (right image).**
