Inspection and Teardown of Aged In-Service Bonded Repairs

JAMS 2019 Technical Review – May 23, 2019

Waruna Seneviratne, John Tomblin, and Brandon Saathoff

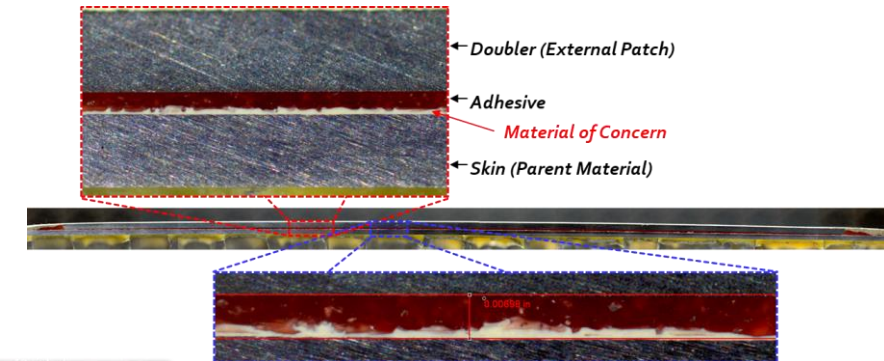
Peel Initiation
Start of Peel Test

- Lab prepared coupons used as “baseline” & compared to repair test results
- Component 14
 - Interfacial anomaly between the film adhesive and parent structure when an external patch was bonded over metallic honeycomb core repairs (witnessed on all 6 bonded repairs)

- Mechanical Testing: Post mechanical test failure analysis showed fracture across interfacial anomaly in all specimens
 - Repair Peel Strength: **≈64% of BL panels**

• Poor bond performance related to repair surface preparation (not aging)

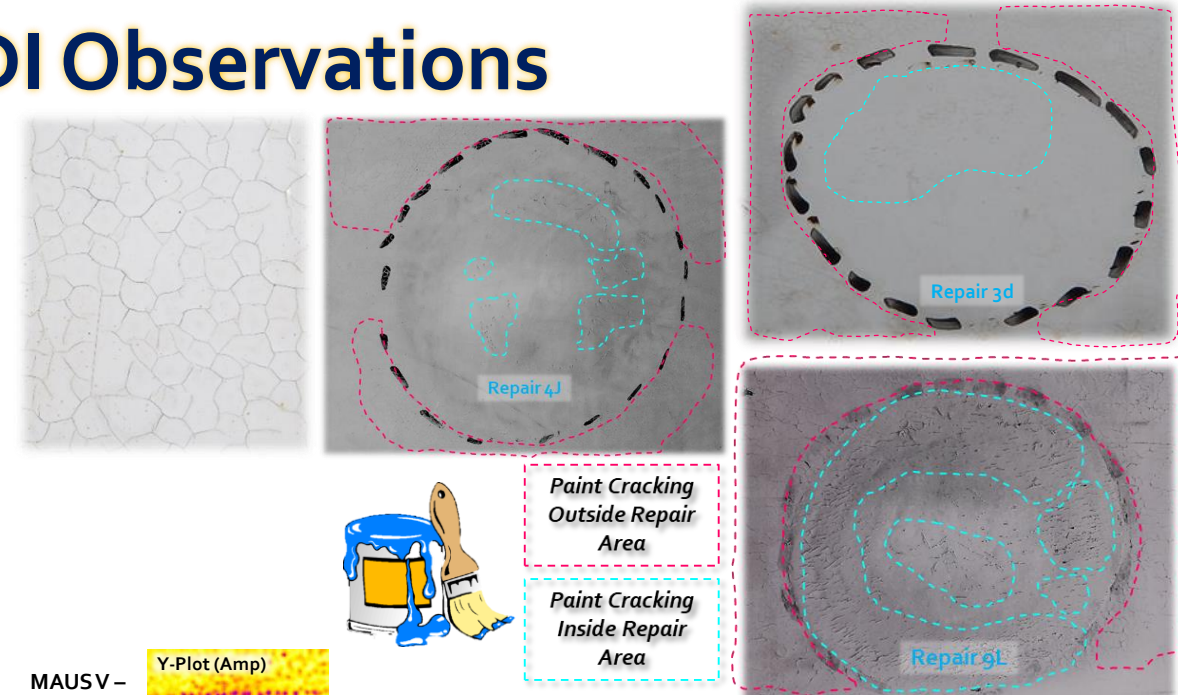
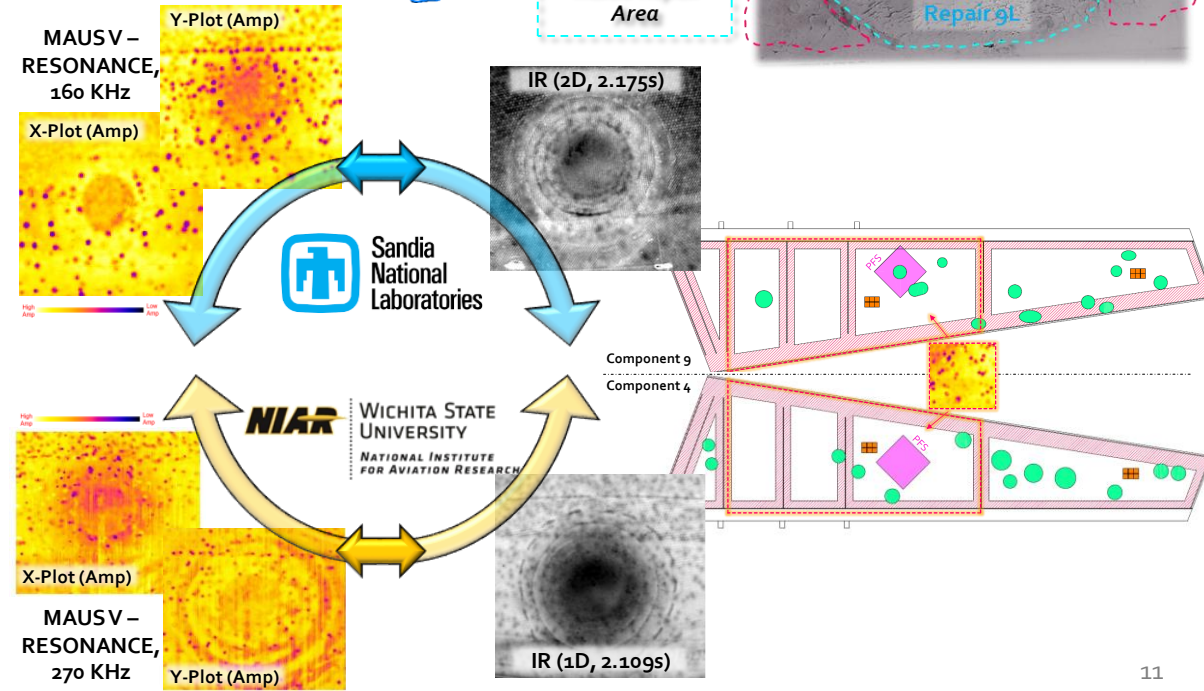
Structural Level NDI Observations

- Inspection Findings
 - Repair extended away from surface (not fully flush)
 - Paint Cracking (**32 of 41 repairs**)
 - Once cracking occurs, paint can no longer perform as an environmental barrier and can provide paths for moisture ingress to the structure
 - Concern for sandwich constructions with thin facesheets
 - Speckling Pattern (**9 of 41 repairs**)
 - Only witnessed in particular regions of O/B Components (4 & 9) – finding not related to repairs
 - Found in Resonance & Thermography (**not witnessed with MIA**)
 - Consistent amplitude change and pattern indicates build-up of material in individual honeycomb cells

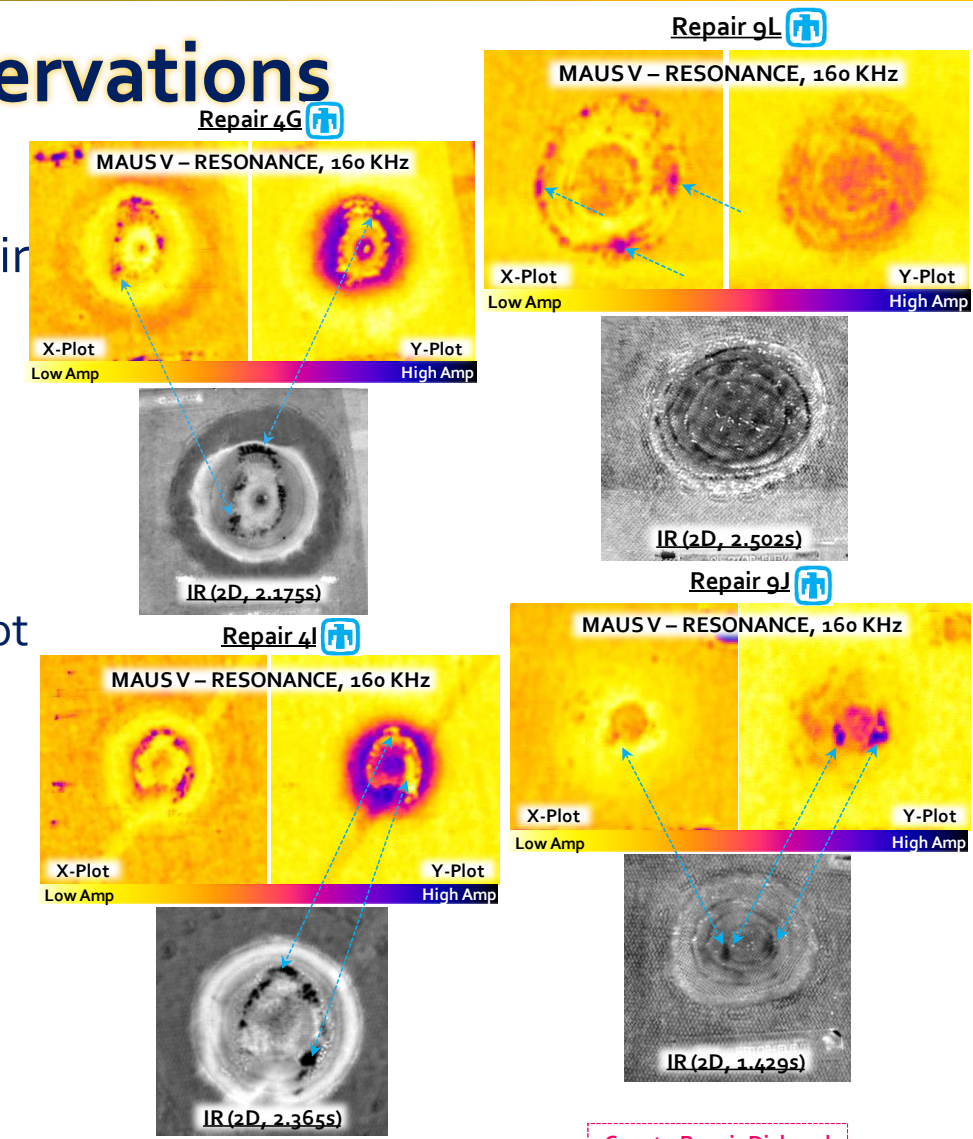
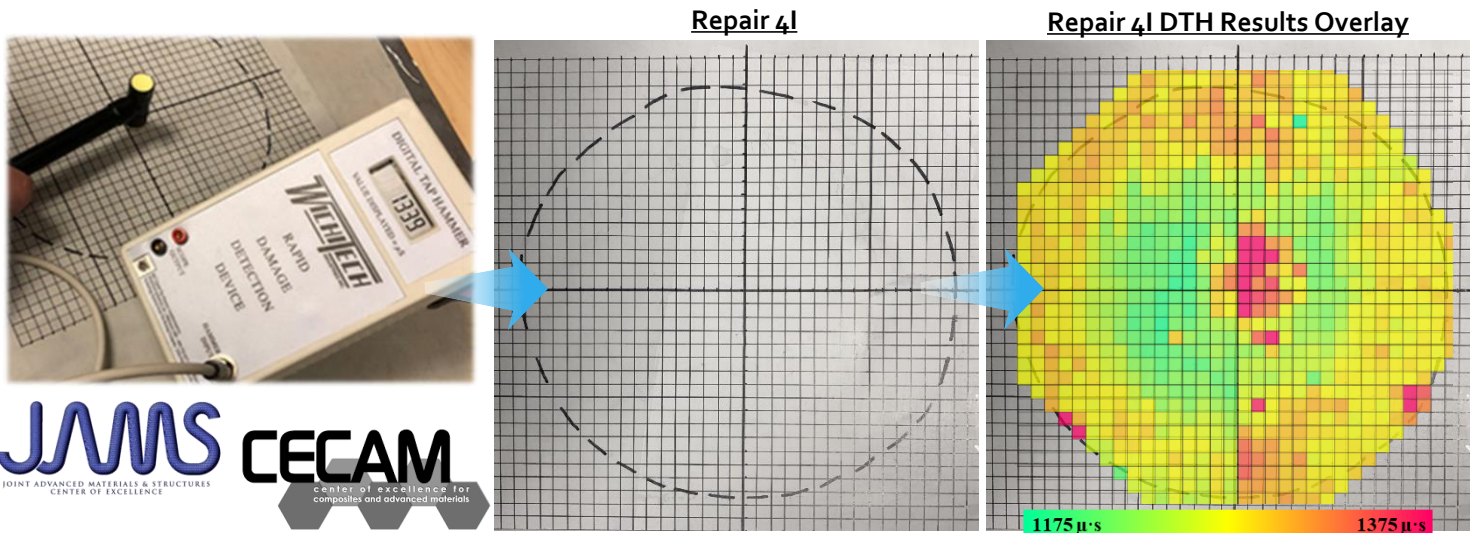
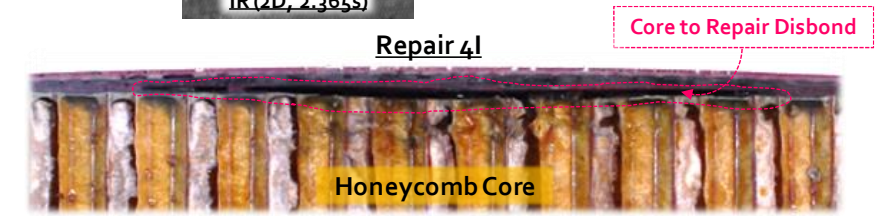
Structural Level NDI Observations

- Structural Level Inspection Findings
 - 4 of 41 repairs contained indications isolated within the repair region (Repairs 4I, 4G, 9J, & 9L – highest interest)
 - Indications isolated within the repair region were most pronounced in resonance and thermography inspections (not witnessed with MIA)
 - Indications could be due to porosity or small damages near repaired damage that fell within allowable damage criteria (not repaired)
 - Digital tap hammer inspections showed similar features

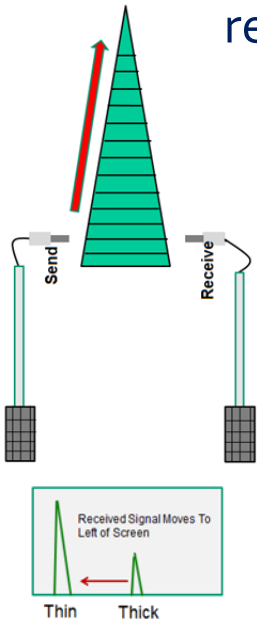
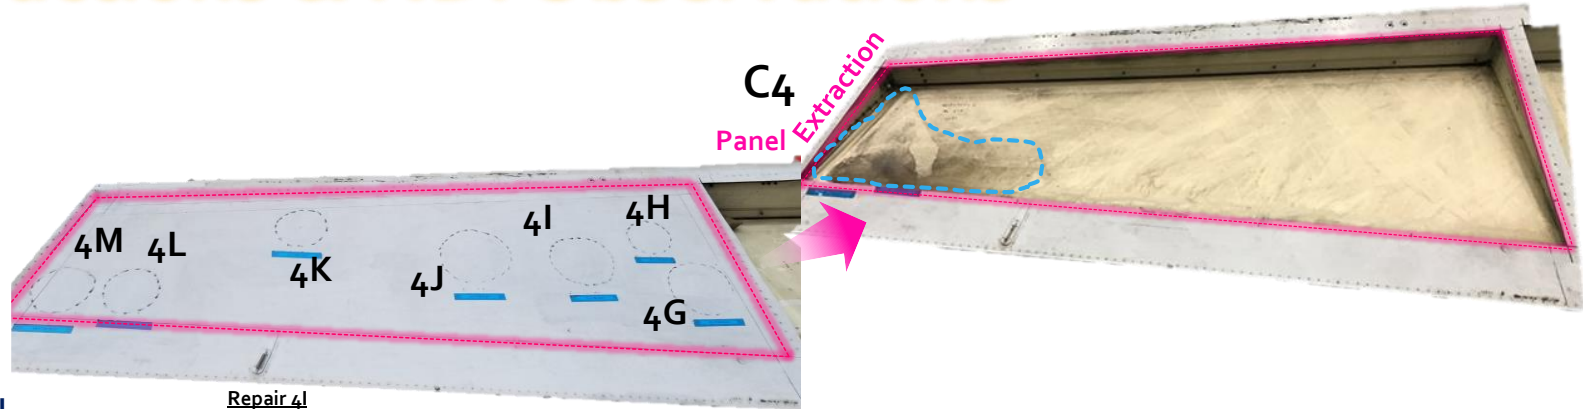
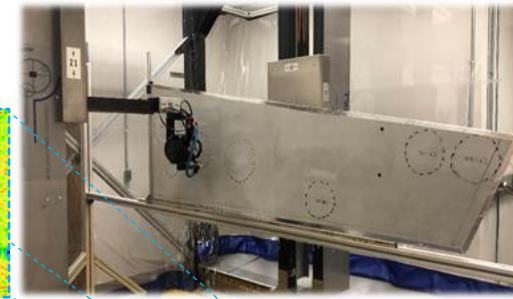
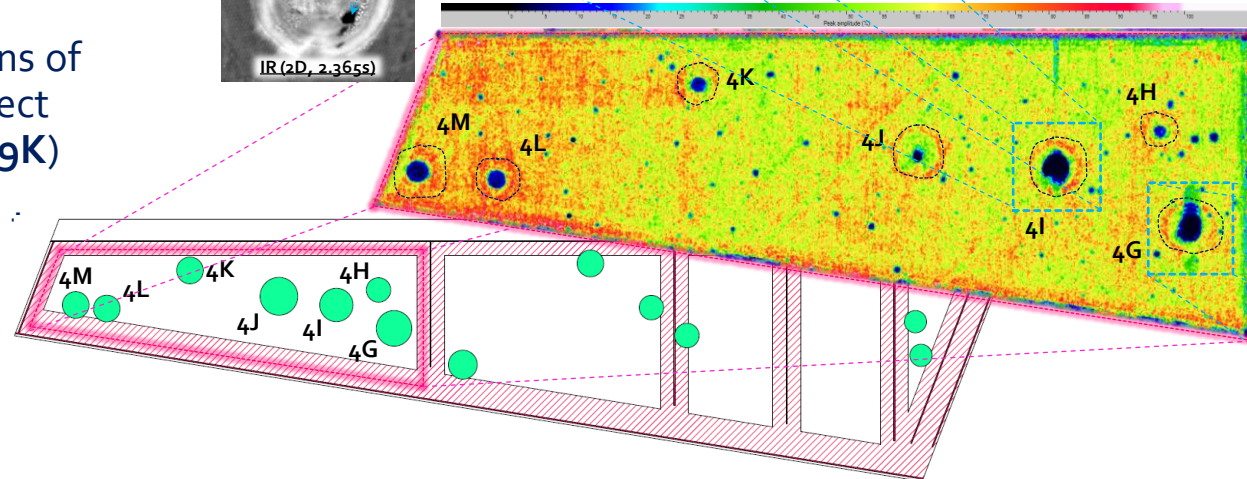
Panel Extractions & NDI Observations

- Panel Level TTU C-scan Inspection Findings

- 6 of 41 repairs contained indications isolated within the repair region

- 4 of these 6 repairs were noted within structural level inspections for containing indications within the bond region

- 2 repairs contained indications missed at structural level inspections due to limitations of the methods applied to detect sub-surface features (9B & 9K)

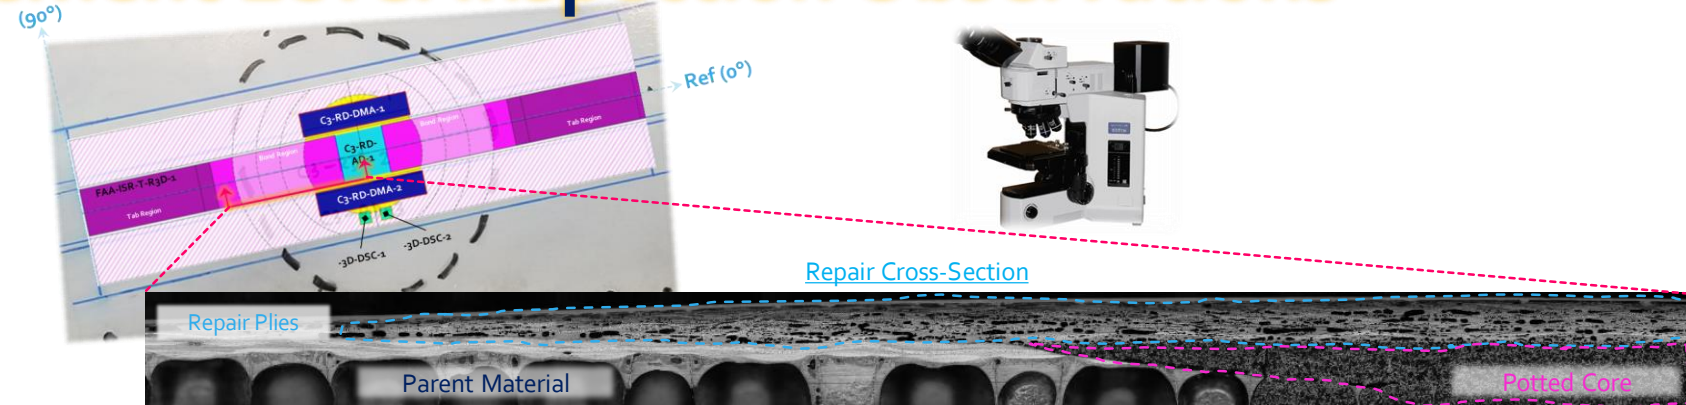
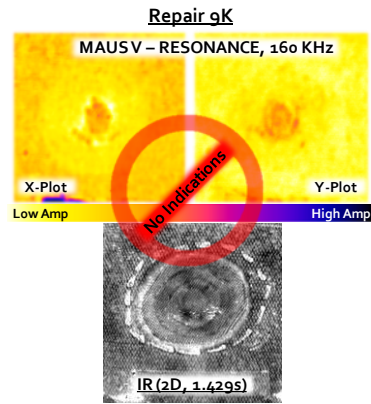
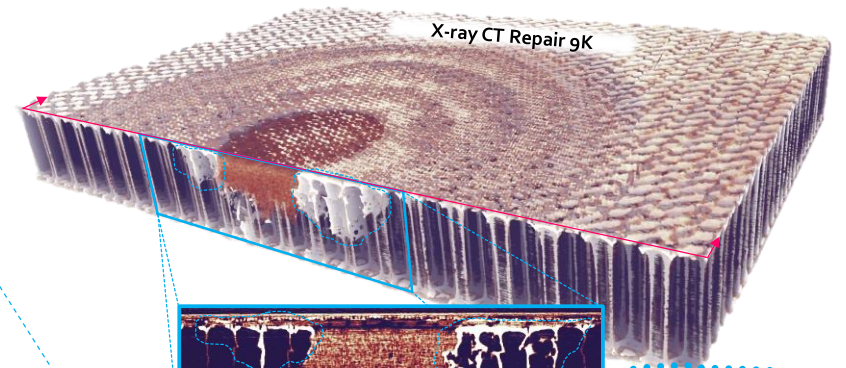
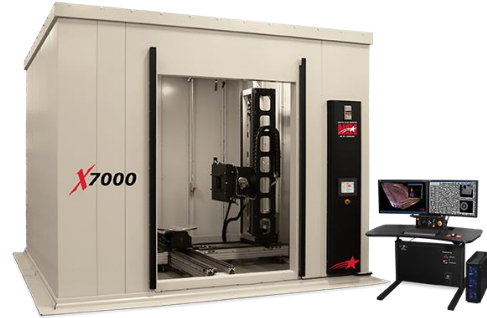
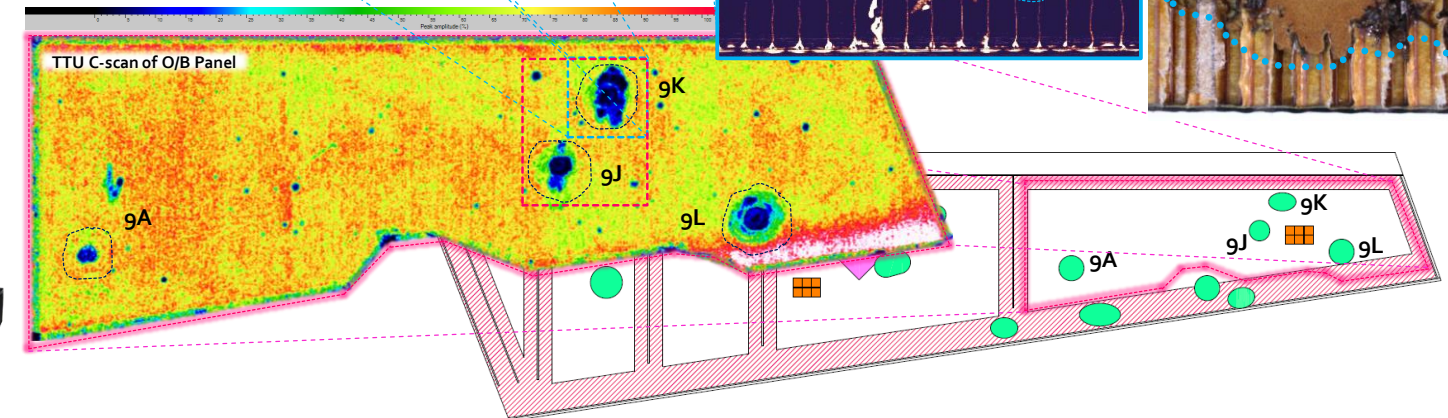
Specimen/Element Level Inspection Observations

- Microscopic Inspection
 - High levels of porosity noted
 - Cross-sections evaluated to determine root-cause of indications
- X-ray CT
 - Select repairs evaluated prior to element level testing
 - Focused on repairs with indications within repair region at panel level and not structural level inspections

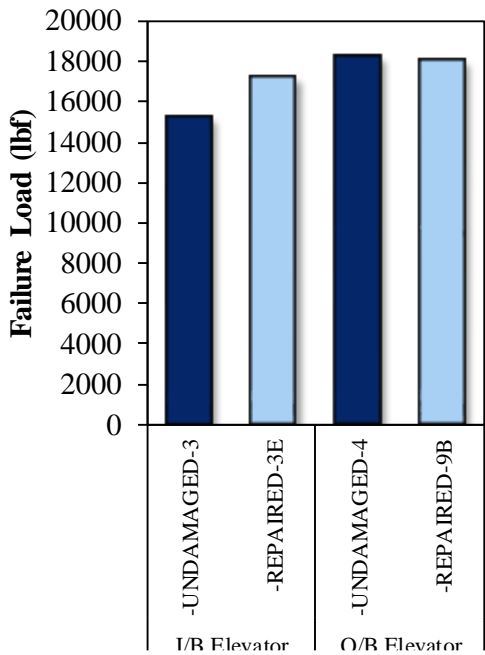
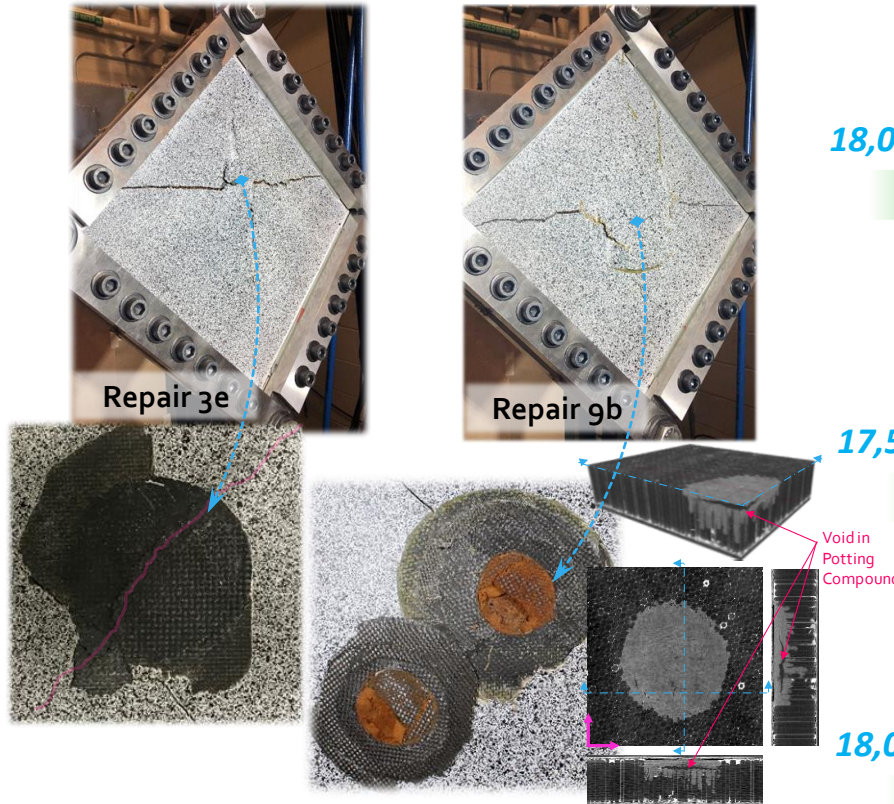
Picture Frame Shear Test Results

- No significant loss in strength witnessed
- Repair 9b popped away from parent material with no failure through patch material
- Repair 3e failed through repair patch material

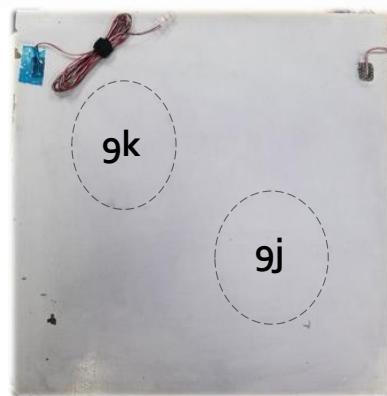
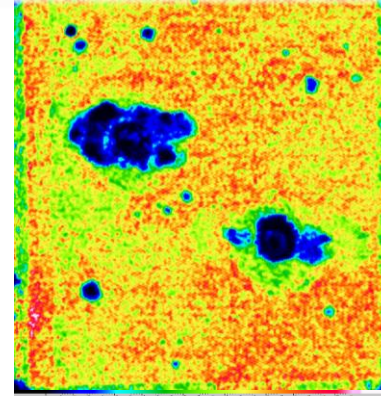
Repair 9j & 9k TTU C-scan

- Edgewise Compression Configurations (16-inches x 16-inches)
 - Pristine “Baseline” – Extracted from component 9 adjacent to repairs 9j/9k
 - Multiple Repairs (Close Proximity w/ Indications from NDI) – Component 9 repairs 9j & 9k
 - Single Repair (no indications) – Component 4 repair 4j

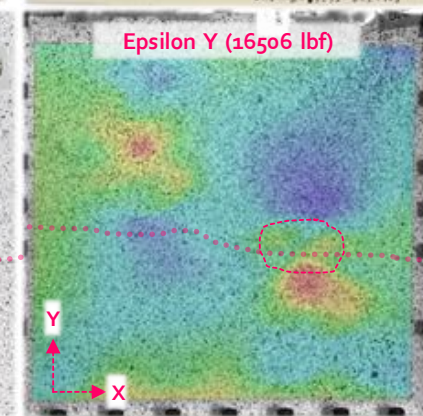
Repair gJ/gK Post-Test Picture (ARAMIS Paint Removed)

- No significant loss in strength witnessed (repair failure loads **within 3.2%** of pristine failure load)
- Failure witnessed through repairs
 - Failure was not witnessed through any of the indications noted in the pre-test inspections for repair gk
