## Effects of Several Variables on the performance of Repairs Applied to Laminate and Sandwich Structures

# To investigate different variables on the performance of repairs applied to solid laminates and sandwich structures

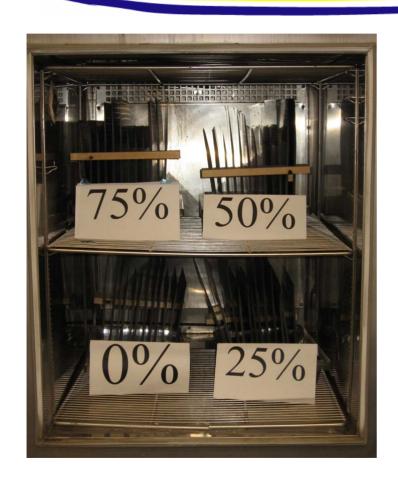
**Exposure to Water and Skydrol in progress**
