JAMS

Fluid Ingression Damage Mechanism in Composite Sandwich Structures

Allison Crockett, Wichita State University
Hal Loken, Consultant
John Tomblin, Wichita State University
July 10, 2007

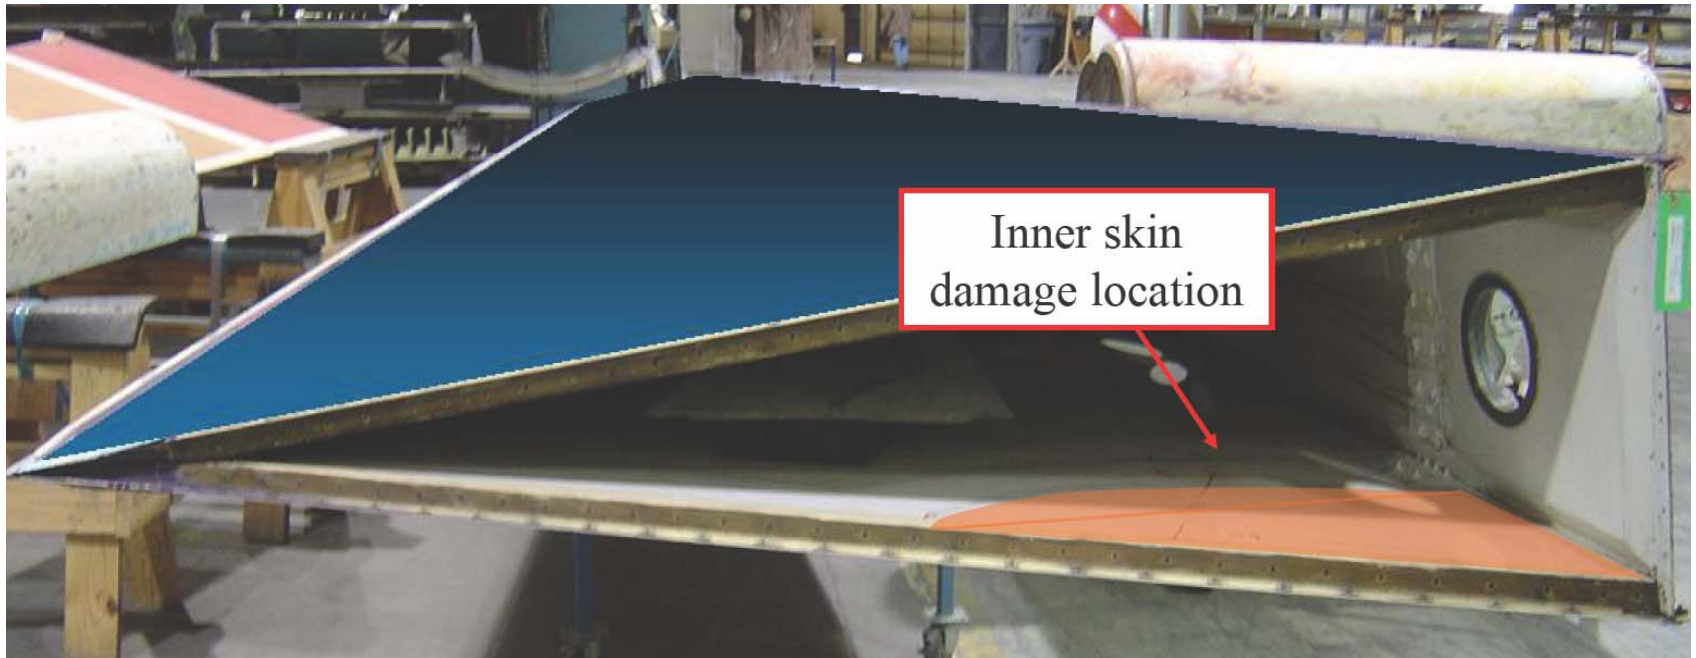
- Upon removing the inner skin for maintenance the fluid damage was revealed.
- After some investigation the fluid was identified as Hydraulic fluid.

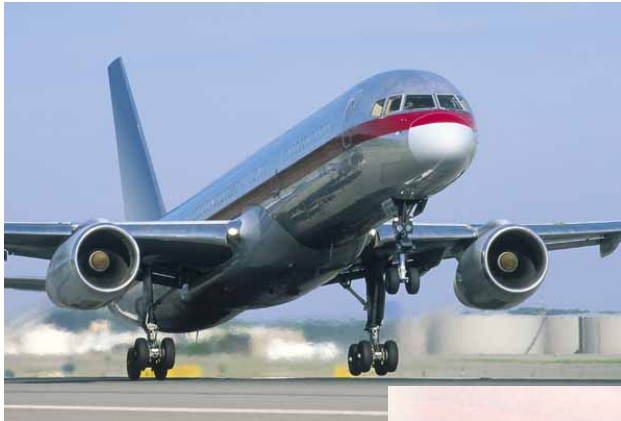
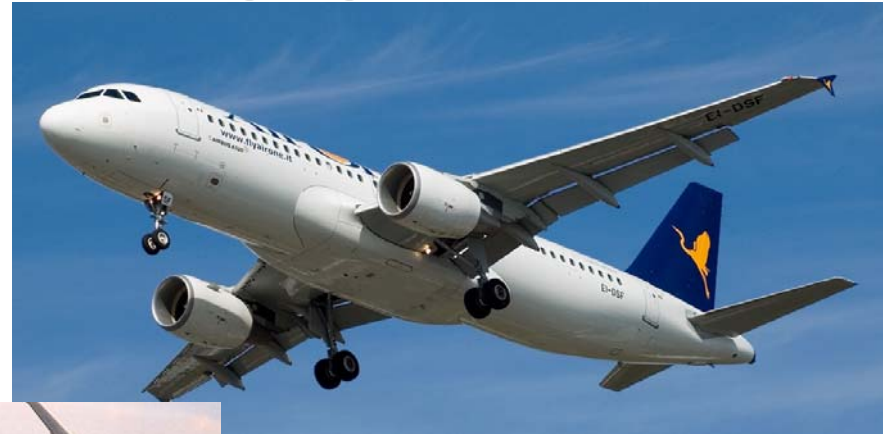
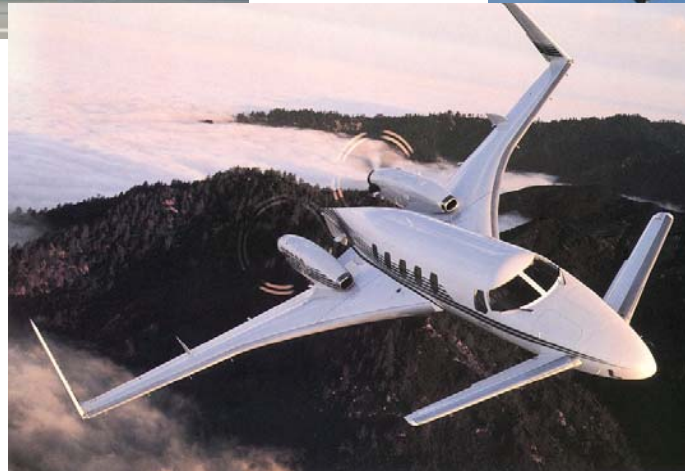
Existing Fleet & Recently Retired

Characterize existing structural parts and configurations (with potential aging effects)
