WICHITA STATE
UNIVERSITY
NATIONAL INSTITUTE
FOR AVIATION RESEARCH

NIAR Impact Testing Investigation Report For Hexcel 8552 IM7 Unidirectional Prepreg 190 gsm & 35%RC

NCAMP Test Report Number: CAM-RP-2013-020 Rev N/C

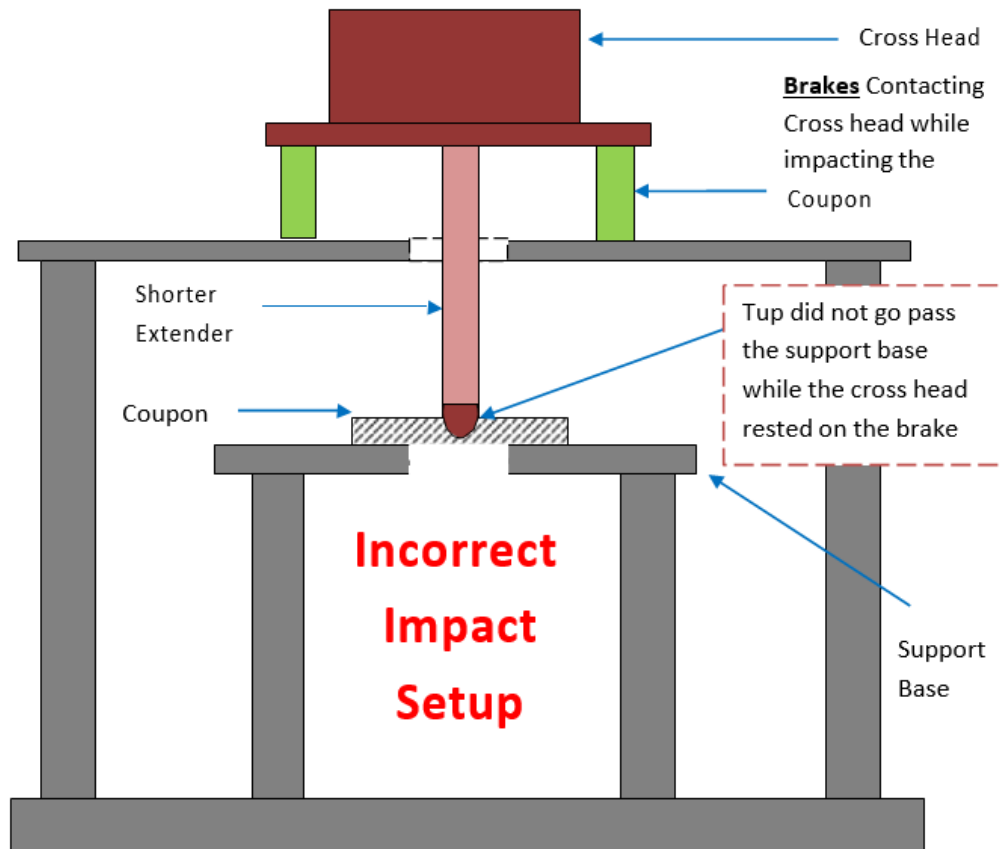
Figure 1 – **Incorrect** Impact Setup for 2008 Qualification/Equivalency program

The impact setup was erroneous due to the use of a shorter extender where the tip of the impactor tup barely reached the top of the support base when the entire crosshead assembly rested on the brakes. Figure 1 illustrates the incorrect setup used where some of the impact energy was absorbed by the breaks during impact and resulted in a smaller damage area.

With the shorter extender impact setup, the entire crosshead assembly struck the brakes when the impactor tup hit the CAI specimen. The impact energy was absorbed by the breaks instead of transferring completely to the CAI specimen. Due to this dampening, a lower drop weight was recorded. Figure 3 shows a measured drop weight of 13.45 lbf compared to 13.81 lbf in Figure 4, which is what should have been recorded if a correct, longer extender was used. Impact tests performed using remnant material from the 2008 program yielded results comparable to the 2012/2013 test data.

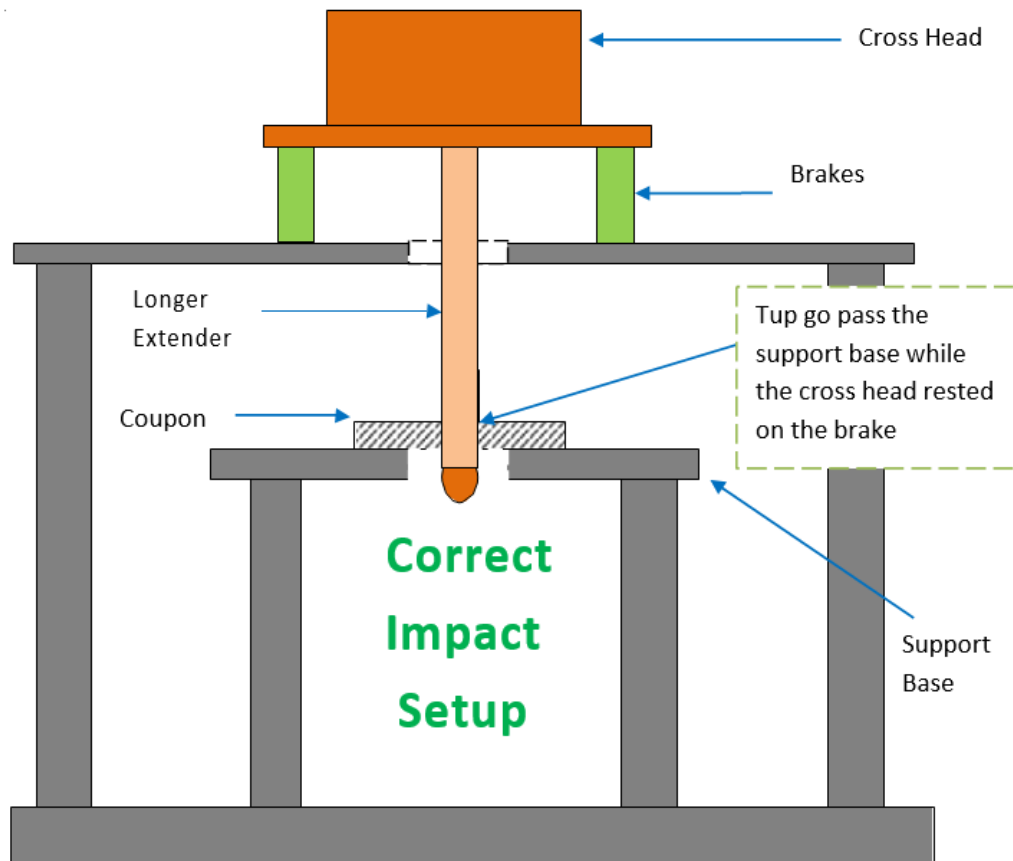
Figure 2 - **Correct** Impact Setup for 2013 Trial CAI and Equivalency Program

A correct impact setup, illustrated in Figure 2, would require utilization of a longer extender that would allow the impactor tup to go past the top of the support base for a complete energy transfer to the coupon before the crosshead assembly reaches the brakes.

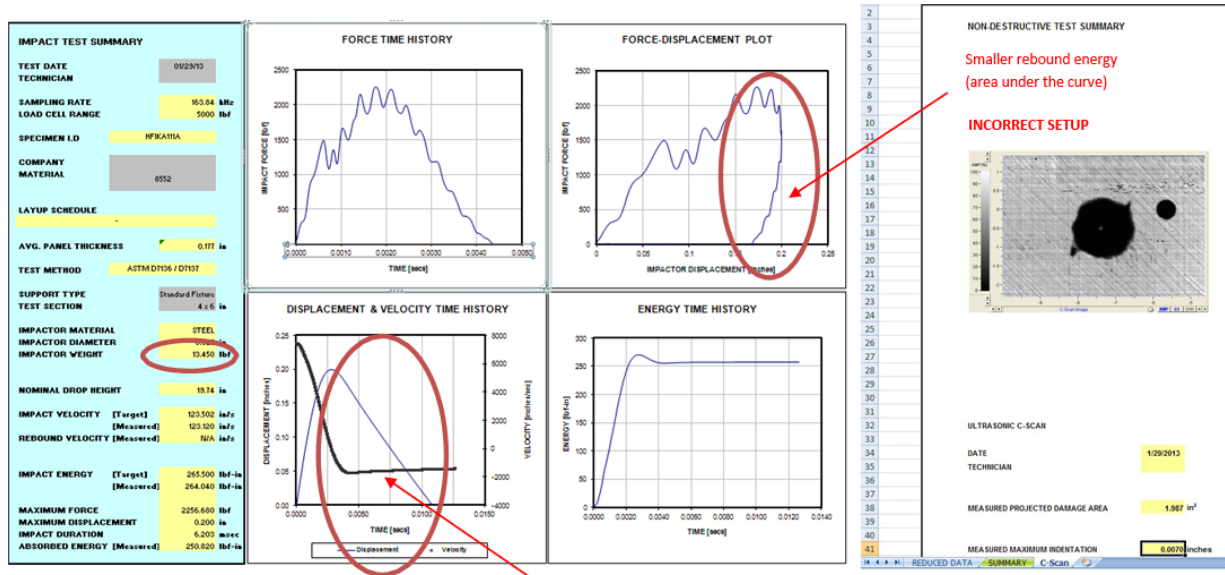
Figure 5 - Plots and C-Scan of 2008 Qualification sample

If the energy is partially absorbed by the brakes, the resulting rebound energy and velocity will also be reduced, which is what was observed in the 2008 qualification. Figure 5 shows the plots and resultant impact damage area. The impact damage is observed to be smaller, thus yielding a larger strength when tested in compression.

Given that the outcome of a correct impact setup would result in a more conservative compressive strength result, the 2008 Qualification dataset is omitted from the reports.

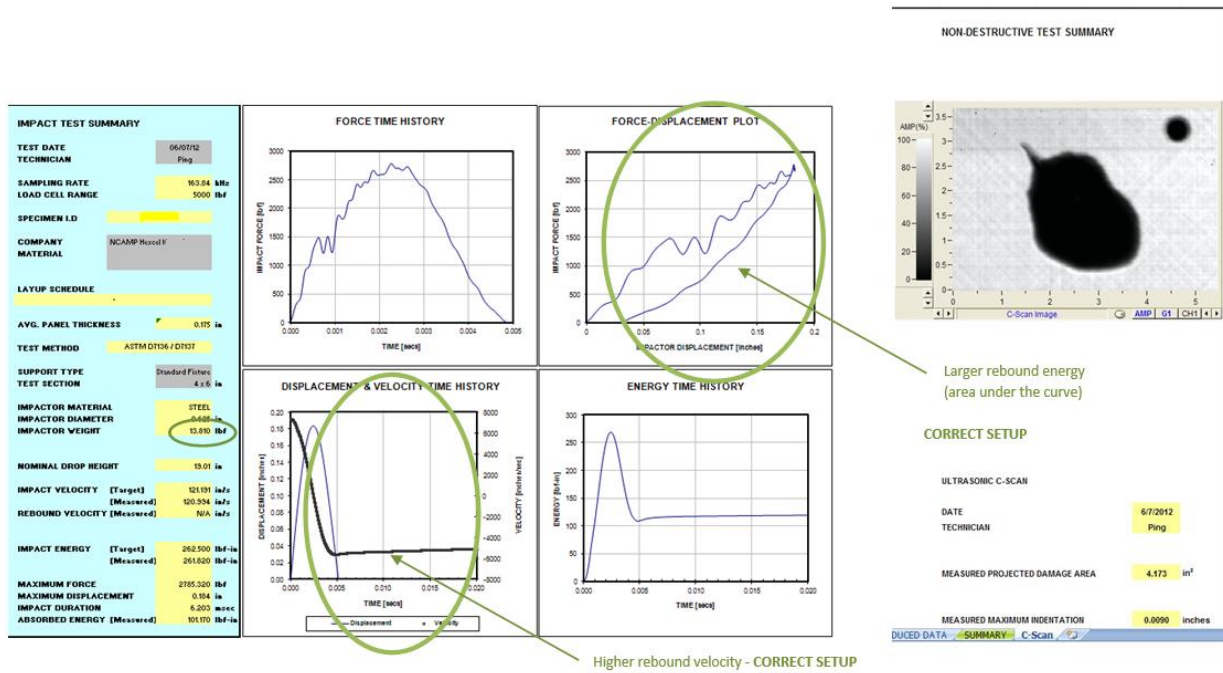
Figure 6 - Plots and C-Scan for 2013 Equivalency sample

When a correct impact setup is used the impact energy is transferred to the specimens completely resulting in a larger rebound energy, and subsequently a higher rebound height and velocity. This is illustrated in Figure 6. With a complete transfer of velocity and energy, the resulting impact damage area will be larger, leading to a lower compressive strength.
