**Kansas Aviation Research and Technology (KART) Program
KART R51827**

**Experimental Identification of
Lightning Conducted-Current
Fastener Sparking Thresholds
(25.981 Project) – Test Results**

Metal Test Report

Document Number: ENV-RP-2016-003– Rev A

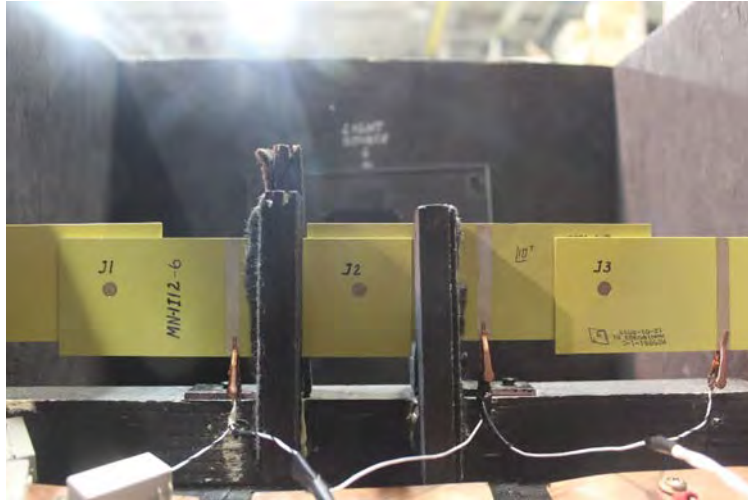
Figure 1: Test Article MN-1I12, #6, before the test

See Figure 1 to Figure 3 for an example of a test article with fluctuating voltage waveforms that represent sparking in a metal test article containing a single HI-LOK™ fastener in each joint. There are external ignition sources in joint 1 and joint 2 and no ignition source in joint 3.

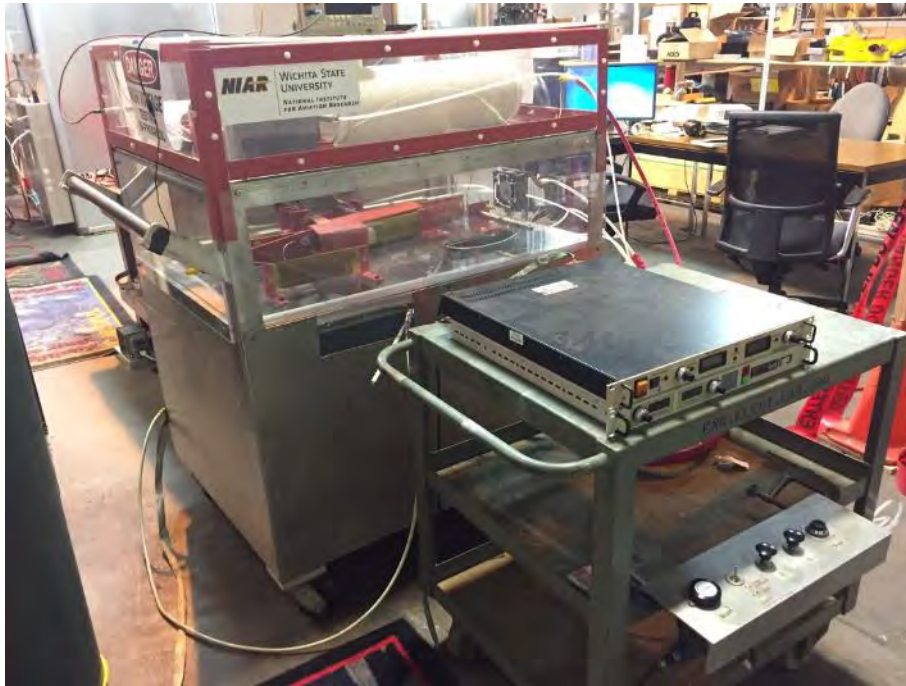
Figure 8: Front View of 25.981 Lightning Generator

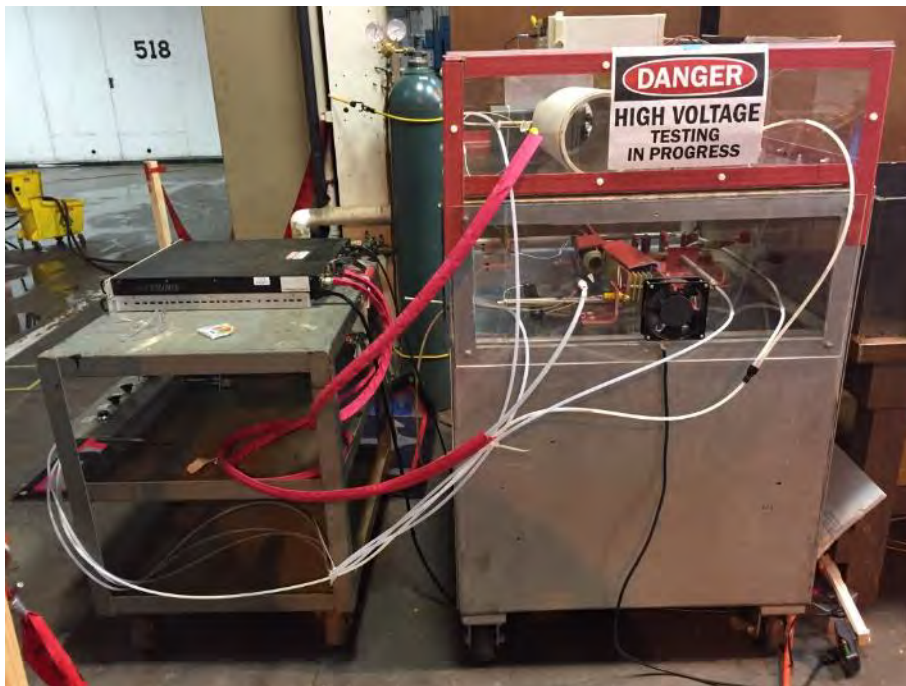
Figure 9: Side View of 25.981 Lightning Generator

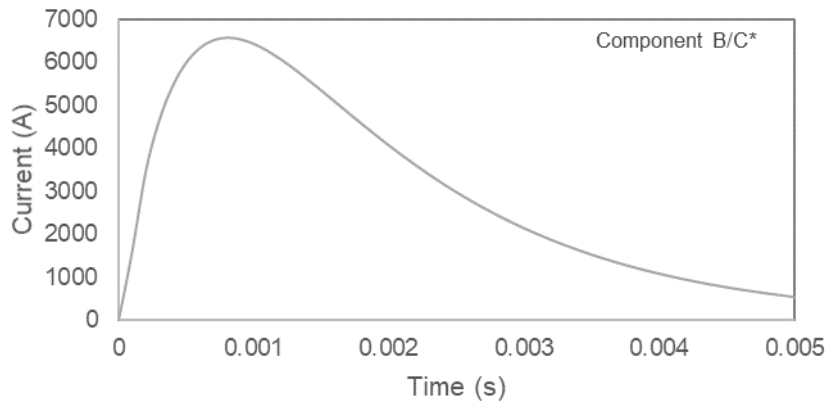
- Unidirectional waveform
- 250 kA²s±20% action integral in 500 μs
- Peak current of 100 kA
- 6.4 μs rise time, 70 μs to 50% decay
- Total time ≤ 500μs

Figure 11: Scaled Current Component B/C* Waveform

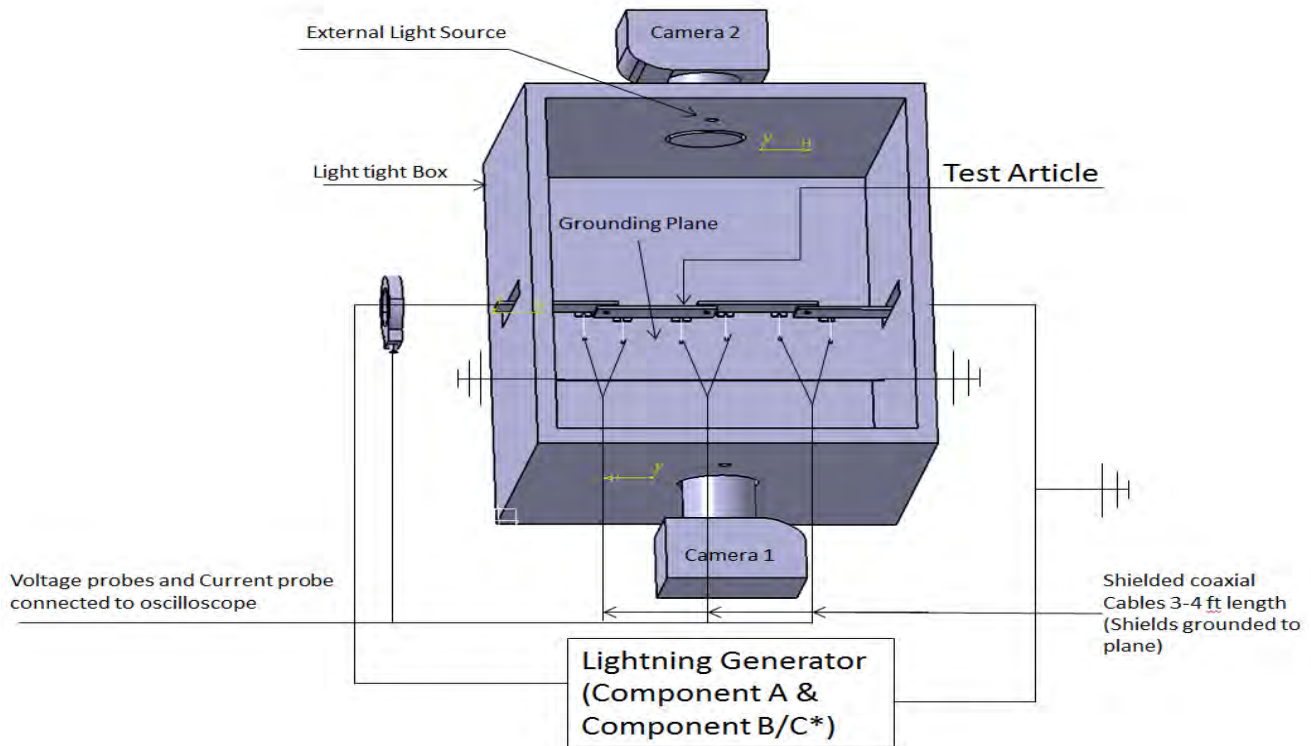
For the 25.981 generator, the light-tight photographic chamber was constructed in accordance with ARP 5416A, Section 7.7.1, which describes the photographic test method. The chamber contains two reference light sources, one on each side, for verifying the camera shutters proper opening during the test. A schematic of the electrical circuit containing the photographic chamber is shown in Figure 12. The test setups between the two generators were identical, except the voltage probes were not used at the direct effects generator.

Figure 12: Schematic of the Photographic Chamber

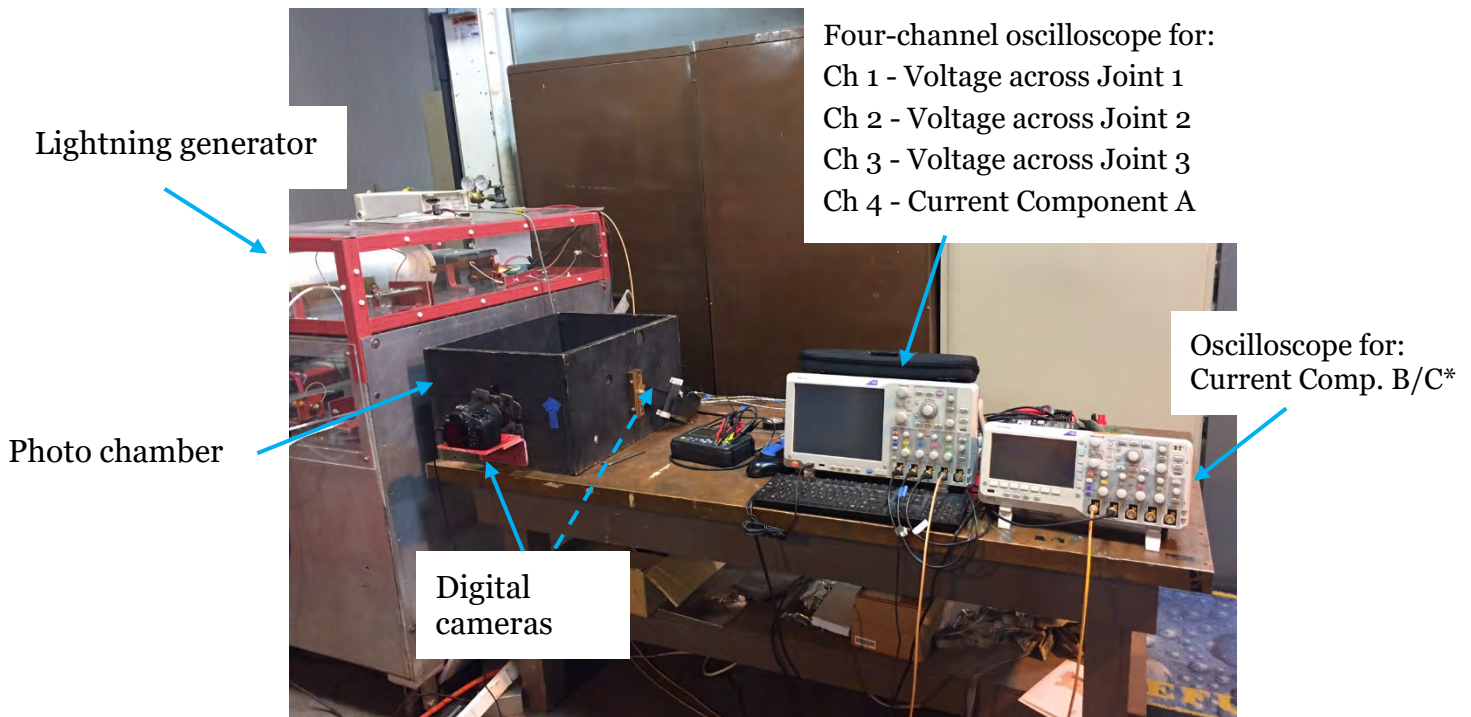
Figure 13: 25.981 Generator Test Setup

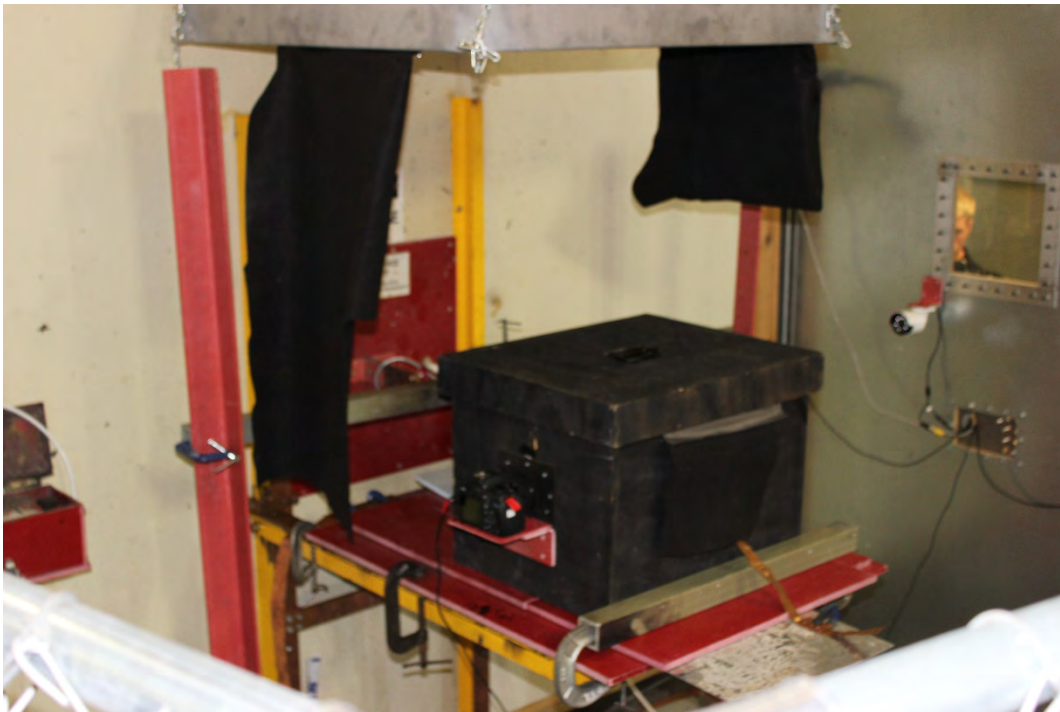
Figure 15: DEL Generator Setup

Figure 14. The test setup for the direct effects generator is shown in Figure 15.

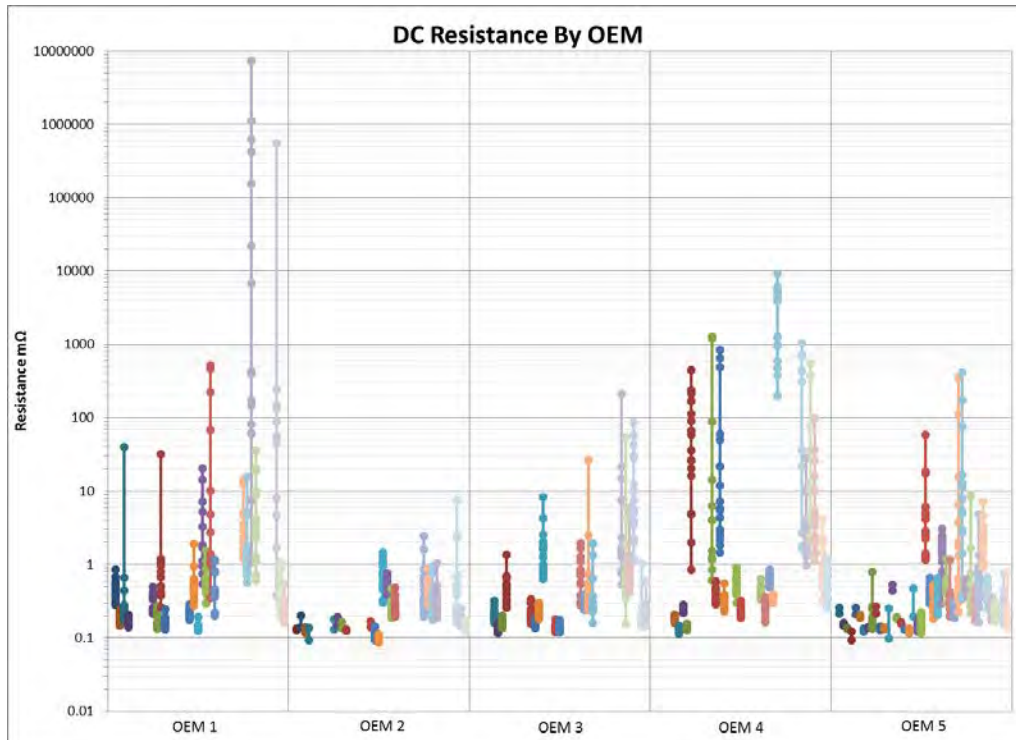
Check-in resistances for OEM 5 were consistent with the other OEMs where most of the resistance measurements were below 10 mΩ. The check-in resistance values for the two configurations with the non-conductive coating were high, measuring around 400 mΩ, but that is also consistent across all OEMs. The one anomaly for OEM 5 is that the check-in resistance measurements for MN-1I01 were higher than other comparable test articles.

Figure 16: Nominal DC Resistance at Check-In

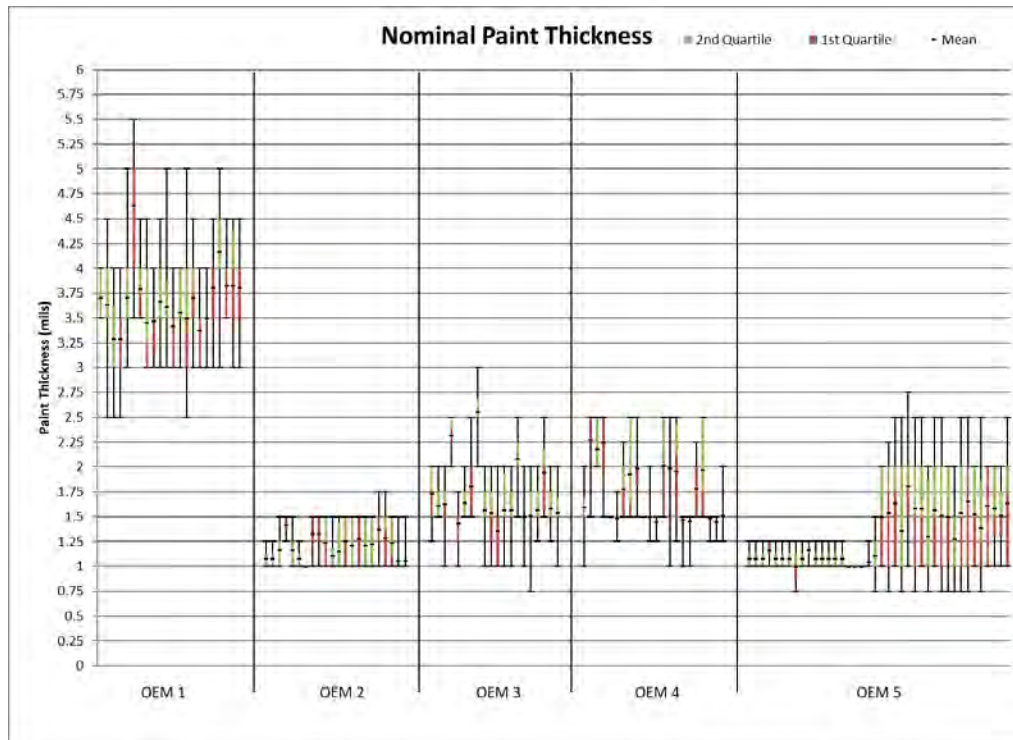
Check-in coating thicknesses for OEM 5 were consistent with the other OEMs where most of the thickness measurements were around 1.5 mils. The variance difference between the quadruples and the singles is understandable because there were 6 single-fastener test articles and only 1 quad test article so the single-fastener test articles would have a much larger variance. The difference in the mean coating thickness between the quadruples and the singles may be due to different painters, different equipment, or different painting times.

Figure 17: Nominal Paint Thickness at Check-In

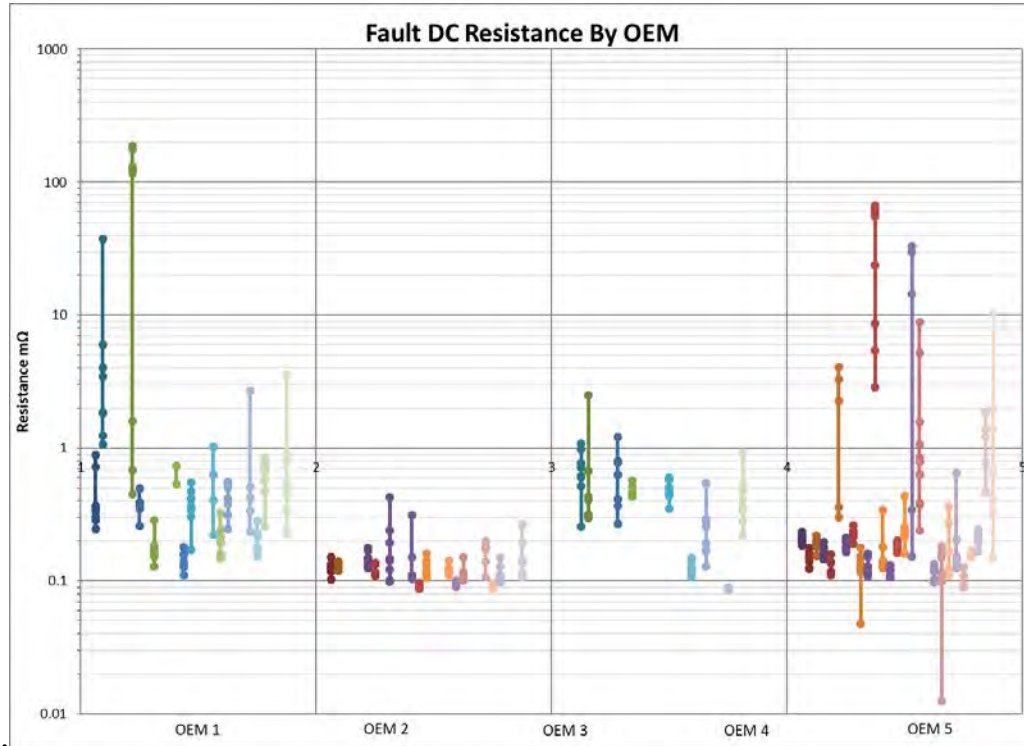
Check-in resistances for OEM 5 was consistent with the other OEMs where most of the resistance measurements were below 10 mΩ. Some of the test articles of the MF3-4T11, MF4-4T11, and MF6-4T12 configurations had resistances greater than 10 mΩ.

Figure 18: Faulted DC Resistance at Check-In

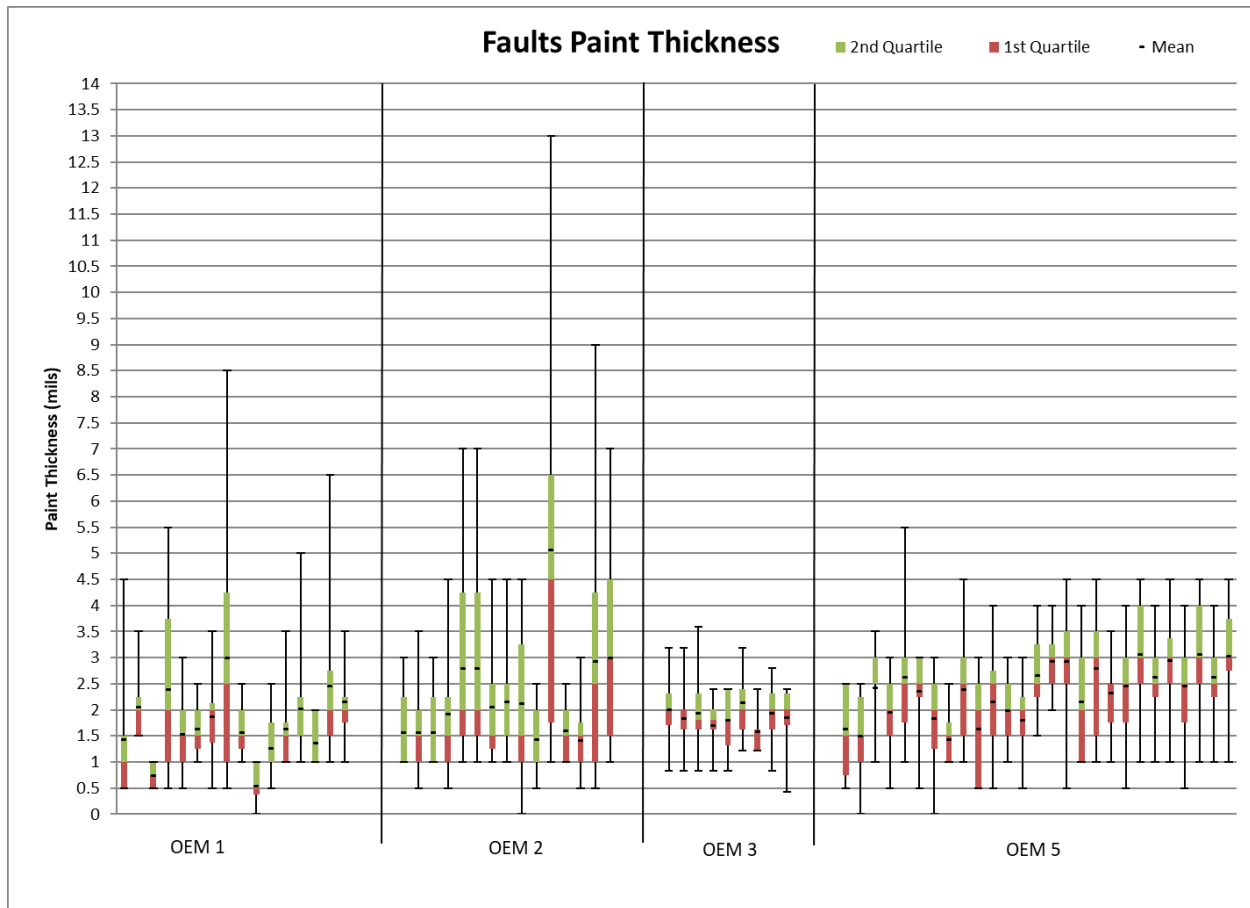
Check-in coating thicknesses for OEM 5 was consistent with the other OEMs where the average thickness measurement was 1.18 mils.

Figure 19: Faulted Paint Thickness at Check-In

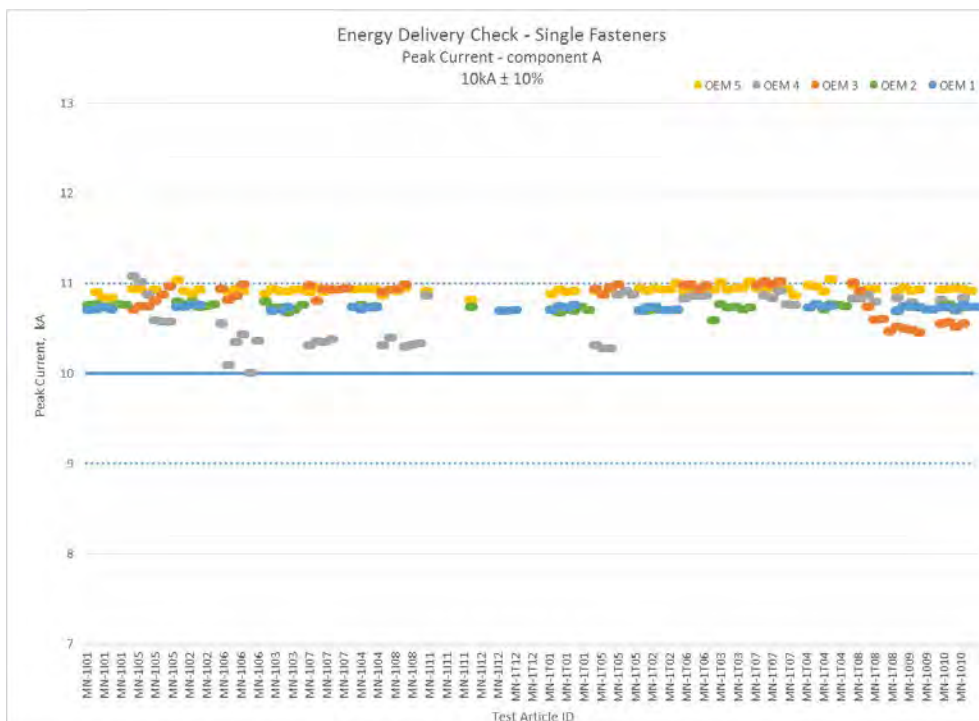
Graphs of peak current for single fastener test articles and for quadruple fastener test articles for all OEMs are shown in Figure 20 and Figure 21. The ideal value of 10 kA is shown on the graphs as a solid blue line. The acceptable $\pm 10\%$ values are shown on the graphs as dashed

blue lines. Most of the data hovers close to 11 kA at the top dashed blue line. There were a few times when the current exceeded the upper limit but none of those times resulted in a spark. Figure 20: Energy Delivery Check - Nominal - Single, Peak Current - Component A

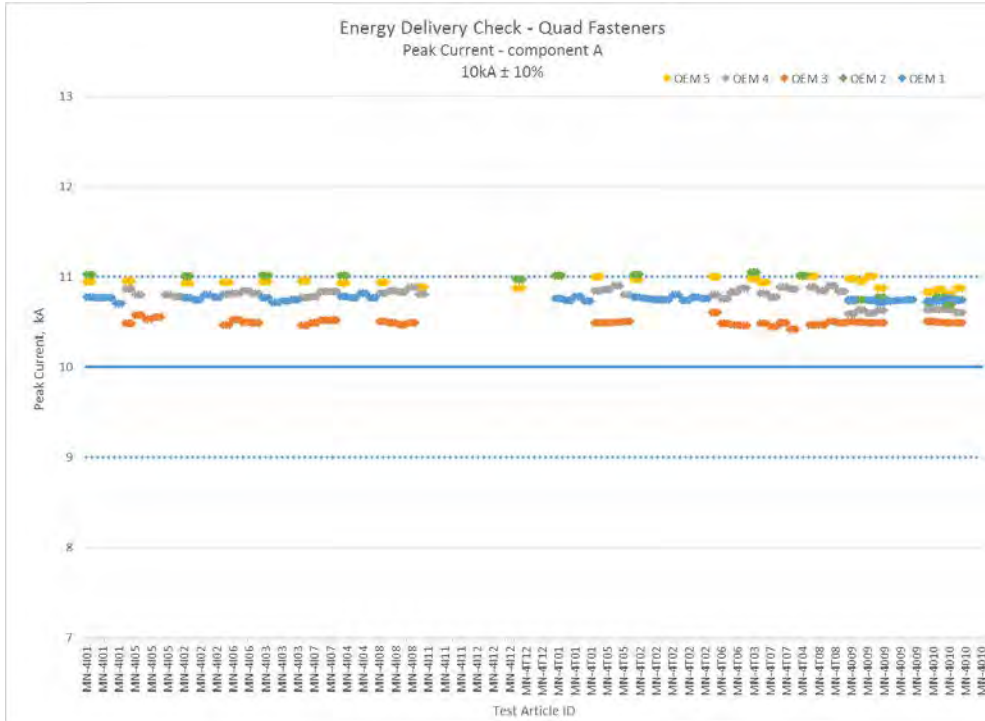
Figure 21: Energy Delivery Check – Nominal - Quad, Peak Current - Component A

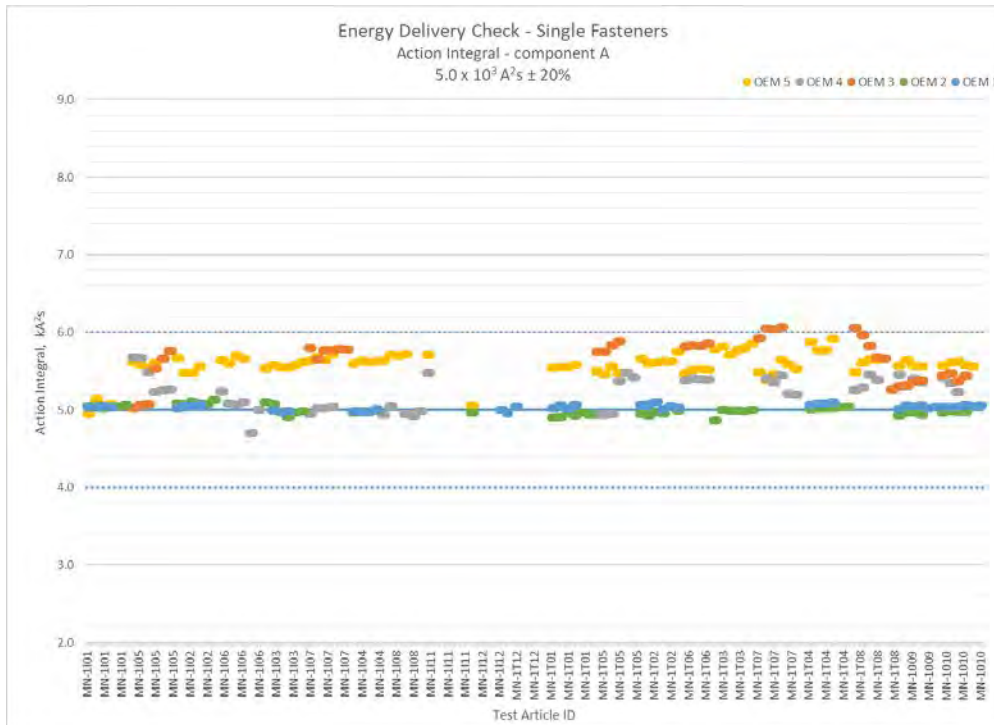
Graphs of action integral for single fastener test articles and for quadruple fastener test articles for all OEMs are shown in Figure 22 and Figure 23. The ideal value of 5.0×10^3 A²s is shown on the graphs as a solid blue line. The acceptable $\pm 20\%$ values are shown on the graphs as dashed blue lines. Most of the data hovers close to the ideal value at the center blue line.

Figure 22: Energy Delivery Check - Nominal - Single, Action Integral - Component A

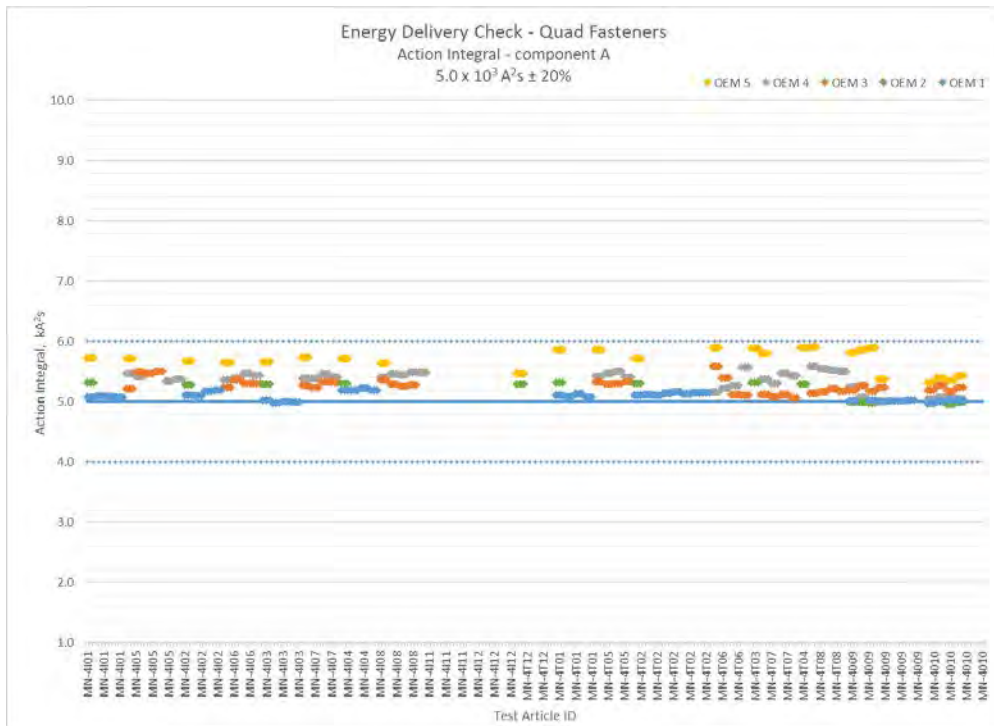
Figure 23: Energy Delivery Check – Nominal Quad, Action Integral - Component A

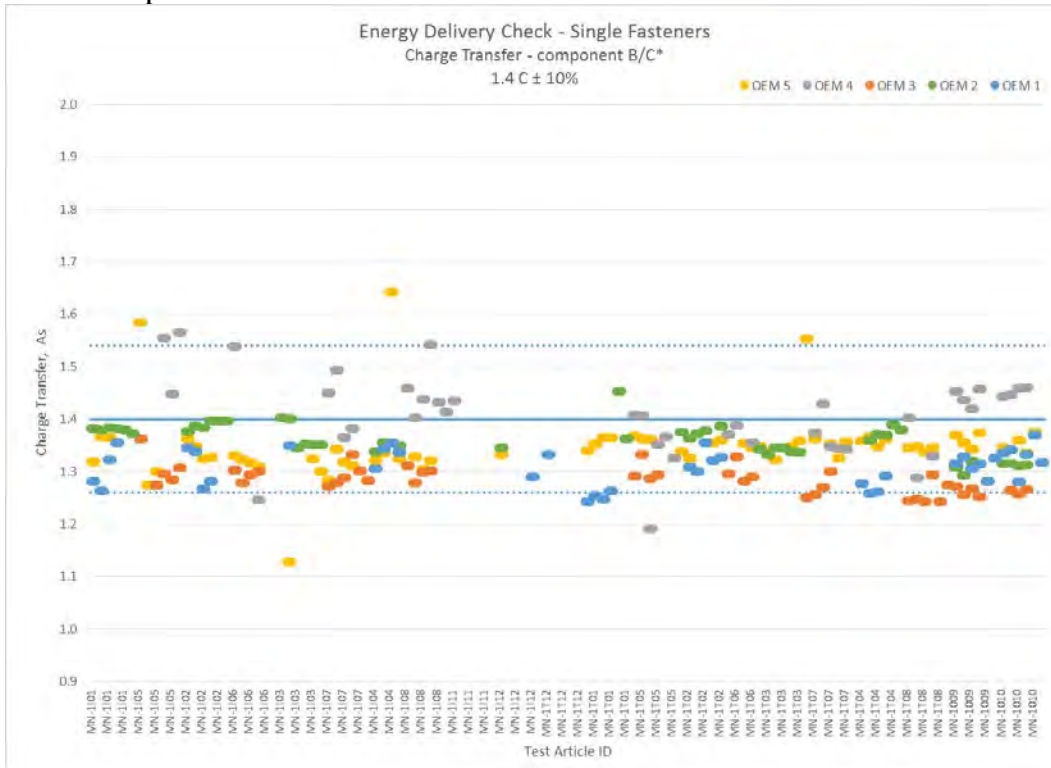
when the charge transfer for the nominal fasteners exceeded the upper limit but none of those times resulted in a spark.

Figure 24: Energy Delivery Check – Nominal - Single, Charge Transfer - Component B/C*

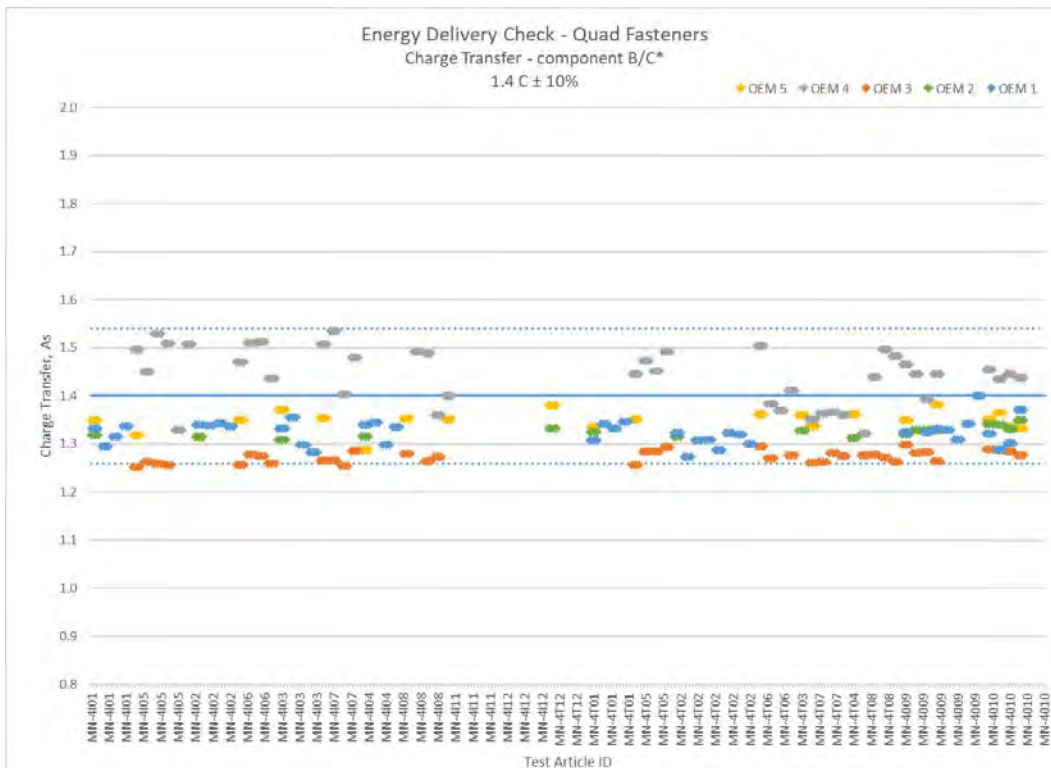
Figure 25: Energy Delivery Check – Nominal - Quad, Charge Transfer - Component B/C*

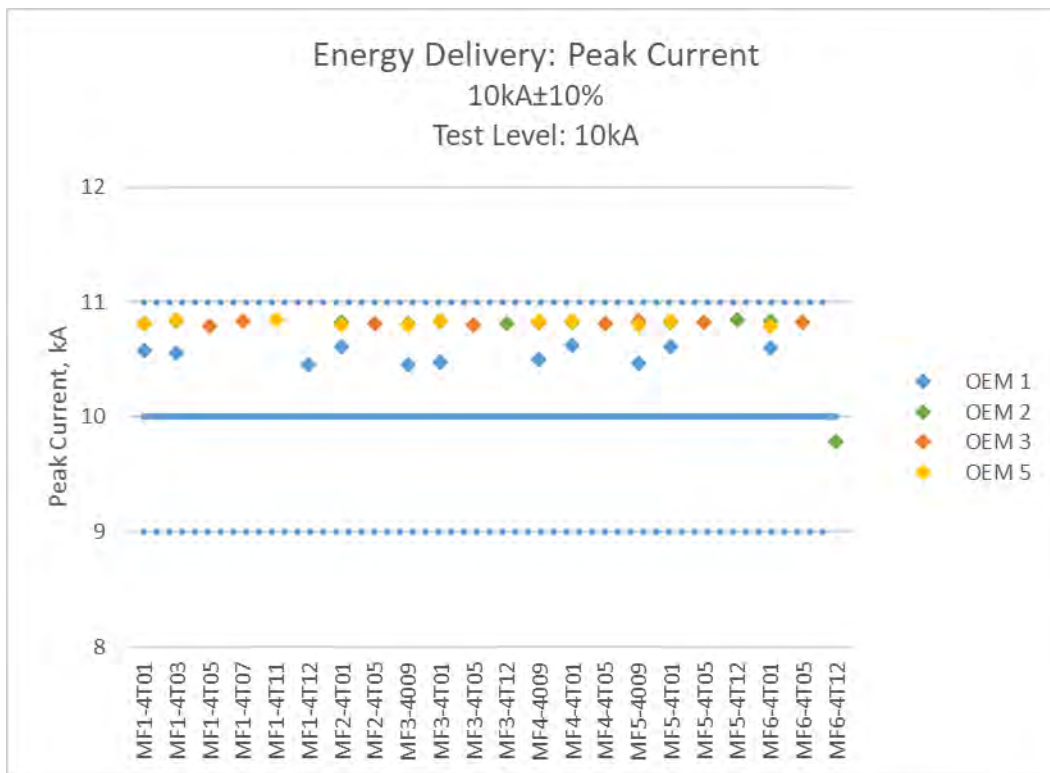
Graphs of the peak current for both test levels of the faulted quadruple fastener test articles are shown in Figure 26 and Figure 27. For the 10 kA test level, the ideal value of 10 kA is shown on the graphs as a solid blue line. The acceptable $\pm 10\%$ values are shown on the graphs as dashed blue lines. Most of the data hovers close to 11 kA at the top dashed blue line. The conductive faulted fasteners were also tested 100 kA test level. As shown in Figure 27, the ideal value of 100 kA is the solid blue line while the 10% bounds are shown as dashed lines. Most of the data hovers close to the ideal value at the center blue line.

Figure 26: Energy Delivery Check – Faults, Peak Current 10 kA – Component A

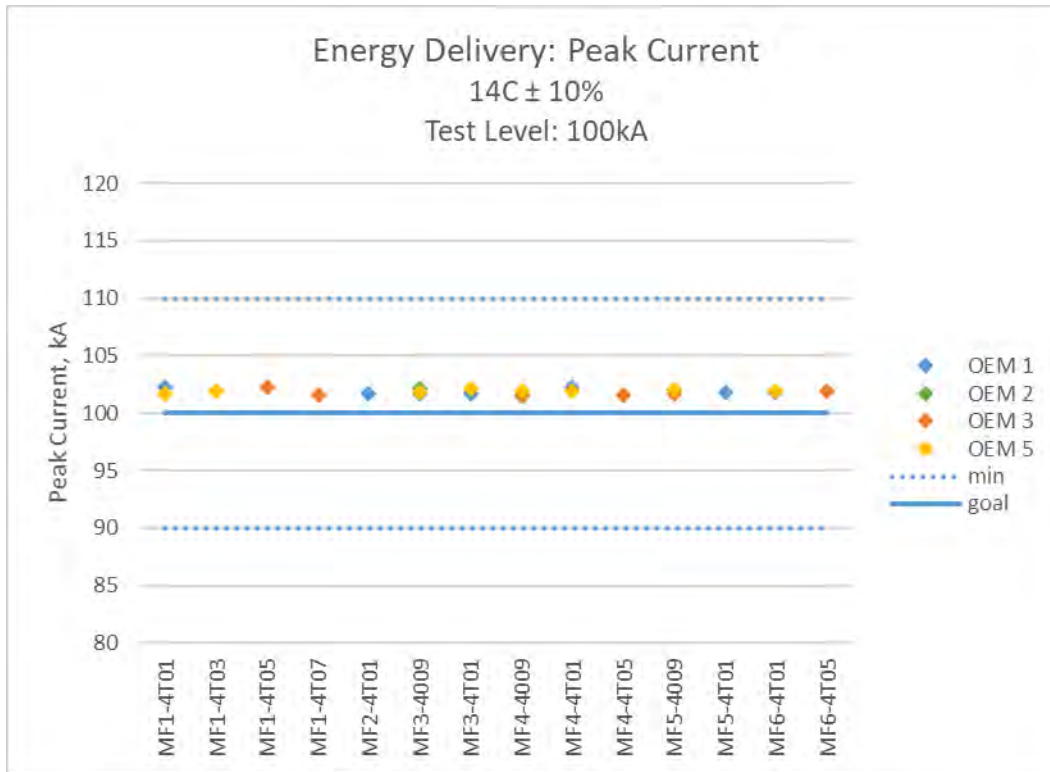
Figure 27: Energy Delivery Check – Faults, Peak Current 100 kA – Component A

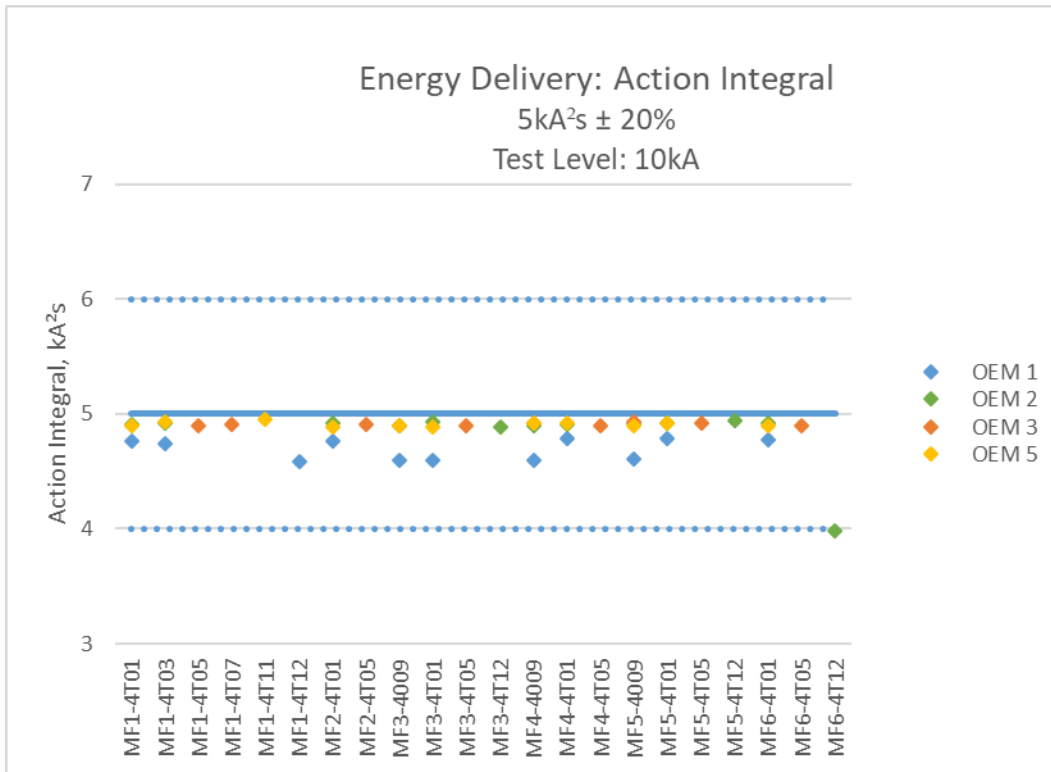
Graphs of action integral for the faulted quadruple fasteners tested at 10kA is shown in Figure 28. The ideal value of $5.0 \times 10^3 \text{ A}^2\text{s}$ is shown on the graphs as a solid blue line. The acceptable $\pm 20\%$ values are shown on the graphs as dashed blue lines. Most of the data hovers close to the ideal value at the center blue line. The graph of the action integral for the faulted fasteners tested at 100kA is shown in Figure 29. The ideal value of $500 \text{ kA}^2\text{s}$ is shown on the graphs as a solid blue line. The acceptable $\pm 20\%$ values are shown on the graphs as dashed blue lines. Most of the data hovers close to the maximum value at the top dashed blue line.

Figure 28: Energy Delivery Check – Faults, Action Integral – 10 kA Test Level

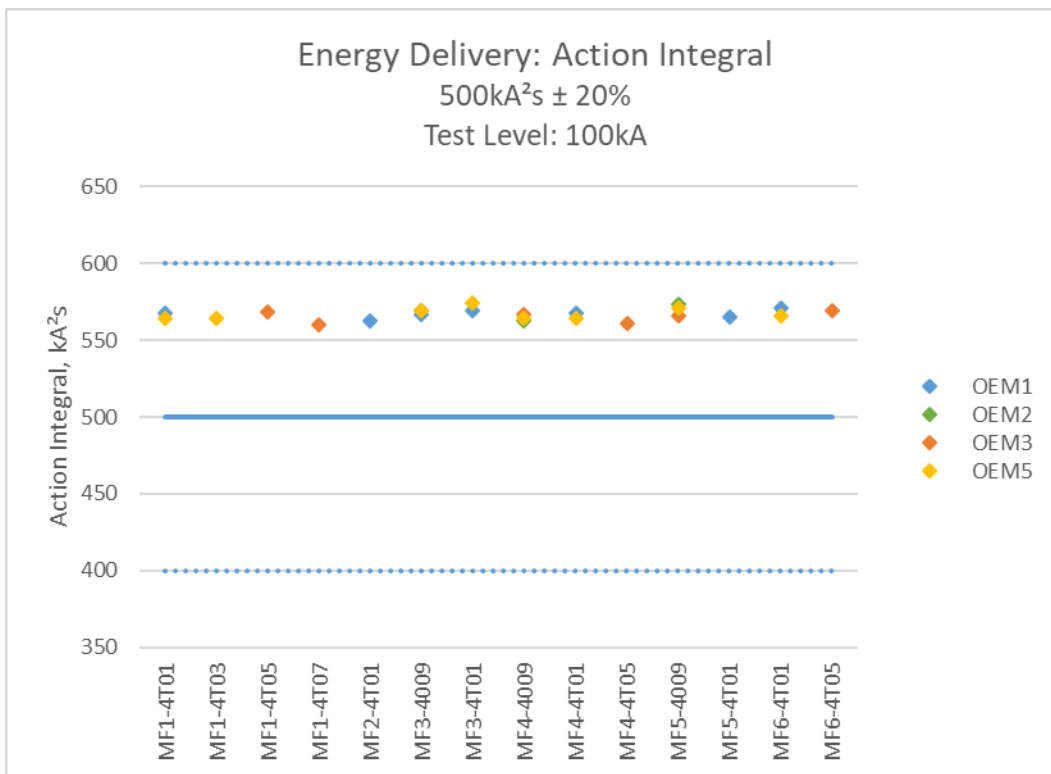
Figure 29: Energy Delivery Check – Faults, Action Integral – 100 kA Test Level

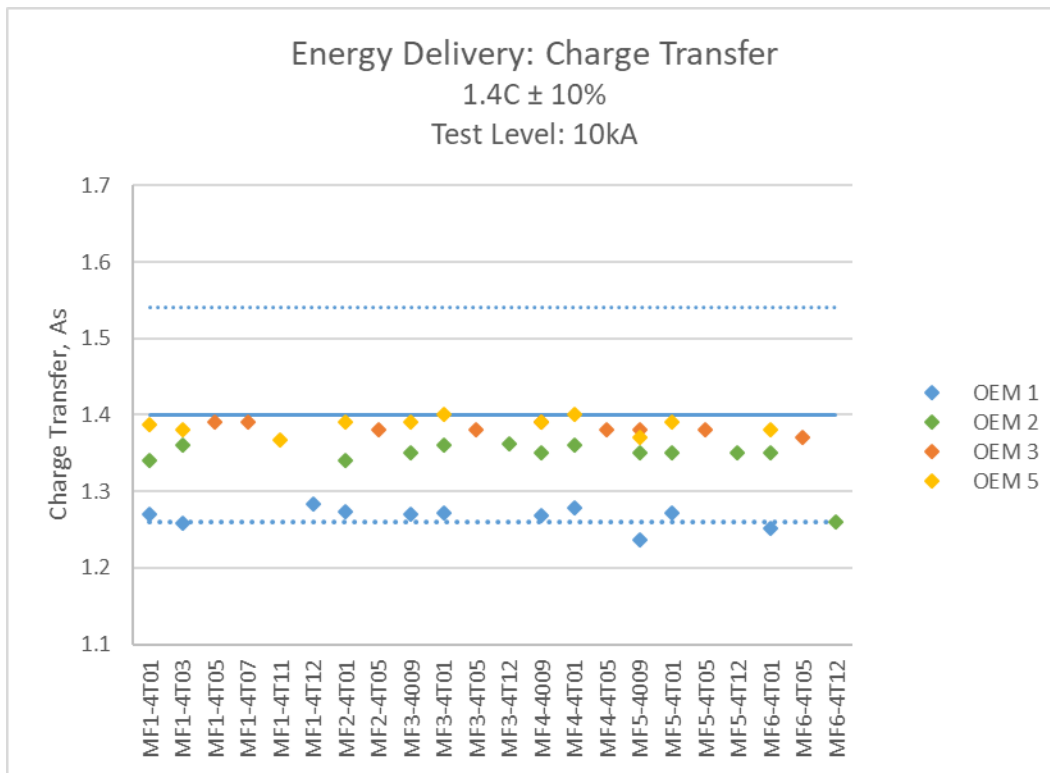
Graphs of charge transfer of the faulted fasteners tested at 10kA is shown in Figure 30. The ideal value of 1.4 C is shown on the graphs as a solid blue line. The acceptable $\pm 10\%$ values are shown on the graphs as dashed blue lines. Most of the data is below the center blue line but within the lower limit. The graph of the charge transfer for the fasteners tested at 100 kA is shown below in Figure 31. The ideal value of 14 C us shown on the graphs as a solid blue line. The acceptable $\pm 10\%$ values are shown by the dashed blue lines. Most of the data hovers around the solid blue line at 14 C.

Figure 30: Energy Delivery Check – Faults, Charge Transfer – 10 kA Test Level

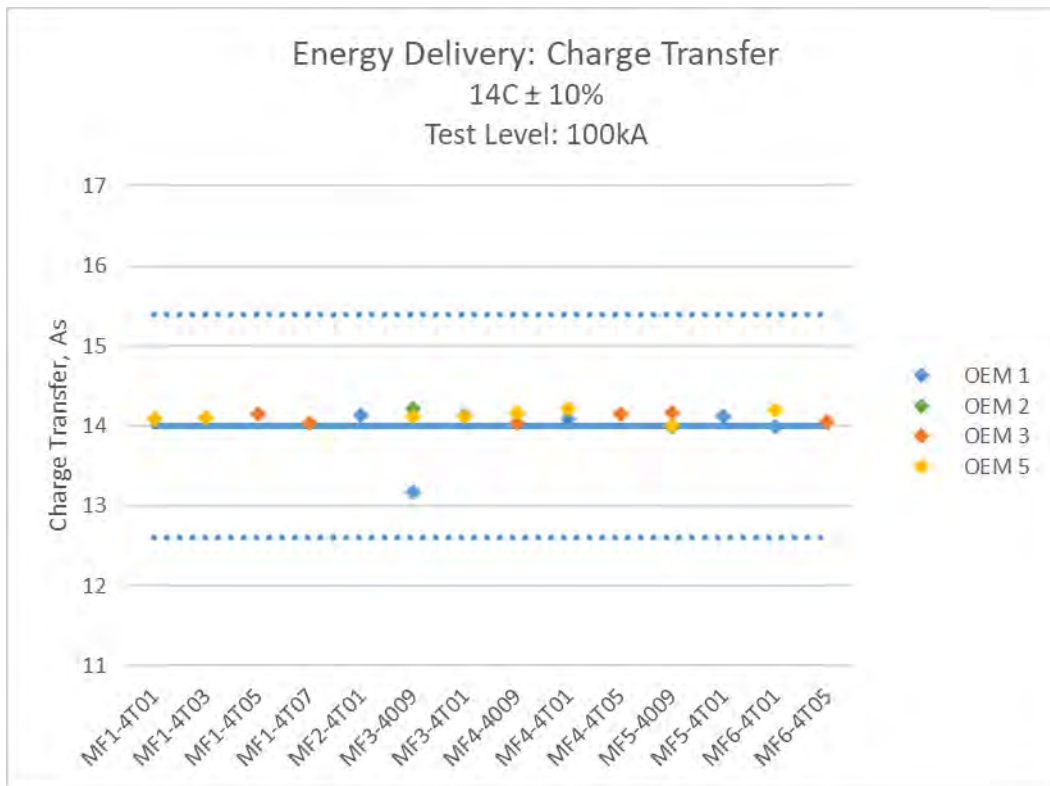
Figure 31: Energy Delivery Check – Faults, Charge Transfer – 100 kA Test Level

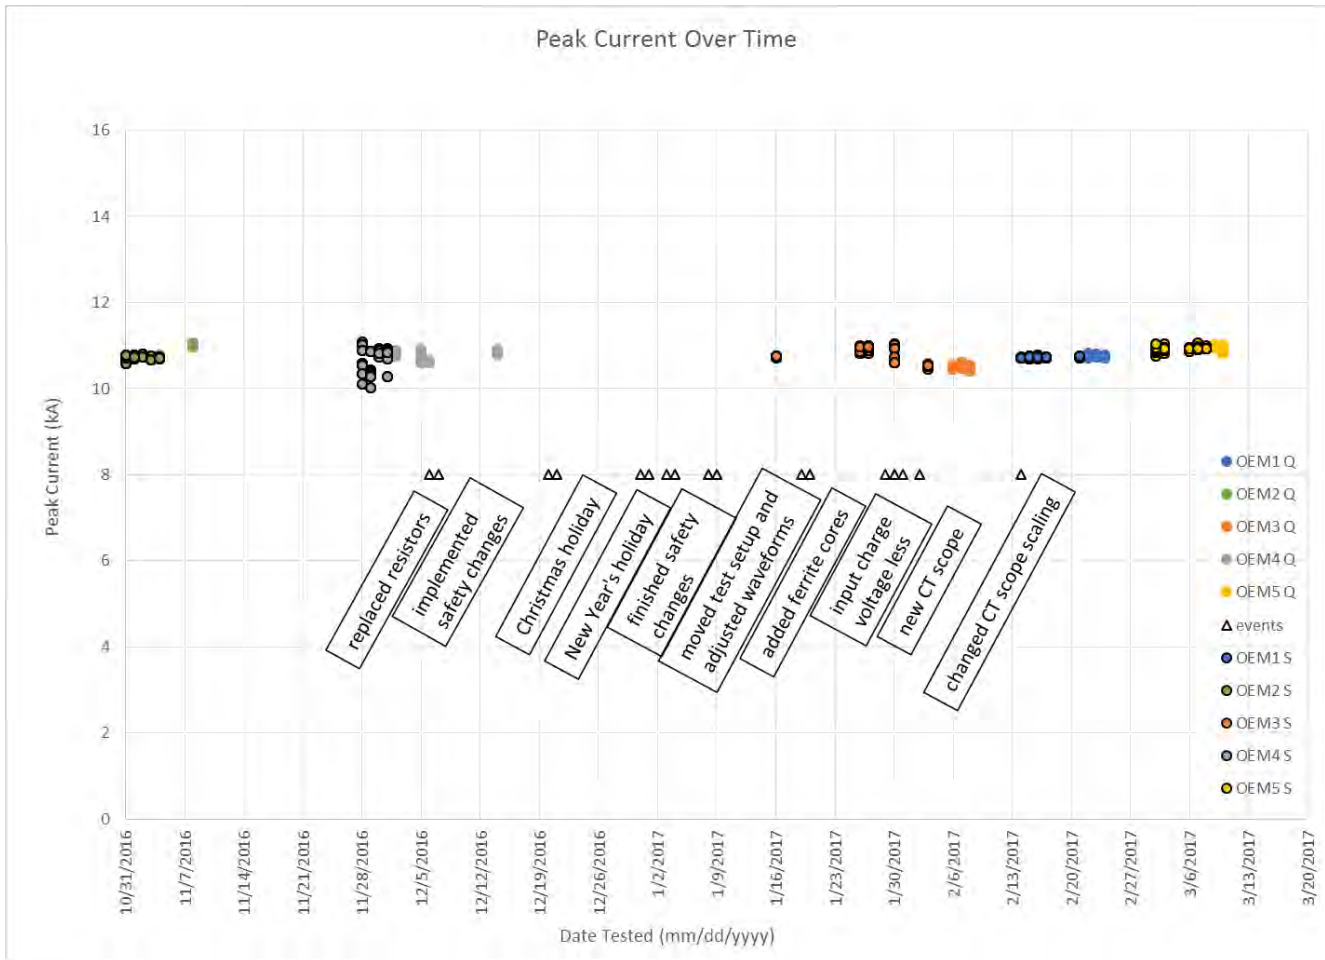
A common way to spot a bias is to look at a supposed constant value over time. Figure 32 shows the values of peak current over the entire course of the nominal testing for all OEMs. Events that changed the test setup and might have influenced the data are also recorded with their timeframe.

Figure 32: Peak Current Over Time

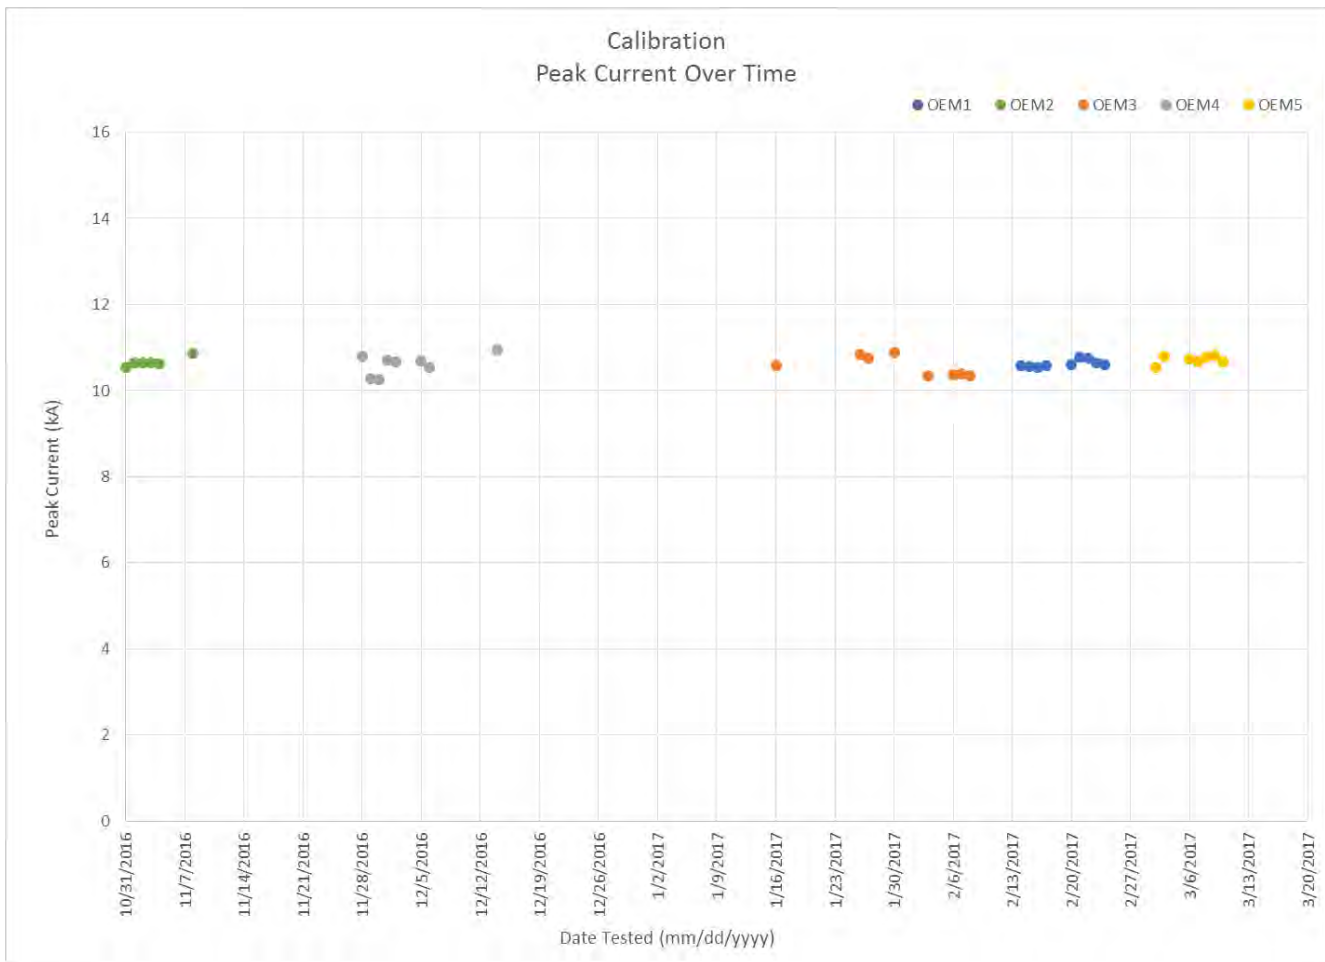
Shown in Figure 33 are the calibration values taken with the Ni-Cr strip each day before the start of testing. The peak current values are used for comparison purposes. There is a small amount of variance but overall the values are consistent. Therefore, no bias is assumed and no adjustments were made to the data.

Figure 33: Calibration Peak Current Over Time

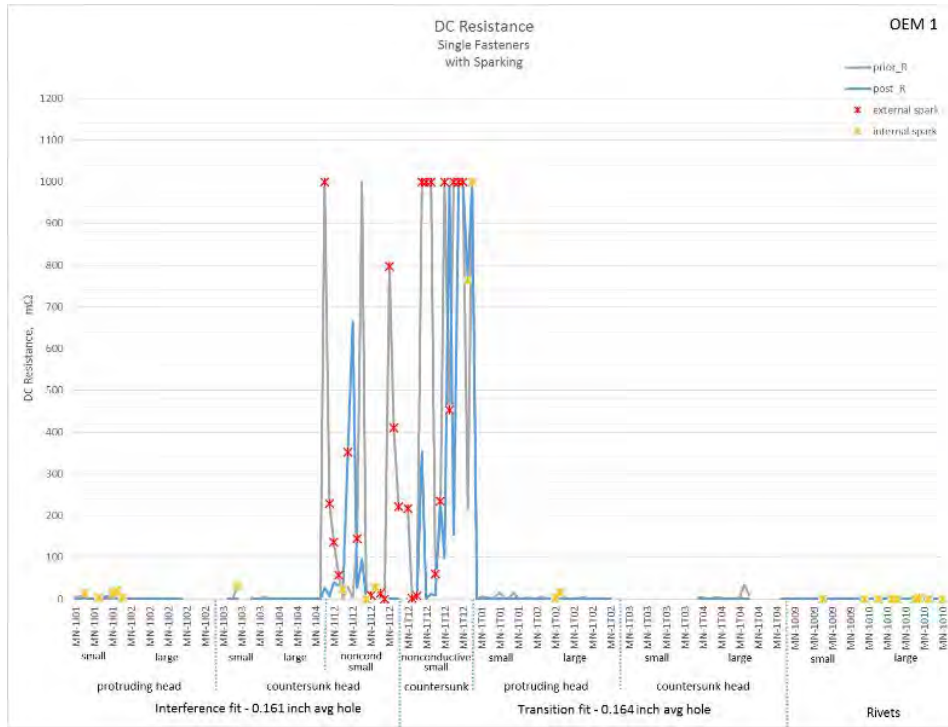
Figure 34: DC Resistance of OEM 1 with sparking – Nominal Single Fasteners

One last anomaly for OEM 1 is that the DC resistance did not decrease between the pre-test and post-test measurements as much as the other OEMs, as seen in Figure 34. For the other OEMs, the post-test DC resistance measurements were greatly reduced from the pre-test measurements due to test article conditioning during testing. From the measurements of the cut open test articles of OEM 1, it appears that this effect is due to the larger hole sizes leading to poor electrical contact.
