**Kansas Aviation Research and Technology (KART) Program
KART R51827**

**Experimental Identification of
Lightning Conducted-Current
Fastener Sparking Thresholds
(25.981 Project) – Test Results**

Metal Test Report

Document Number: ENV-RP-2016-003– Rev A

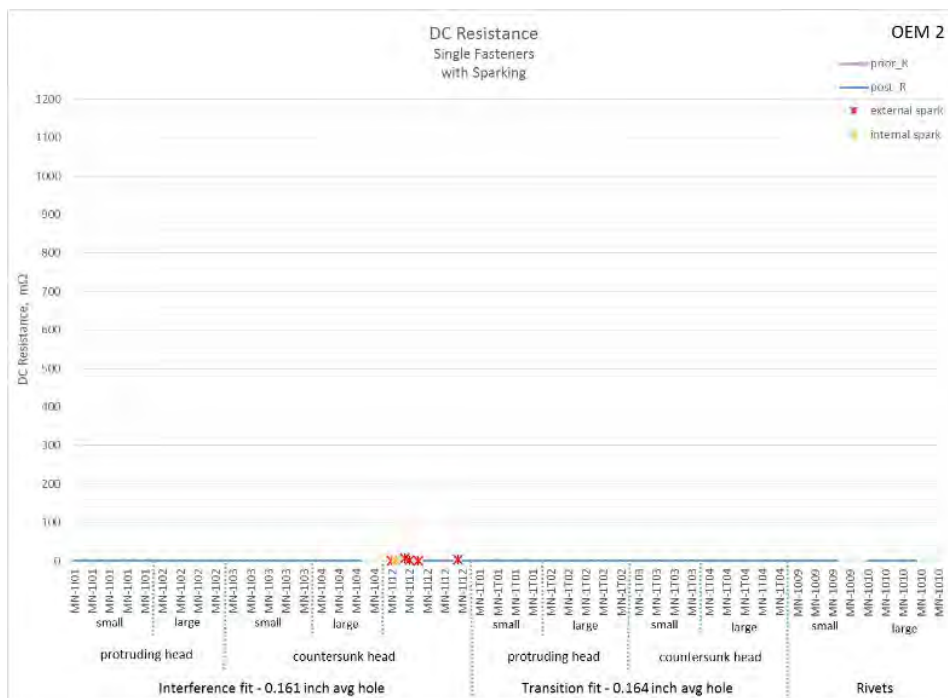
Figure 35: DC Resistance of OEM 2 with sparking – Nominal Single Fasteners

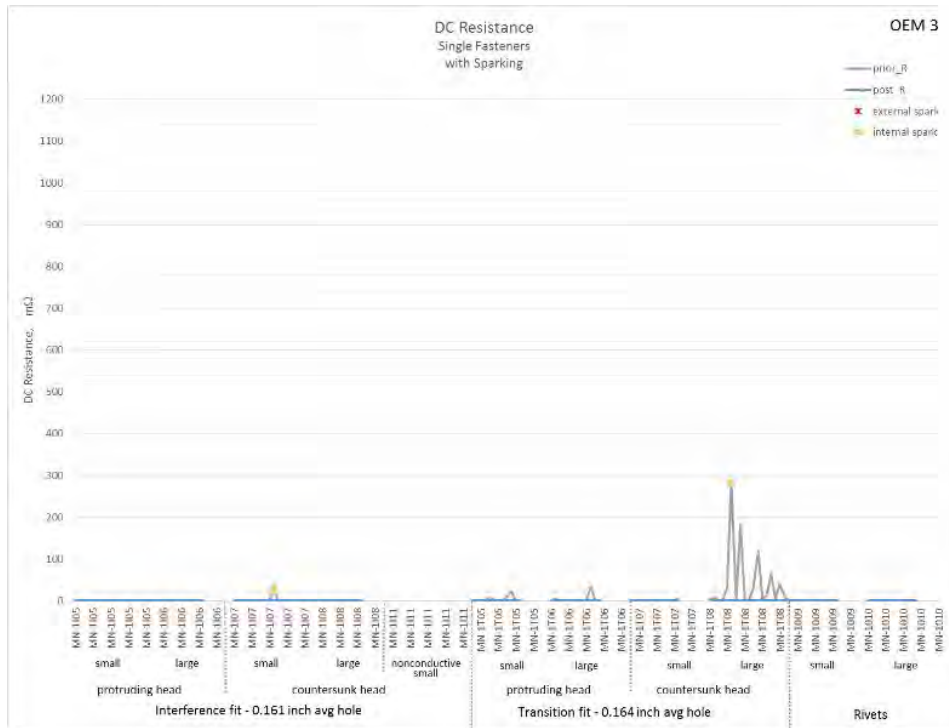
Figure 36: DC Resistance of OEM 3 with sparking – Nominal Single Fasteners

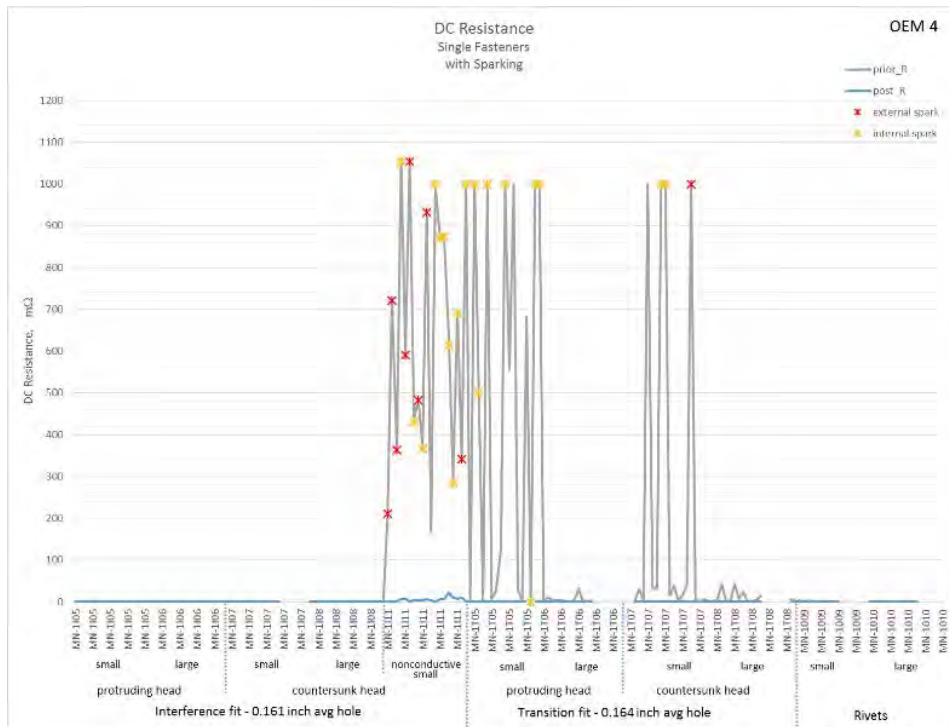
Figure 37: DC Resistance of OEM 4 with sparking – Nominal Single Fasteners

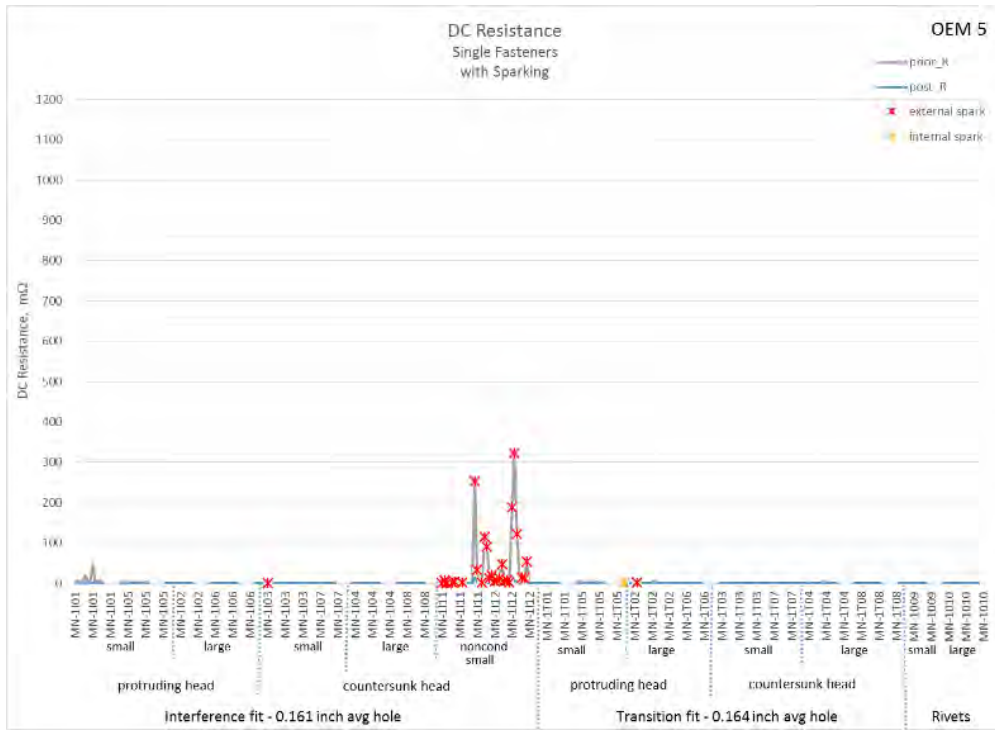
Figure 38: DC Resistance of OEM 5 with sparking – Nominal Single Fasteners

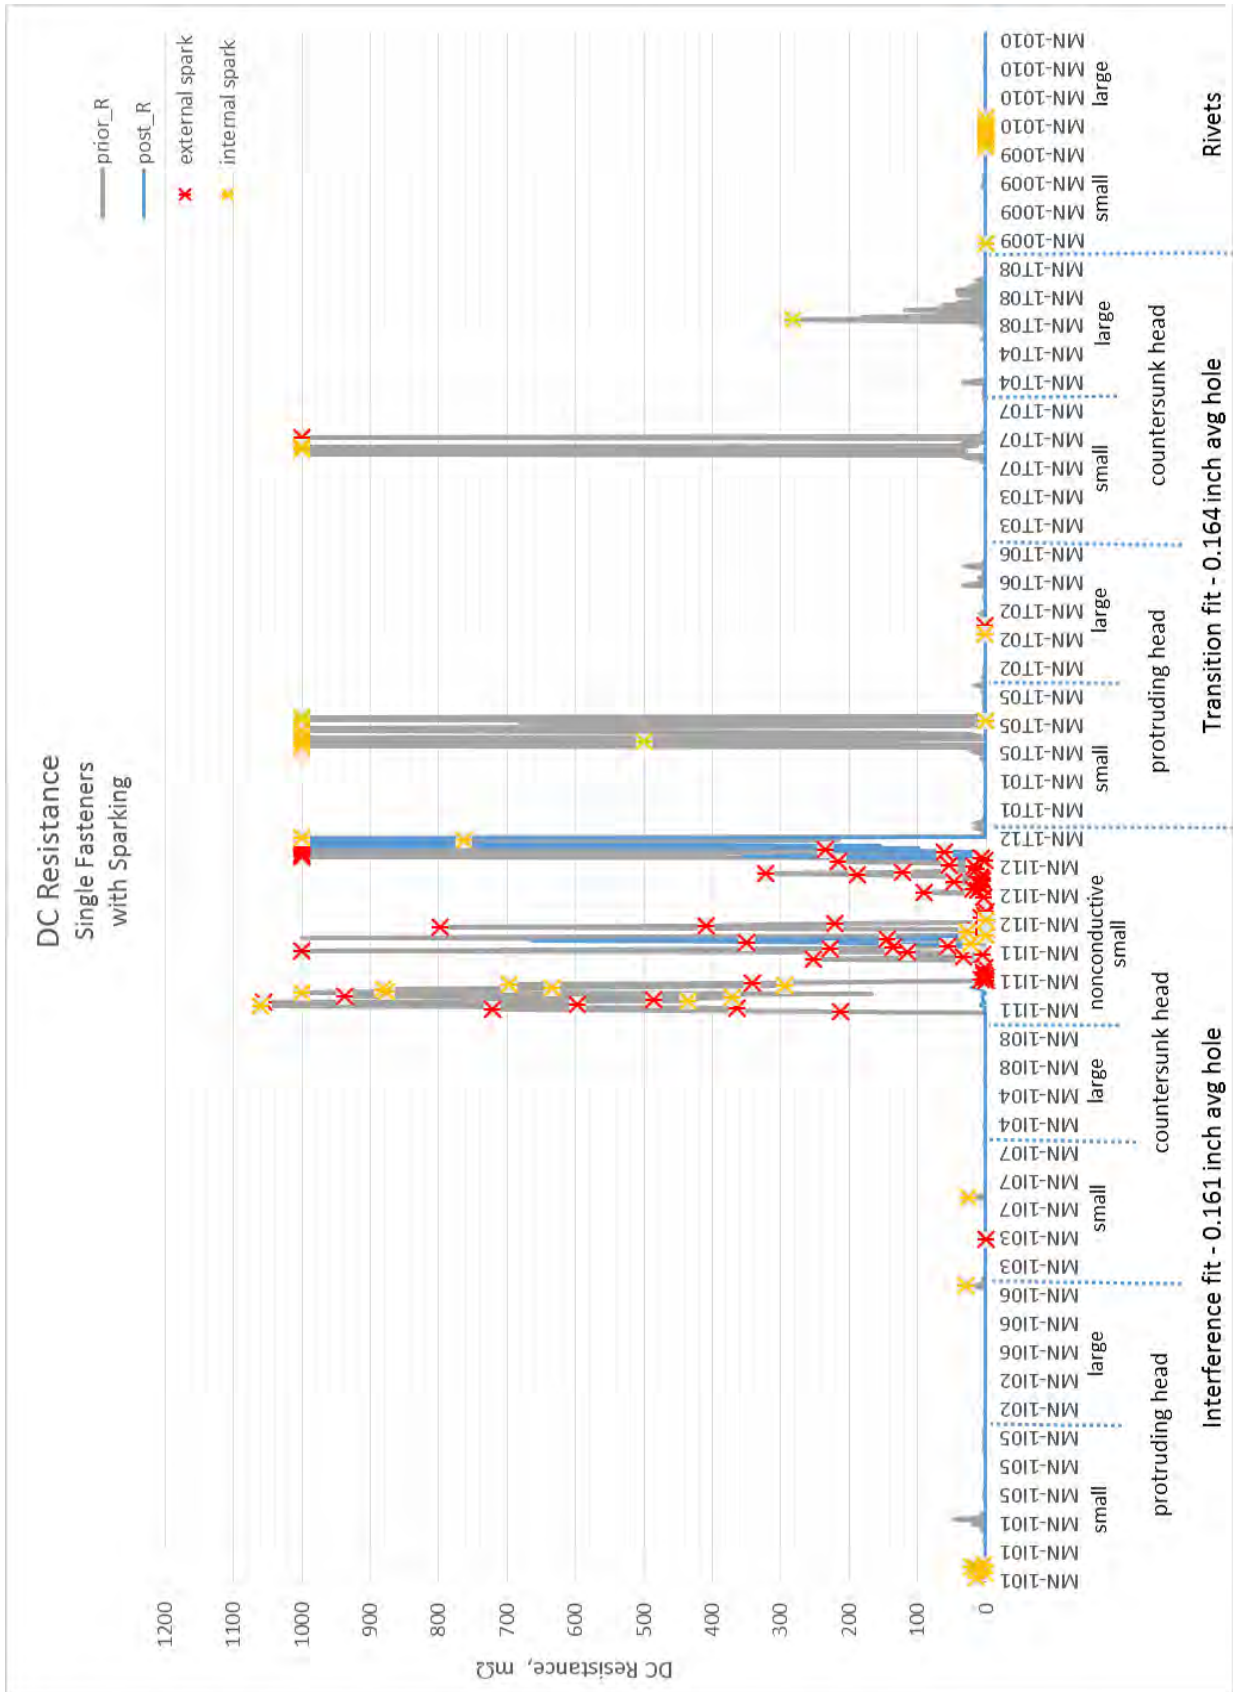
The highest pre-test DC resistance values are for MN-1I11 (Hi-Lite/Hi-Kote) and MN-1I12 (Hi-Lok/Hi-Kote) with the nonconductive coating and for MN-1T05 and MN-1T07 which are the small Hi-Lite transition fit fasteners. The majority of the sparking occurred with MN-1I11 and MN-1I12 (Hi-Lok/Hi-Kote) with the nonconductive coating. As evidence of conditioning the test article, the post test DC resistance (blue line) shown in Figure 39 and Figure 41 is much lower than the pre-test DC resistance for all test articles except the MN-1T12 test articles. All test articles except for the MN-1I11 (Hi-Lite/Hi-Kote) and MN-1I12 (Hi-Lok/Hi-Kote) with the nonconductive coating were tested at the maximum peak current around 11 kA.

Figure 39: DC Resistance with Sparking – Nominal Single Fasteners – All OEMs

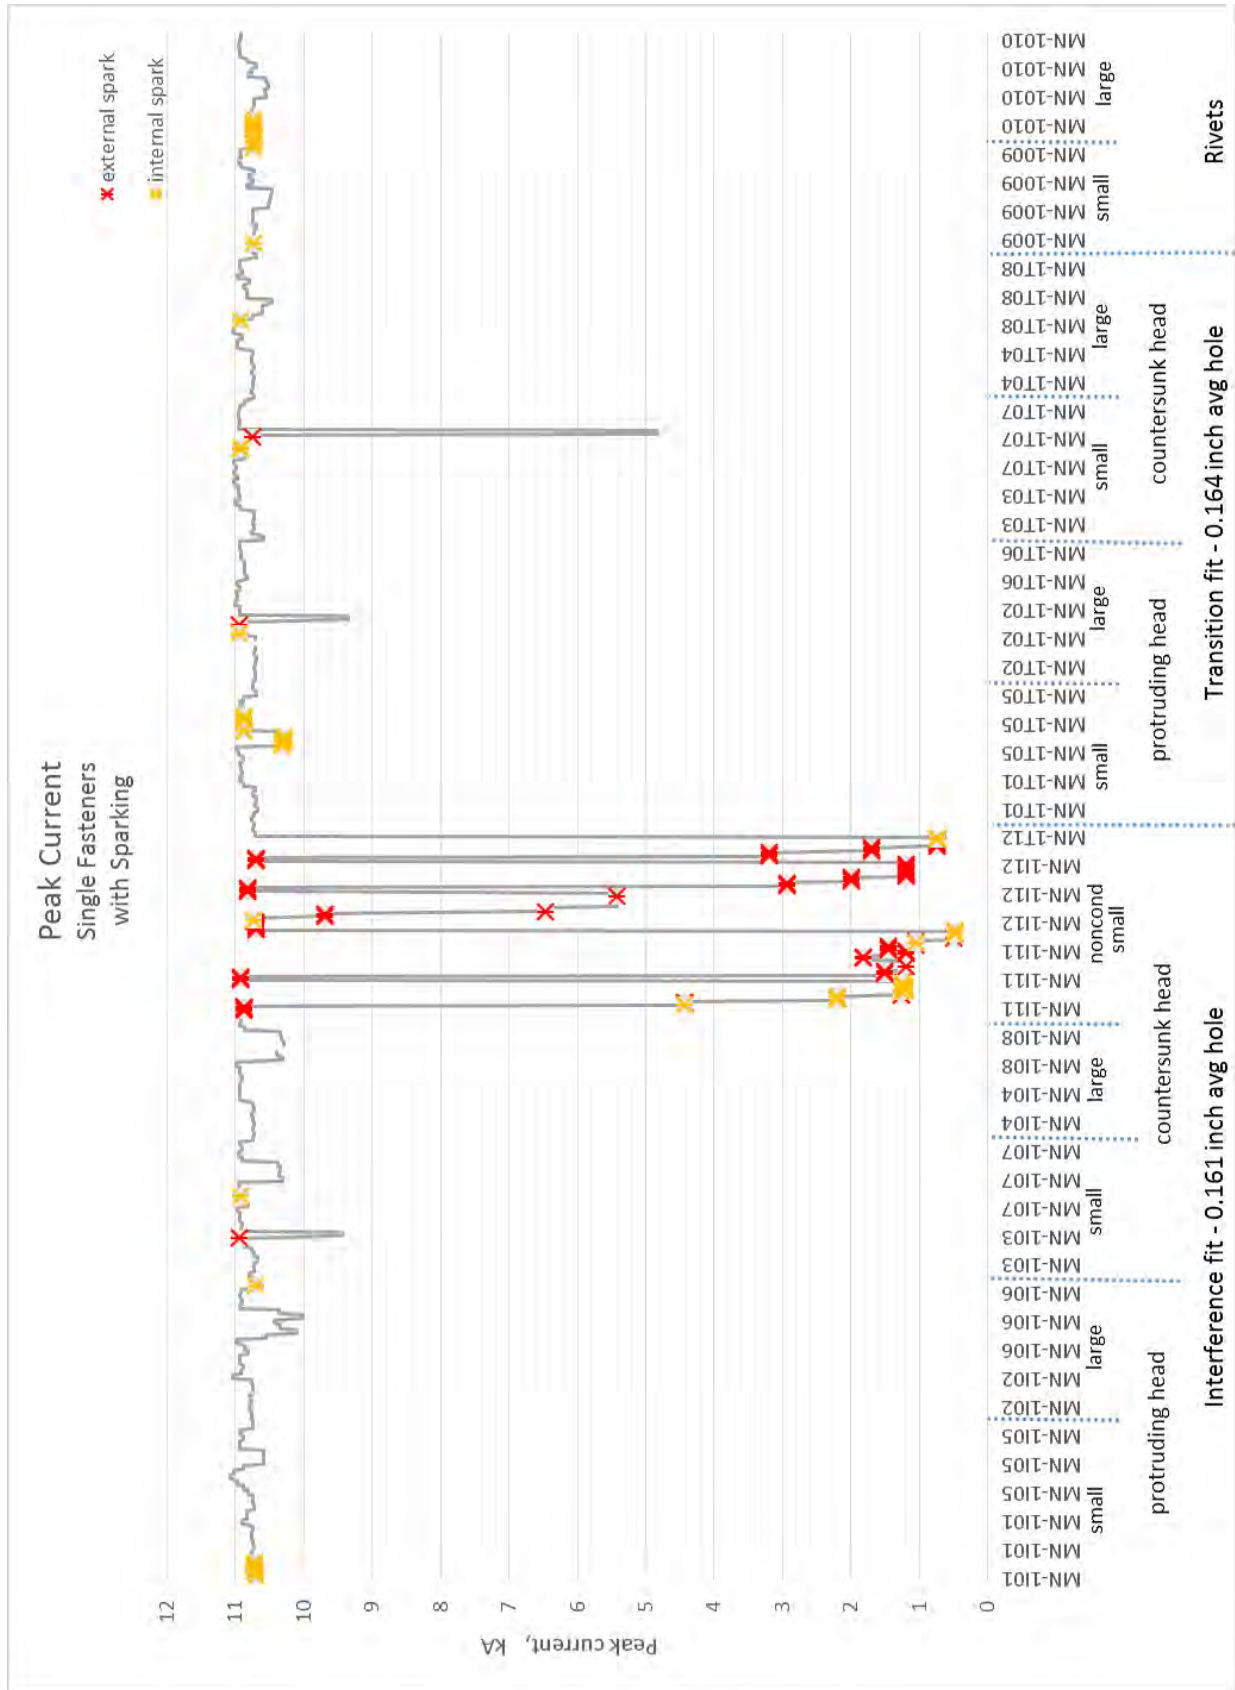
Figure 40: Peak Current with Sparking – Nominal Single Fasteners – All OEMs

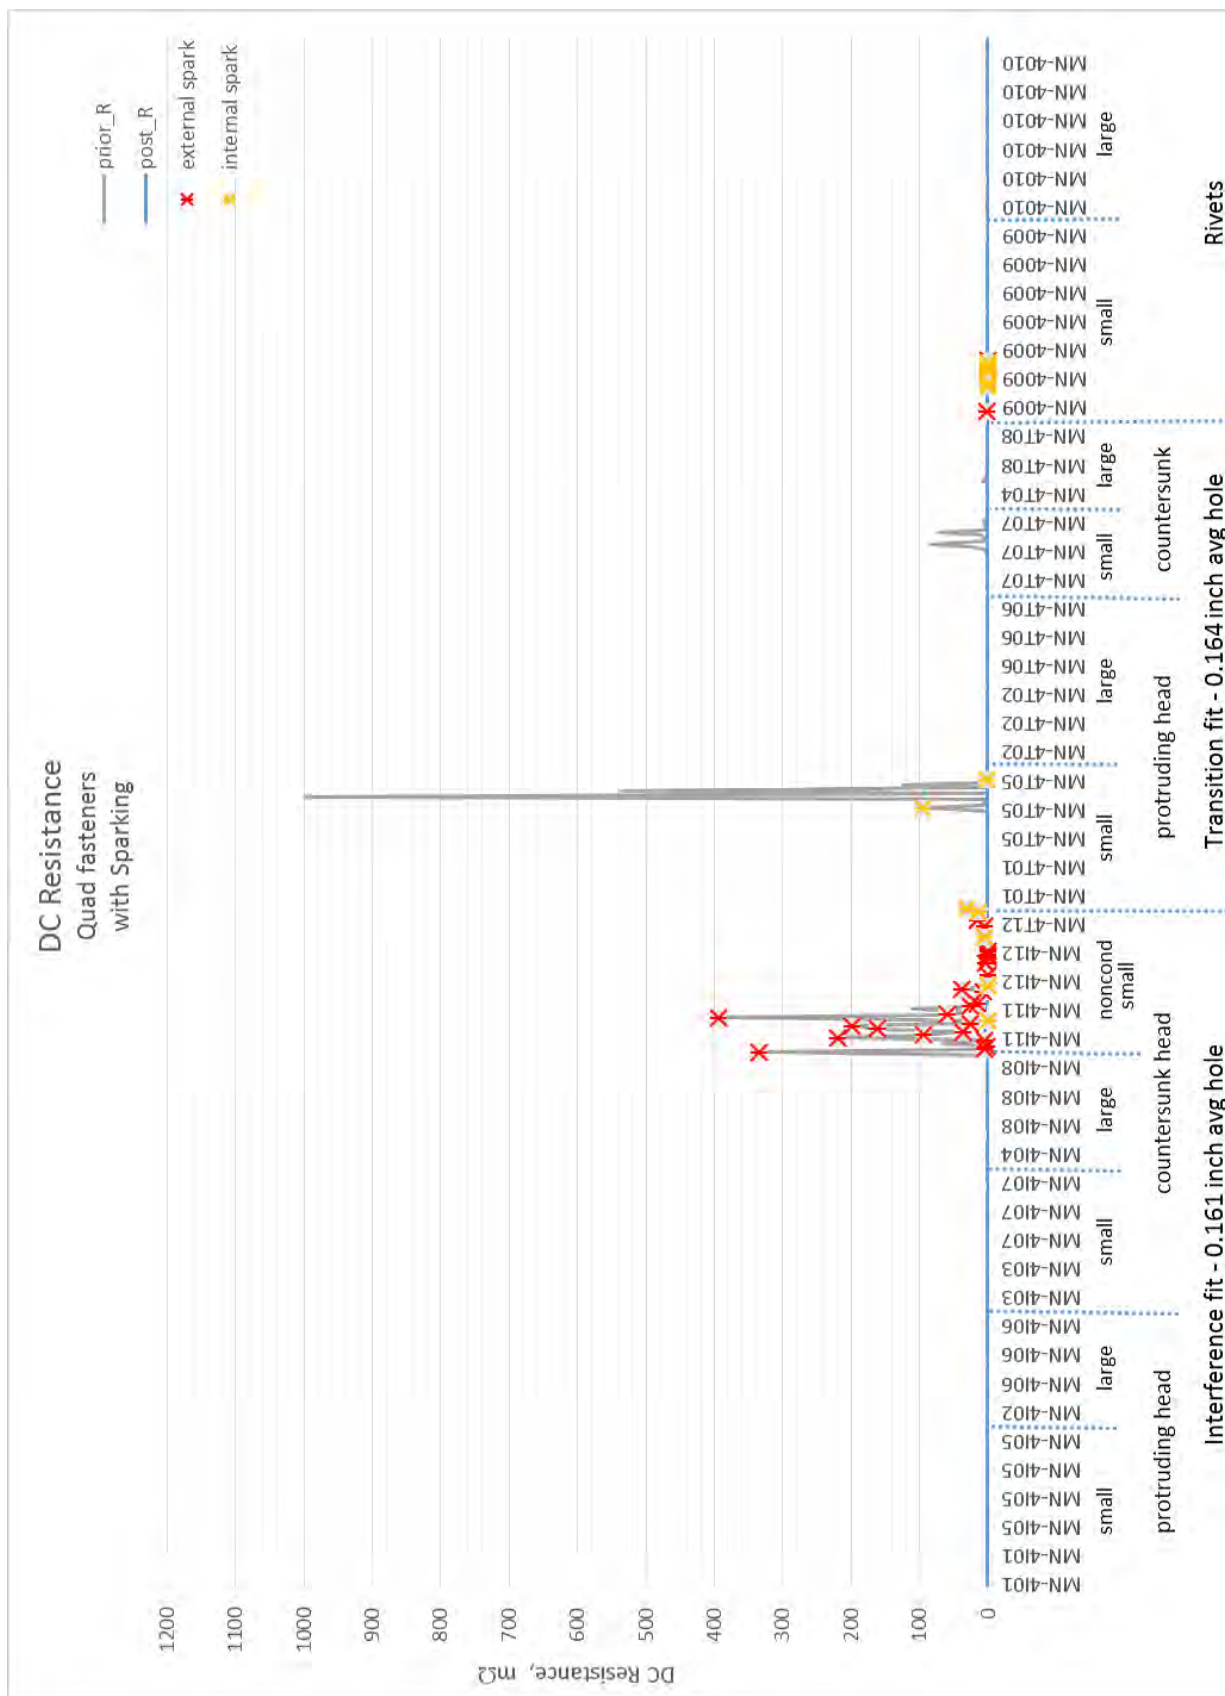
Figure 41: DC Resistance with Sparking – Nominal Quad Fasteners – All OEMs

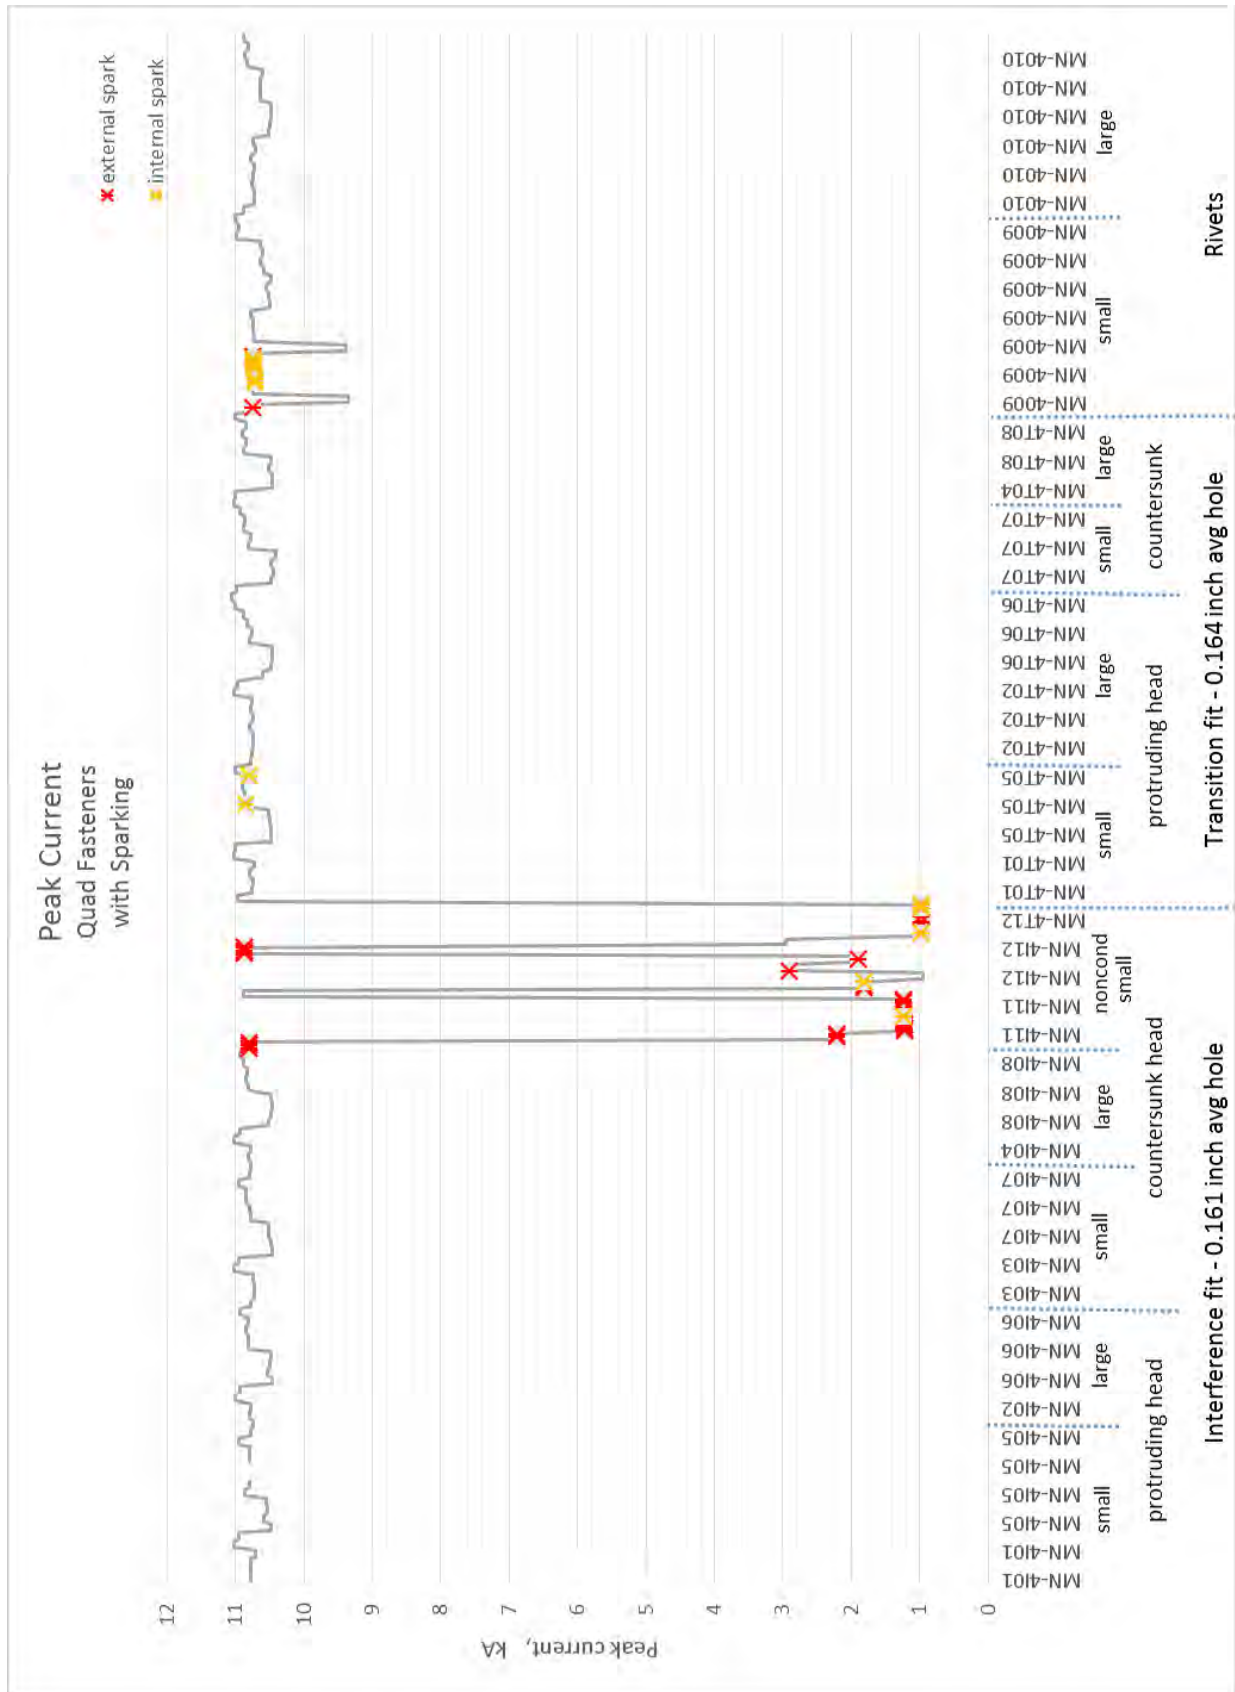
Figure 42: Peak Current with Sparking – Nominal Quad Fasteners – All OEMs

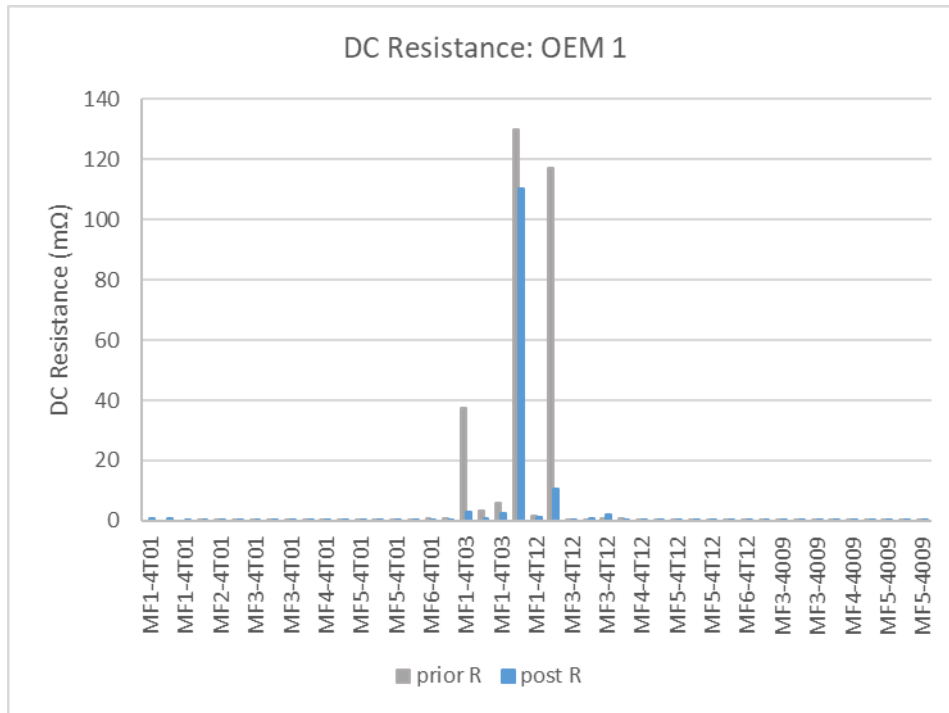
Shown below are the individual graphs for DC resistance with sparking by OEM for both nominal and faulted fasteners for comparison purposes with the overall combined graphs, as well as graphs for the peak currents for the nominal tests. For the nominal fasteners, only the single fastener data is shown by OEM.

Figure 43: DC Resistance of OEM 1 - Faulted Fasteners

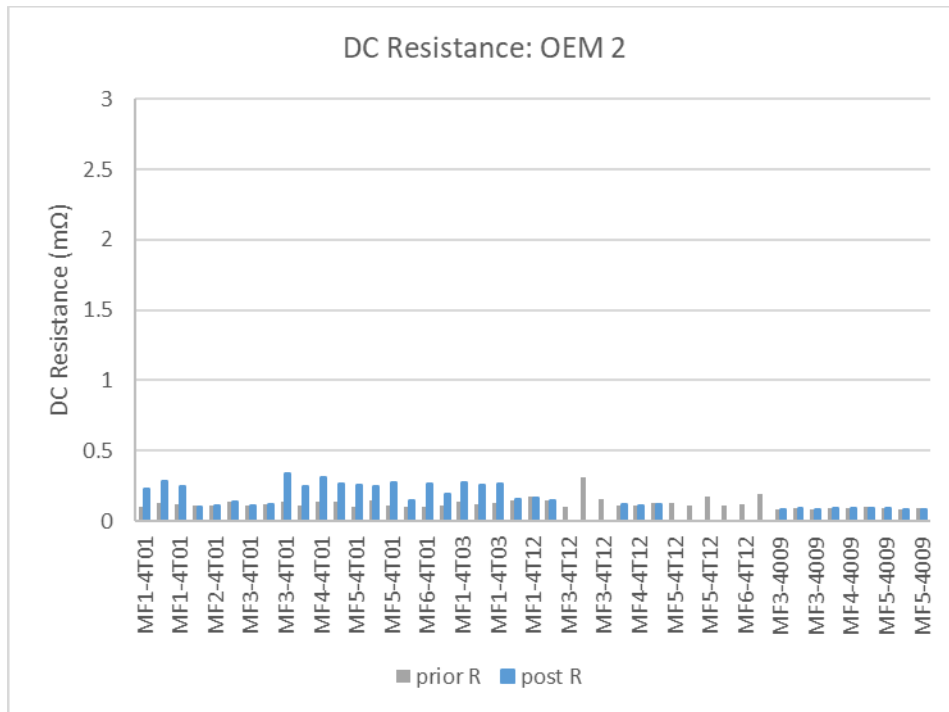
Figure 44: DC Resistance of OEM 2 - Faulted Fasteners

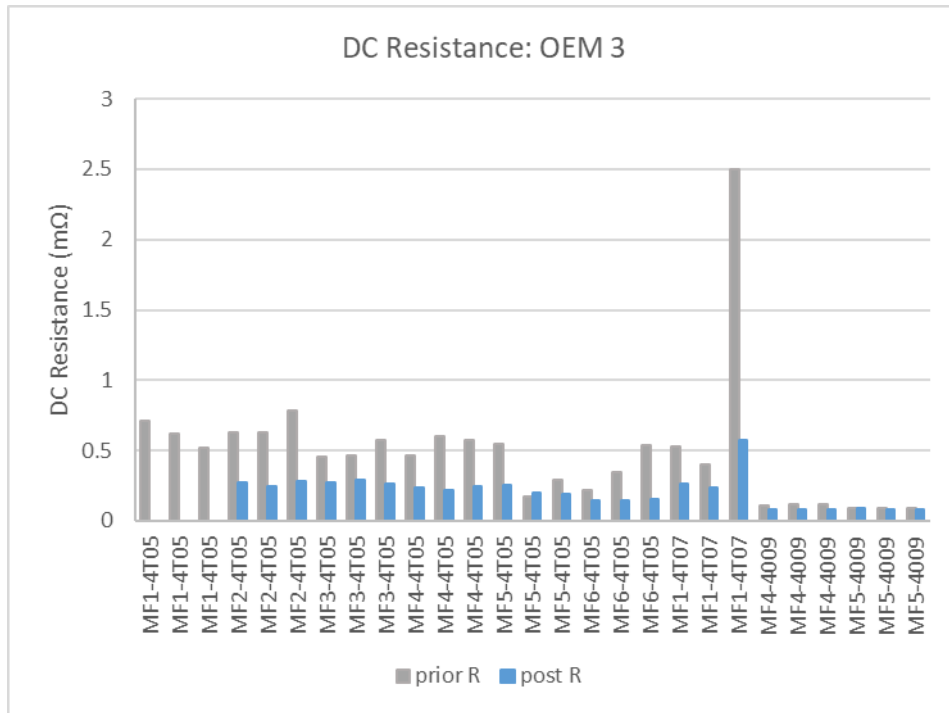
Figure 45: DC Resistance of OEM 3 - Faulted Fasteners

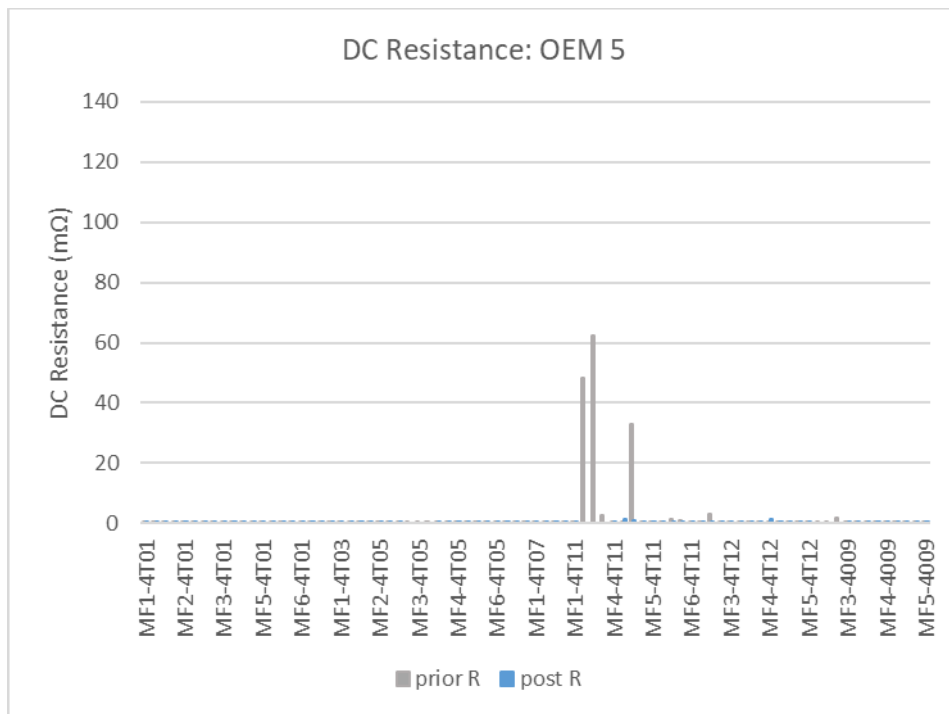
Figure 46: DC Resistance of OEM 5 - Faulted Fasteners

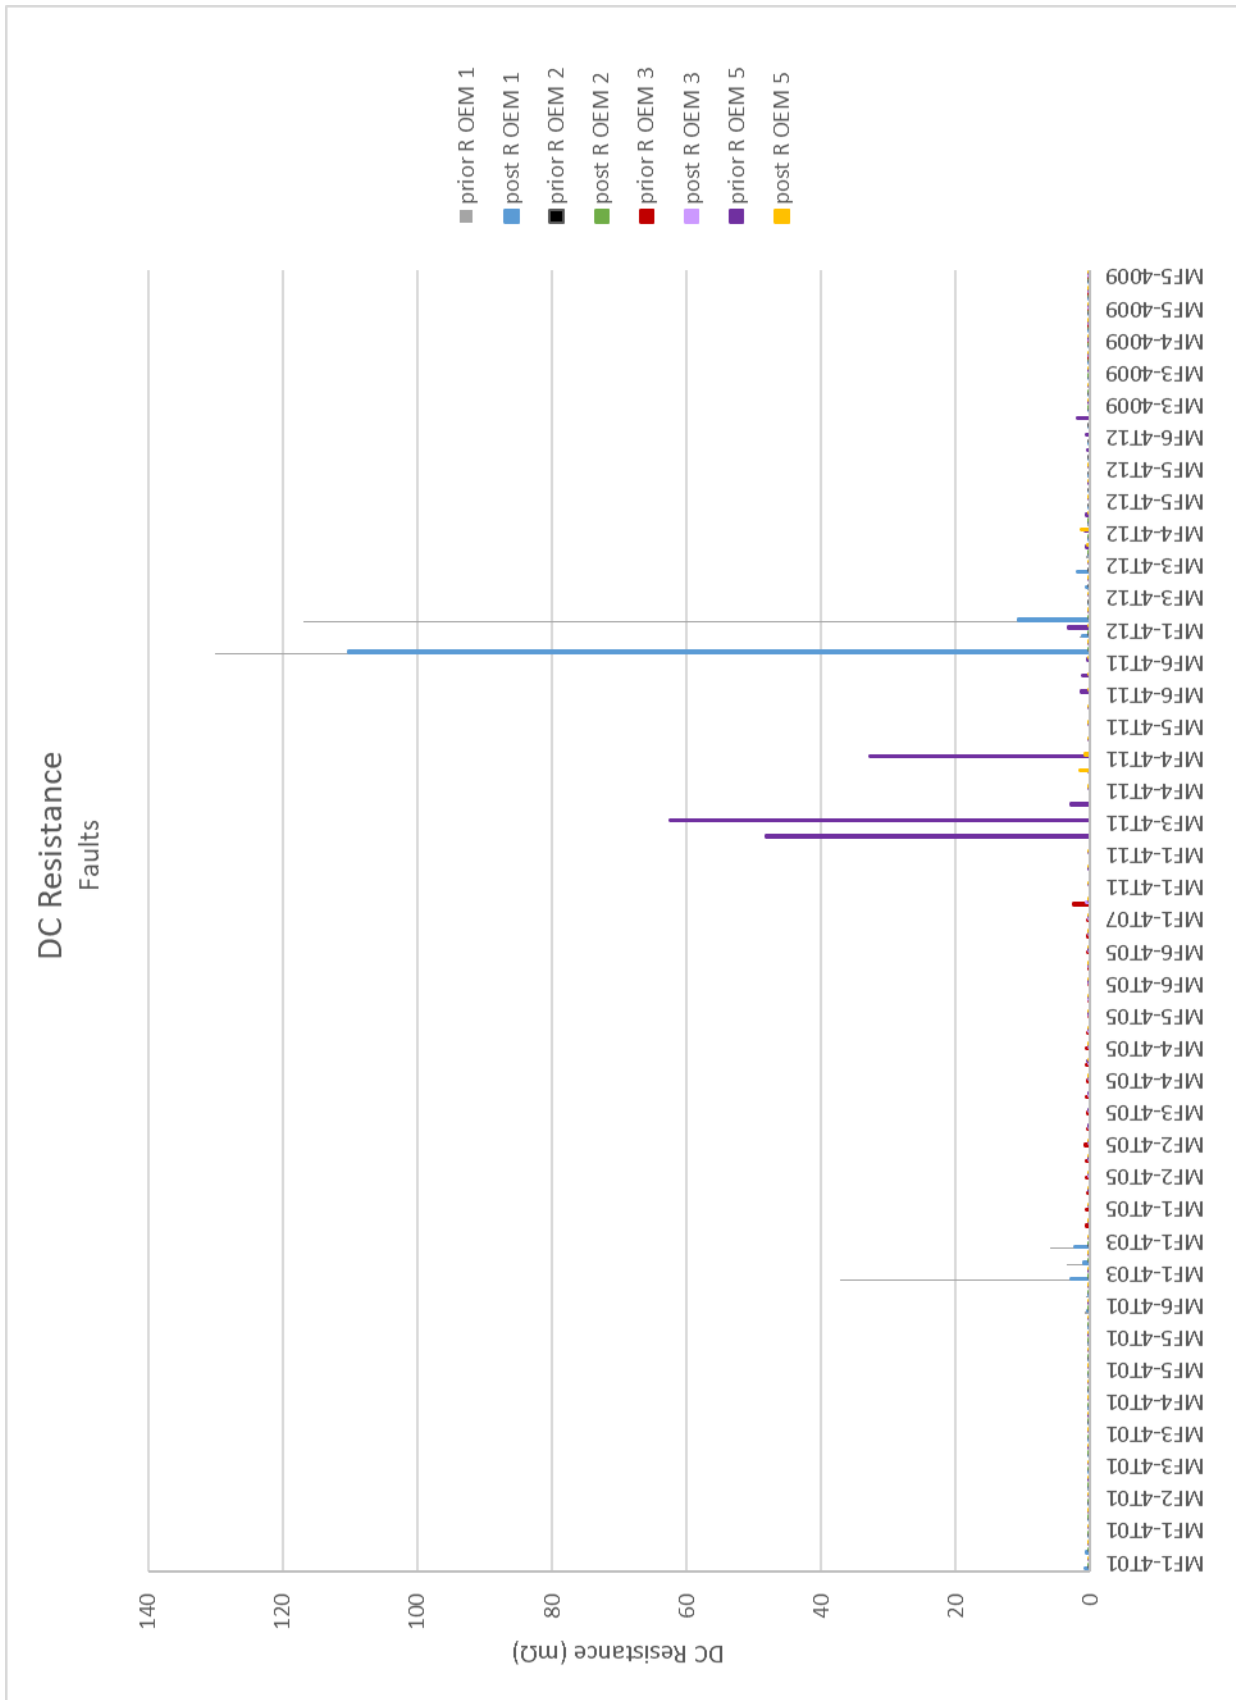
The highest pre-test DC resistance values are for MF4-4T12 (Hi-Lok/Hi-Kote with oversized hole fault) and MF6-4T01 (Hi-Lok with under-torqued fault). The majority of the sparking occurred with MF-4T11 (Hi-Lite/Hi-Kote) and MF-4T12 (Hi-Lok/Hi-Kote) with the nonconductive coating. As evidence of conditioning the test article, in Figure 47-46, the post test DC resistance (blue line) is much lower than the pre-test DC resistance for all faulted test articles except the MF-4T01 and the MF-4T03 articles from OEM 2. All of the faulted test articles except for the MF-4T11 (Hi-Lite/Hi-Kote) and MF-4T12 (Hi-Lok/Hi-Kote) with the nonconductive coating were tested at 10 kA once to show they would not spark before being tested at higher currents (up to 100 kA) on the DEL generator. The MF-4T11 and MF-4T12 fasteners were only tested up to 10 kA.

Figure 47: DC resistances across all OEMs– Faulted Fasteners

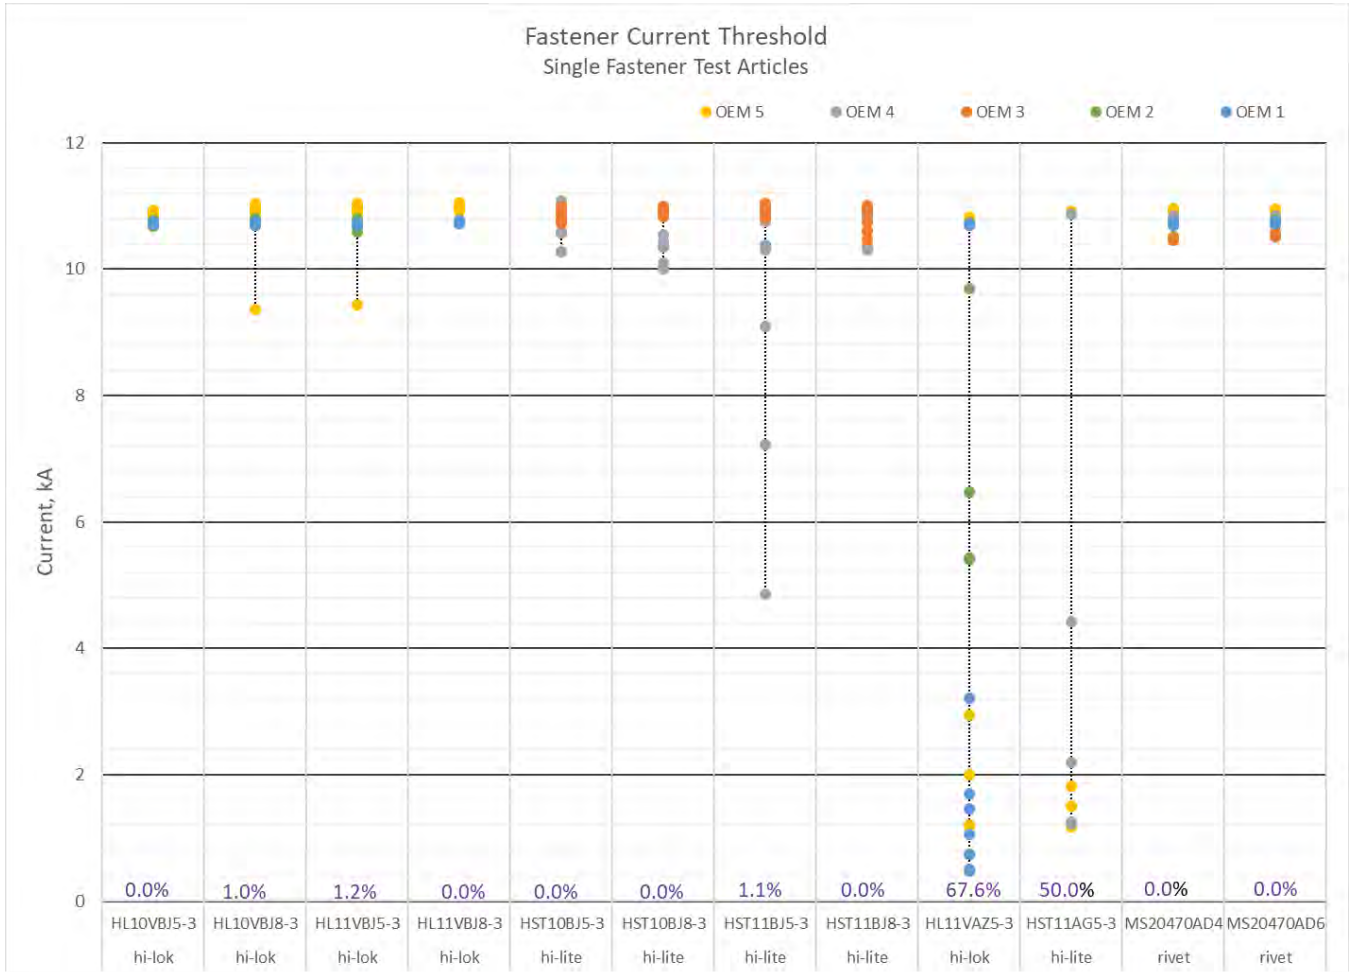
Figure 48 and Figure 49 are detailed representations of the current threshold data, showing all the current values by OEM. The sparking percentage for each type of fastener is noted along the X-axis.

Figure 48: Nominal Single Fastener Sparking Thresholds by OEM

. When there was internal sparking or no sparking, the current threshold is higher than what is shown in Figure 48 and Figure 49.

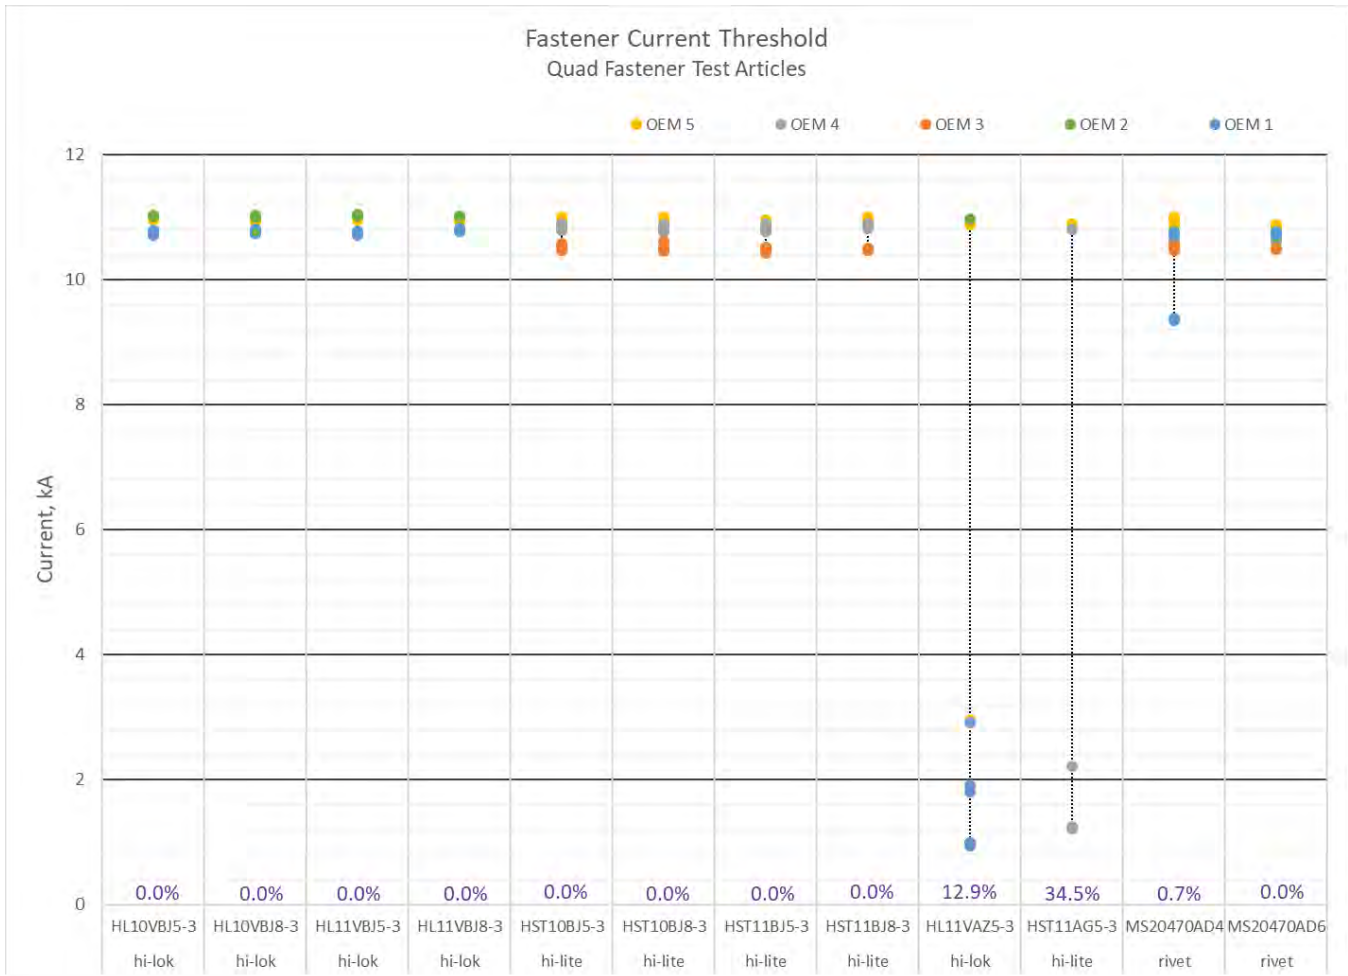
Figure 49: Nominal Quadruple Fastener Sparking Thresholds by OEM

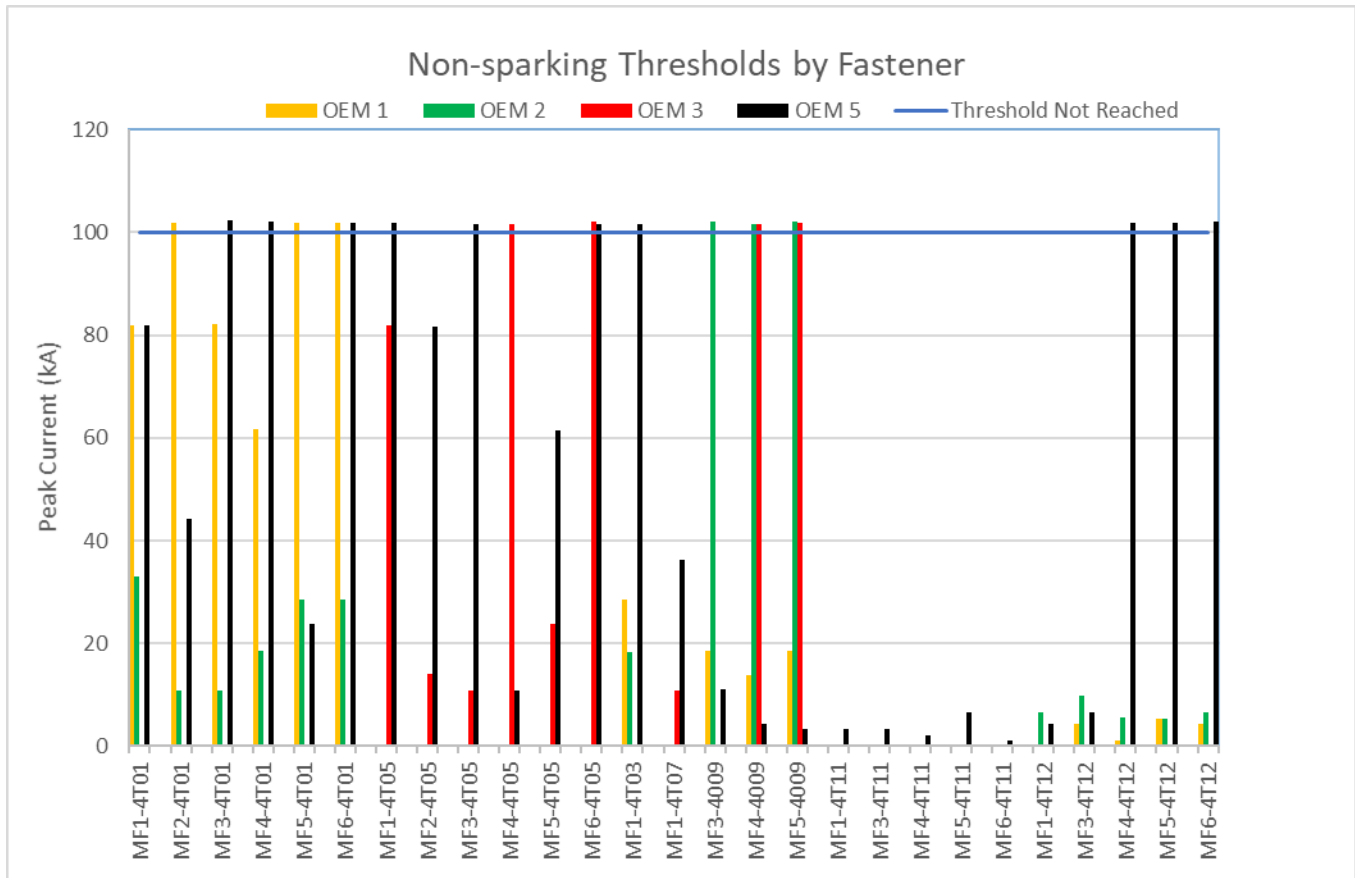
The only nonconductive fastener that did not spark was MF1-4T11. As every other nonconductive fastener sparked, this was taken to be anomalous data and the coupon was not tested higher than 11 kA.

Figure 50: Nonsparking Thresholds by Fastener

The main result to be expected from this research is the maximum peak current amplitude that can be conducted through the simulated fuel tank test articles to determine the sparking and nonsparking threshold for each fastener configuration. Current levels through the nominal single fastener test articles are shown in Figure 48. **Error! Reference source not found.** Current levels through the nominal quadruple fastener test articles are shown in Figure 49. Current levels through the faulted quadruple fastener test articles are shown in Figure 50.

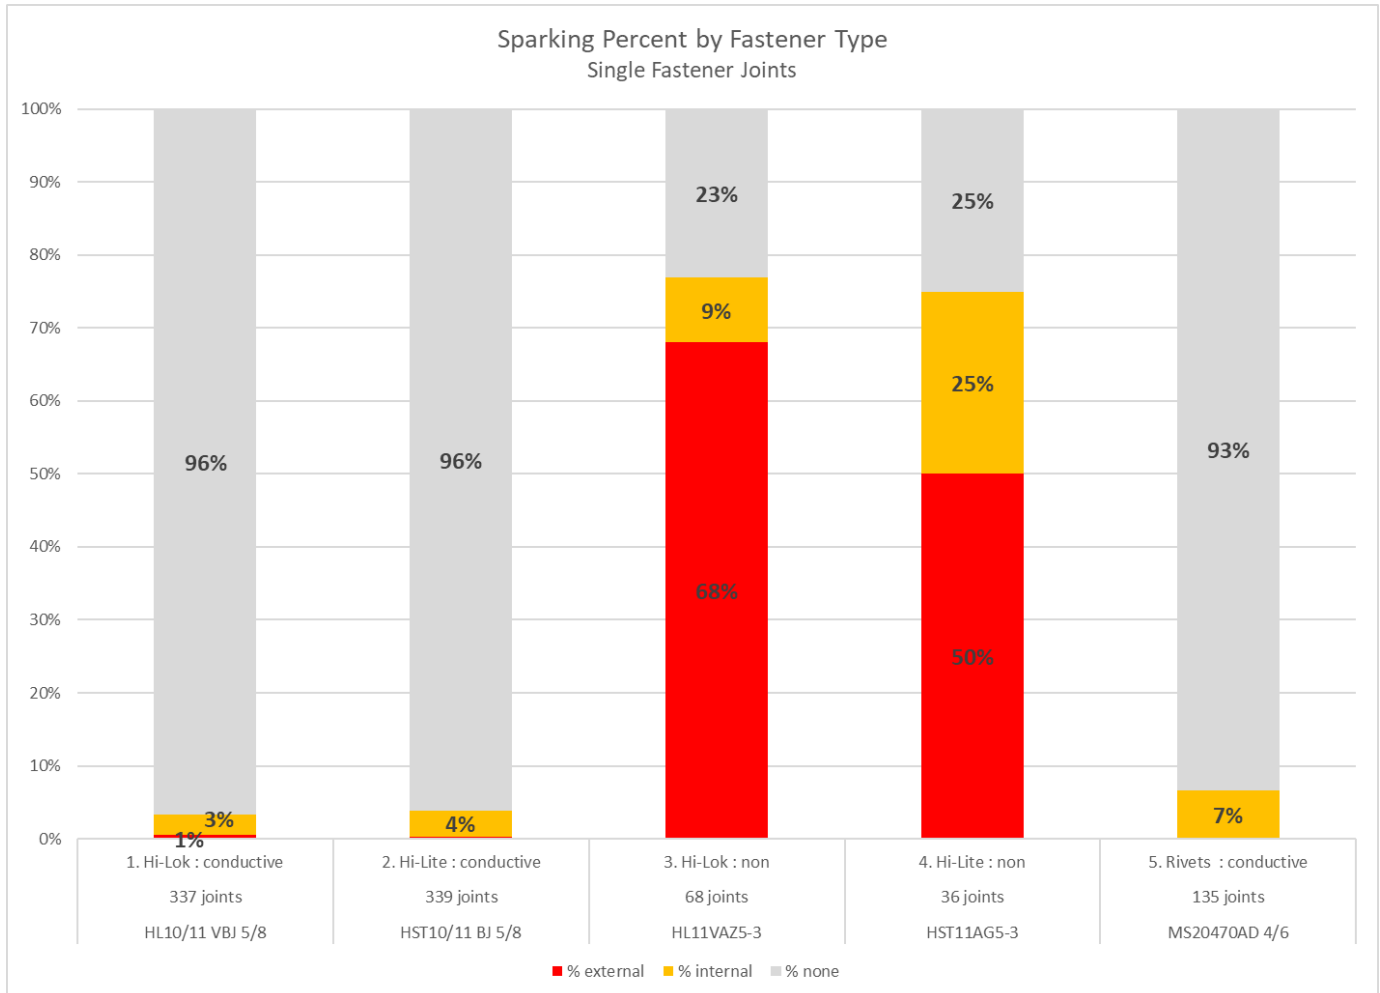
Figure 51: Sparking Percent for Fastener Types of Nominal Test Articles

A contingency table using the levels of 0, 5, and 10 for the sparking and the levels of HI-LOK™ and HI-LITE™ for the fastener type was used to compare the percent difference in sparking between the HI-LOK™ and the HI-LITE™. A general linear model using fit and fastener type for the nonconductive coating fasteners was also used to compare the fastener types. The fastener type was found to be not statistically significant so the difference in the sparking percentages was just normal variance in the data.
