**Kansas Aviation Research and Technology (KART) Program
KART R51827**

**Experimental Identification of
Lightning Conducted-Current
Fastener Sparking Thresholds
(25.981 Project) – Test Results**

Metal Test Report

Document Number: ENV-RP-2016-003– Rev A

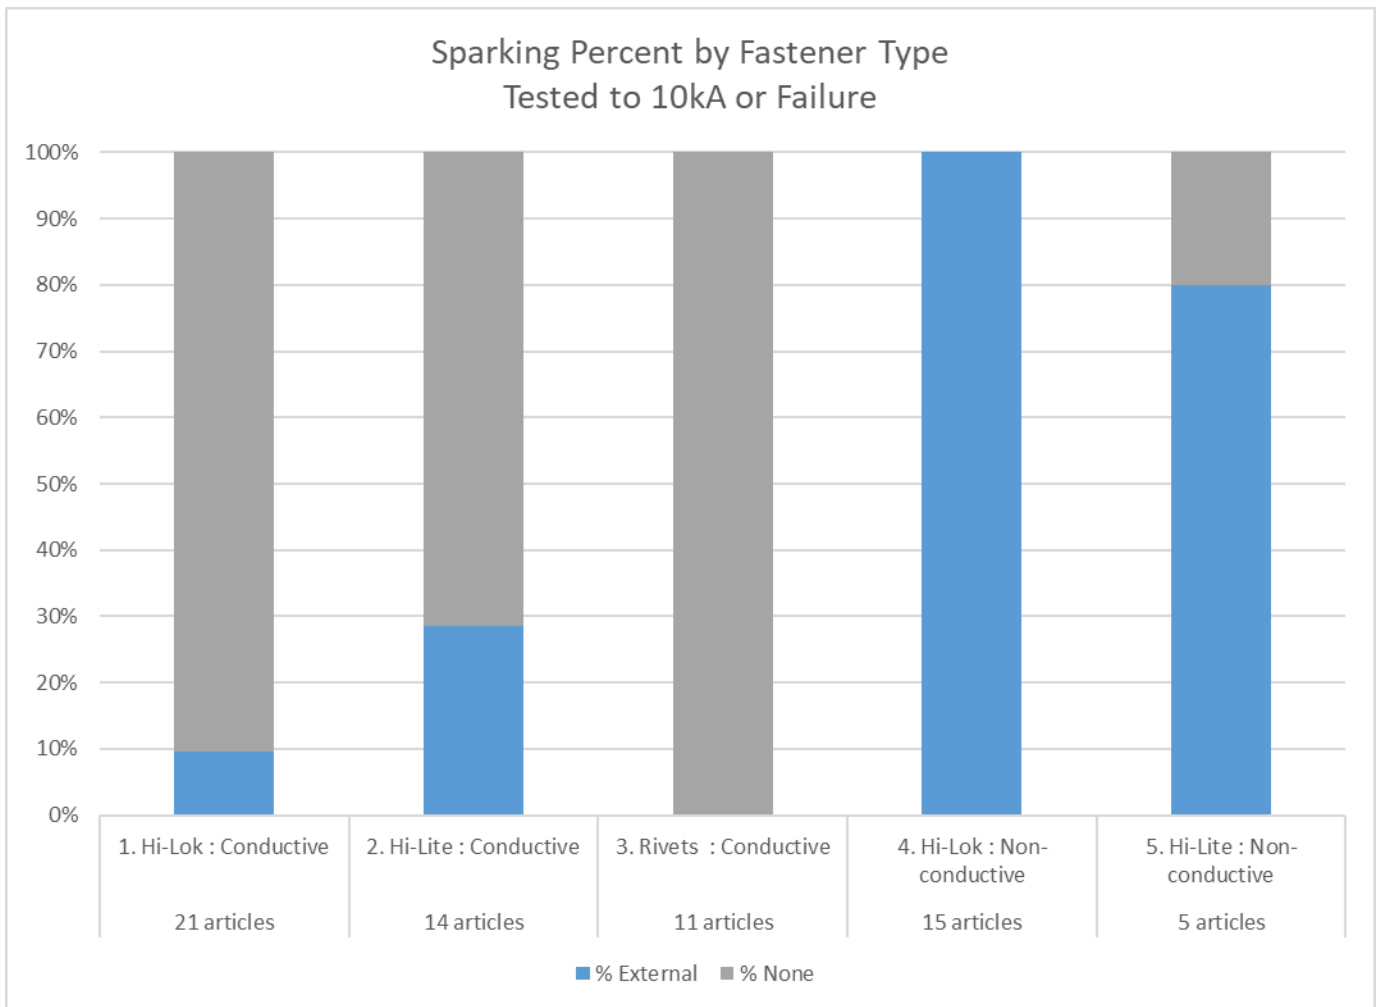
Sparking percentages for each of the five faulted fastener types are shown in Figure 52 and Figure 53. At the lower test level, the majority of the sparks came from the nonconductive fasteners, therefore only the conductive fasteners were tested at the higher test level of 100kA. At this test level, rivets sparked the least. This is likely due to the nature of rivet installation leading to a more effective transfer of current. Due to the high surface contact and good electrical bonding of rivet installations, the sparking threshold was not met for over 75% of the tested articles. Similar percentages of HI-LOK™ and HI-LITE™ fasteners sparked at 100kA. This further supports the conclusion drawn by statistical analysis for the nominal data, that HI-LOK™ and HI-LITE™ are not statistically different.

Figure 52: Sparking Percent for Fastener Types of Faulted Test Articles on 25.981 Generator

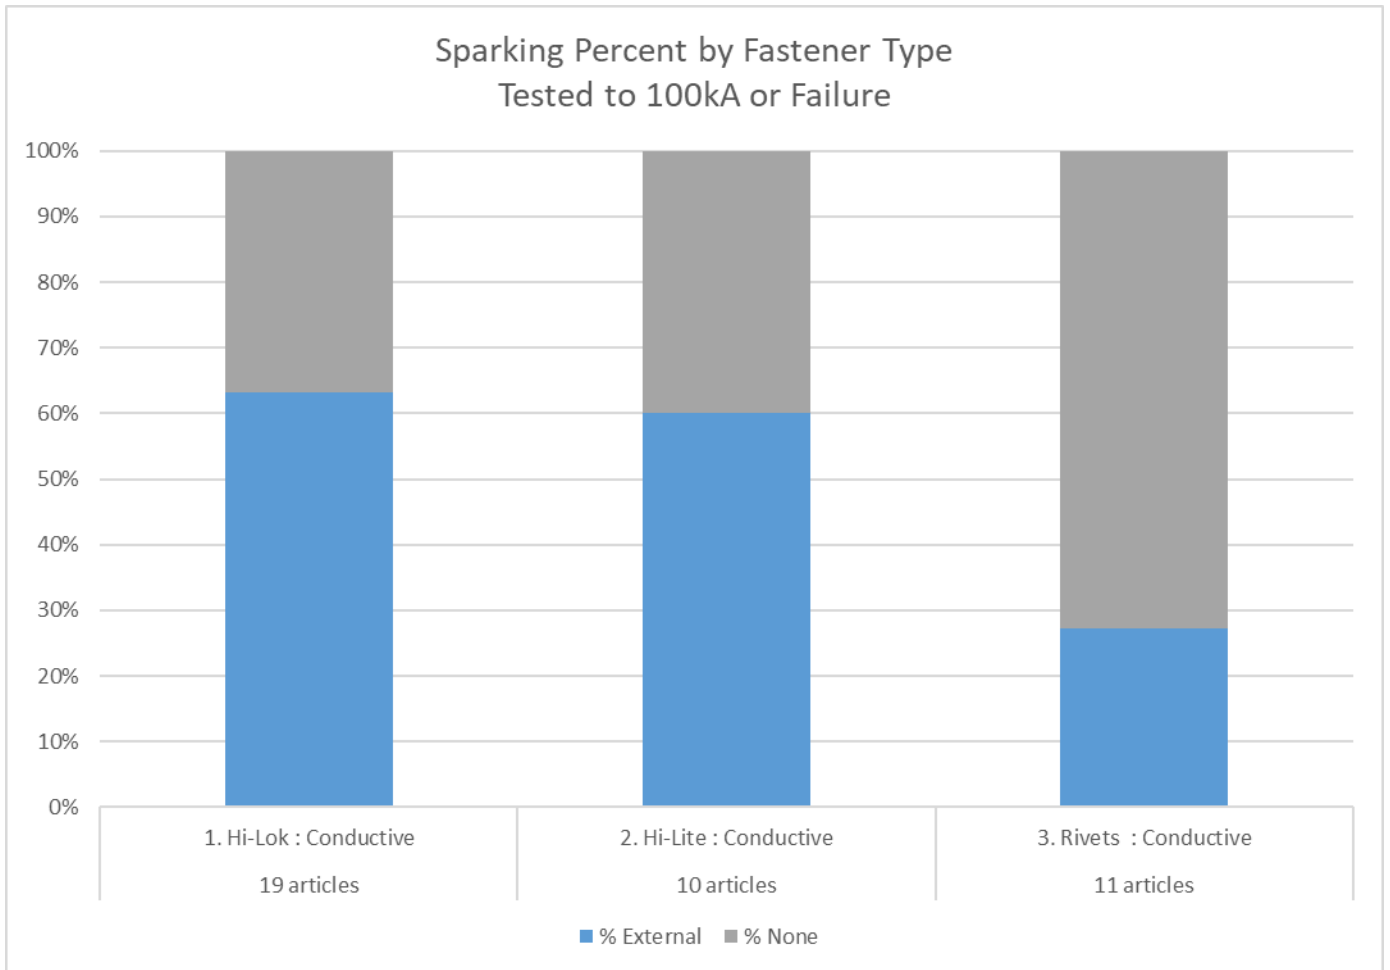
Figure 53: Sparking Percent for Fastener Types of Faulted Test Articles on DEL Generator

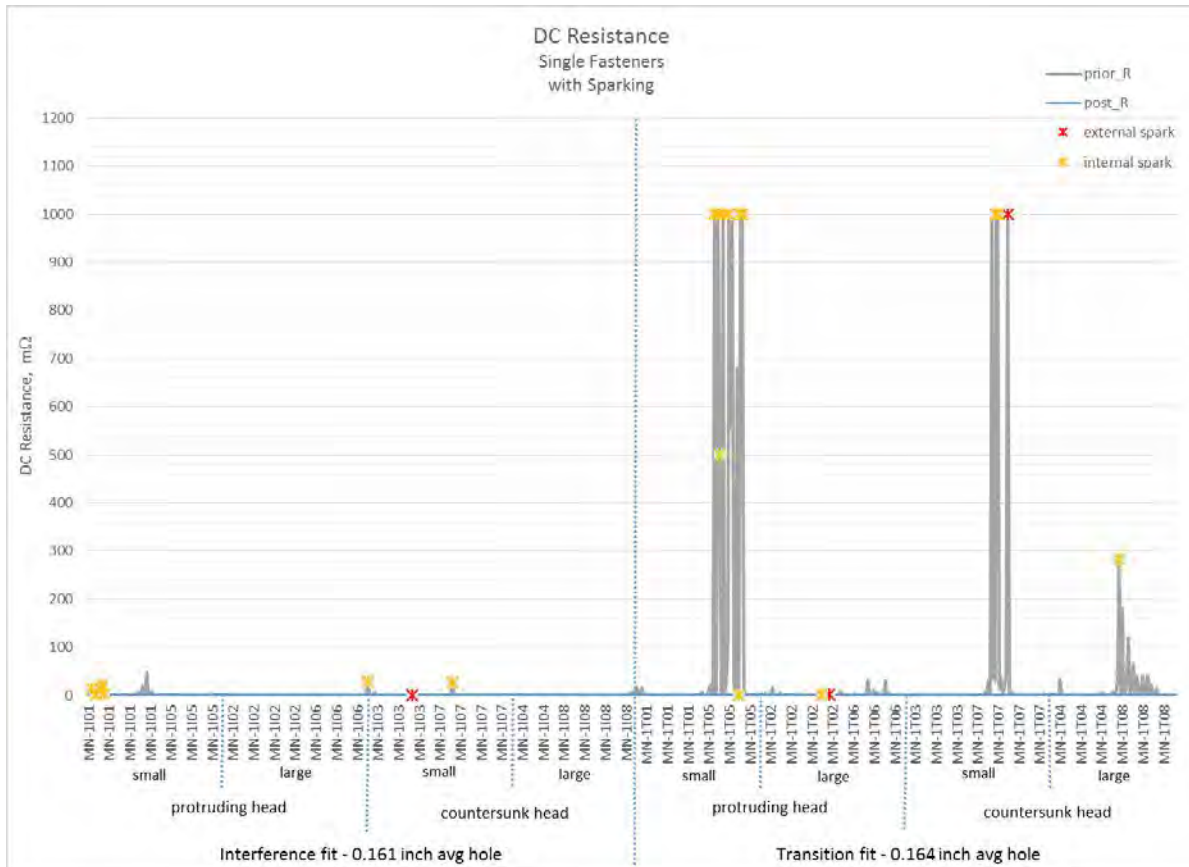
While the fit type might not have a statistical impact on the DC resistance or on external sparking, there was a difference in terms of internal sparking. It is important to note that an internal spark is not an ignition source, but it is a useful indicator of a disturbance on the differential voltage measurements and of potential manufacturing variance.

Figure 54: Effect of Fit Type Differences on DC Resistance - Nominal Single Fasteners

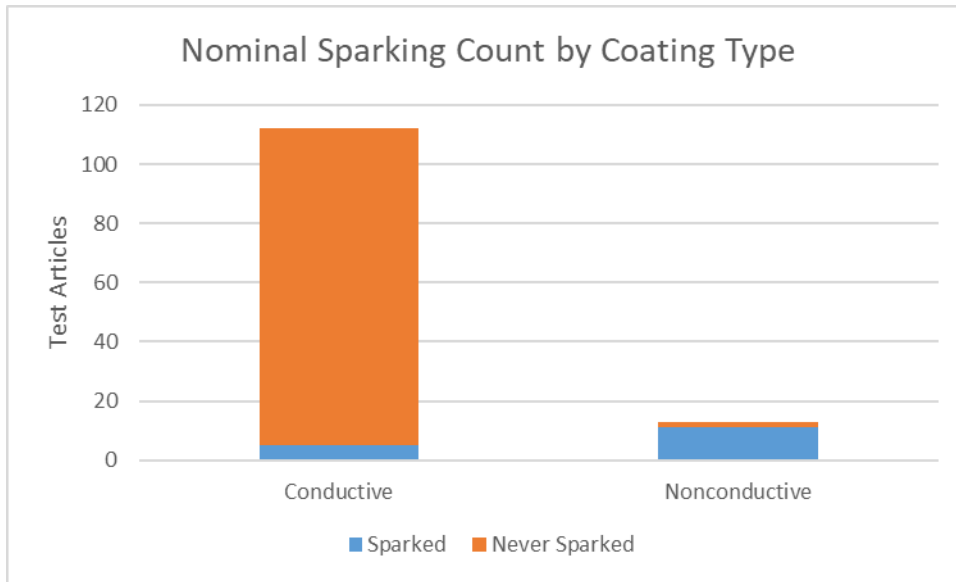
Only the small, countersunk head, HI-LOK™ and HI-LITE™ fasteners were tested with the nonconductive coating. All other fastener combinations used the conductive coating. The effects of coating were the same in both nominal and faulted article testing as shown in Figure 55 and Figure 56 below. The conductive IVD coating sparked less and had a higher nonsparking threshold as compared to the nonconductive Hi-Kote coating.

Figure 55: Nominal Sparking Count by Coating Type

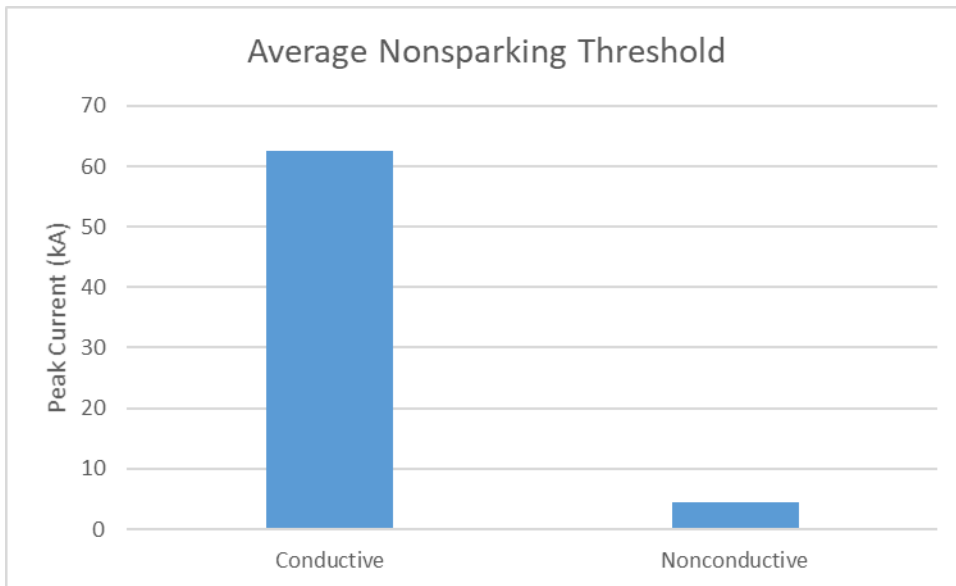
Figure 56: Faulted Average Nonsparking Threshold

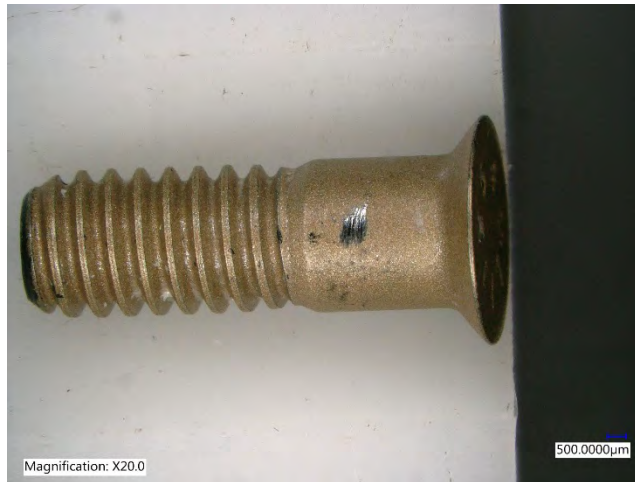
The nonconductive coating used on both the HI-LOK™ and HI-LITE™ fasteners is known as HI-KOTE™ 1. HI-KOTE™ 1 is a phenolic-based aluminium coating with high corrosion and temperature resistance applied by spraying and is then oven cured to fully develop its properties.

HI-KOTE™ 1 was examined more closely under a microscope. The coating was grainy and appeared to be patchy but provided an effective seal as evidenced by the data. Figure 57 shows a HI-KOTE™ 1 coated fastener. A scratch was made in the coating to better judge its depth and adhesion.

Figure 57: HI KOTE 1 coated fastener

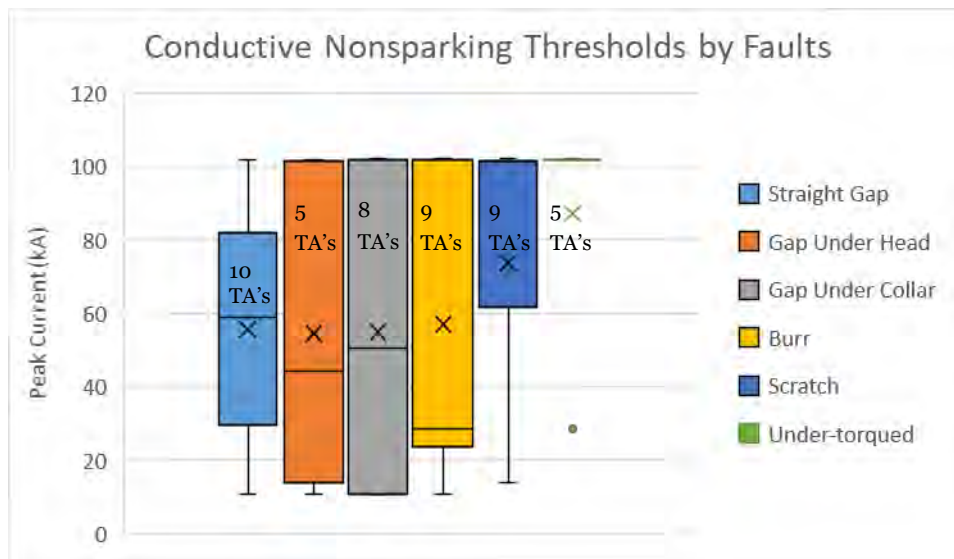
To see if any particular fault had a greater effect on the nonsparking threshold, the threshold values for each fault were plotted separated by coating type (see Figure 58 and Figure 59). OEM 3 only provided conductive fasteners. The number of test articles in the analysis for each fault type is denoted by the number of TA's. It is important to note that fasteners which appear to have a nonsparking threshold value of 100 kA never sparked because the testing was capped at 100 kA. The mean nonsparking threshold across all of the conductive faulted fasteners averages to $62.62 \text{ kA} \pm 38.9 \text{ kA}$. The mean nonsparking threshold across all of the nonconductive faulted fasteners averages to $4.73 \text{ kA} \pm 2.72 \text{ kA}$. The conductive gap under head and gap under collar faults had the lowest average nonsparking thresholds at $54 \text{ kA} \pm 45 \text{ kA}$. The conductive under-torqued faults had the highest average threshold at $87 \text{ kA} \pm 33 \text{ kA}$.

Figure 58: Conductive Nonsparking Thresholds by Faults

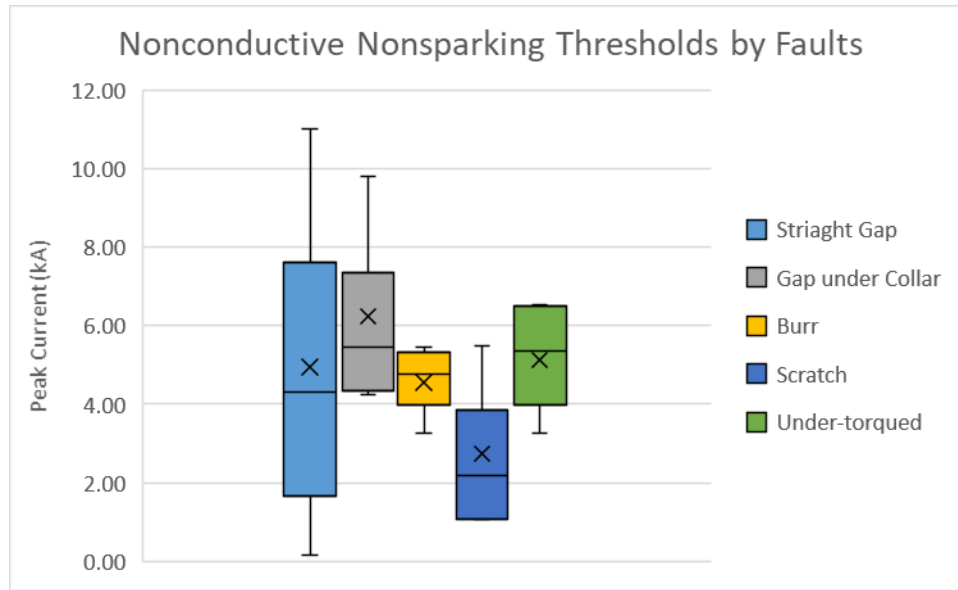
Figure 59: Nonconductive Nonsparking Thresholds by Faults
 *Note that there were 4 TA's for each nonconductive fault configuration.

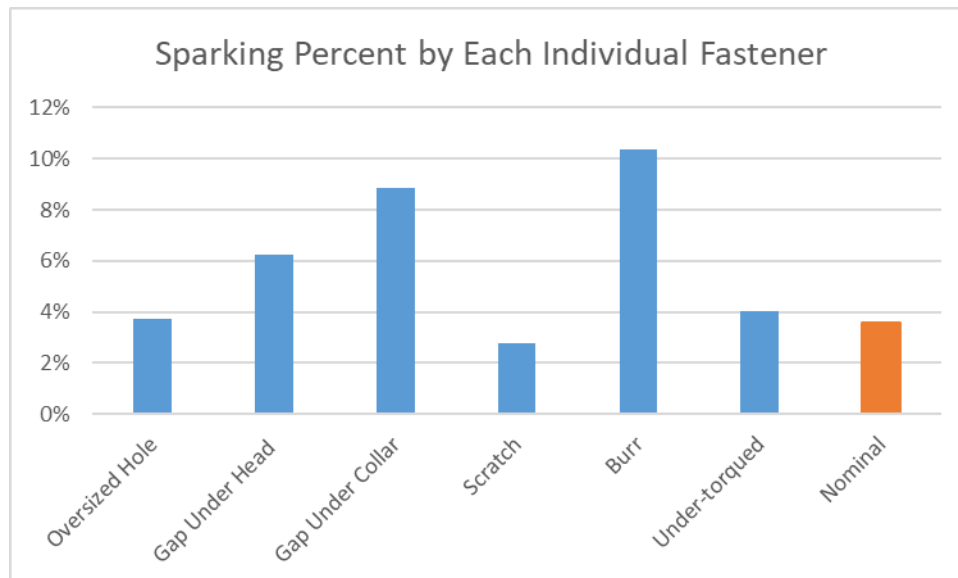
To further investigate the effect of faults on sparking, every sparking incident and the specific fastener they resulted from were tallied. As only 1 fastener per joint was a faulted installation, only 25% of all fasteners tested were faulted. 35% of all sparking came from the faulted fastener installation, while the remaining 65% of sparks originated from the nominally installed fasteners on the faulted test article. Although no specific fault seemed to have a significant impact on the nonsparking threshold, individual analysis of faulted fasteners shows that the burr and gap under collart faults sparked more than any other faulted or nominal installation. The manufacturing anomalies noted earlier and in Section 7.14.2 seemed to effect the nonsparking threshold more than the type of fault present.

Figure 60: Sparking Percent by Each Individual Fastener

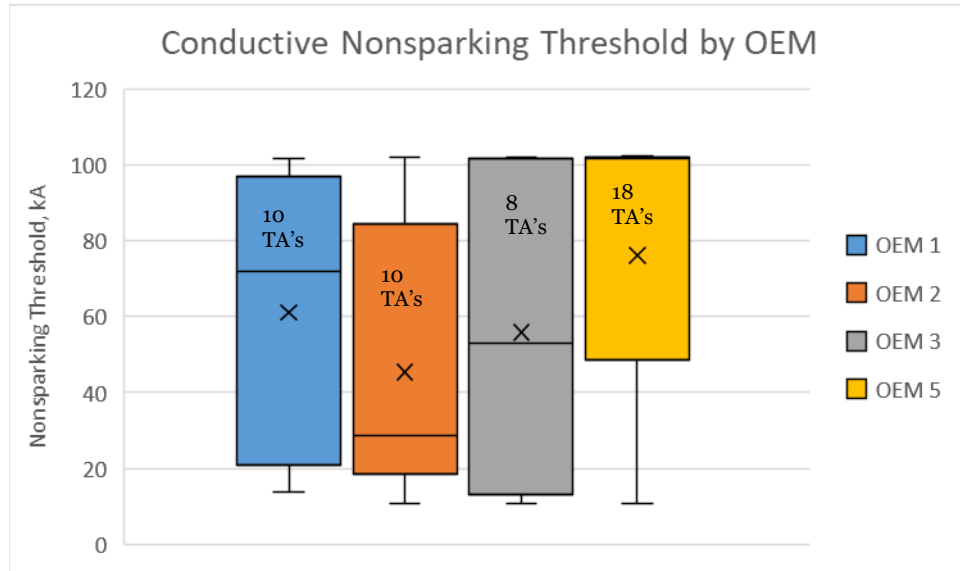
Figure 61: Conductive Fastener Nonsparking Thresholds by OEM

Since the test articles were built using varying manufacturing processes by 4 (faults) or 5 (nominal) OEMs, it is significant to note that the sparking thresholds were all very similar for all OEMs. This indicates that future test data by other OEM's is expected to perform similarly. Based on this observation, the data obtained through the KART Fastener Handbook project is a good baseline for future testing. It should also be noted that the determined nonsparking thresholds for all IVD conductive fastener configurations were significantly higher than the theoretical current densities that would be expected at these fastener locations.

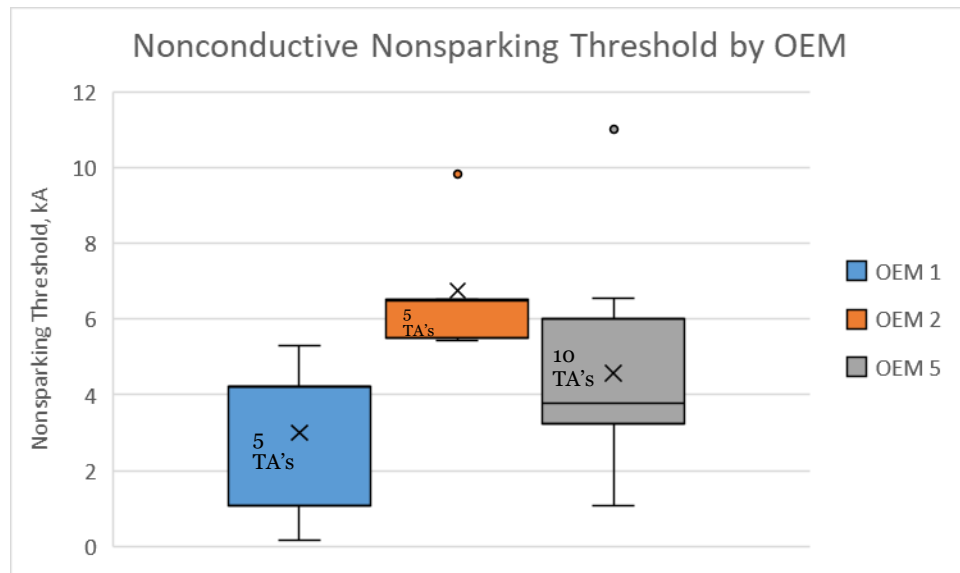
Figure 62: Nonconductive Fastener Nonsparking Thresholds by OEM

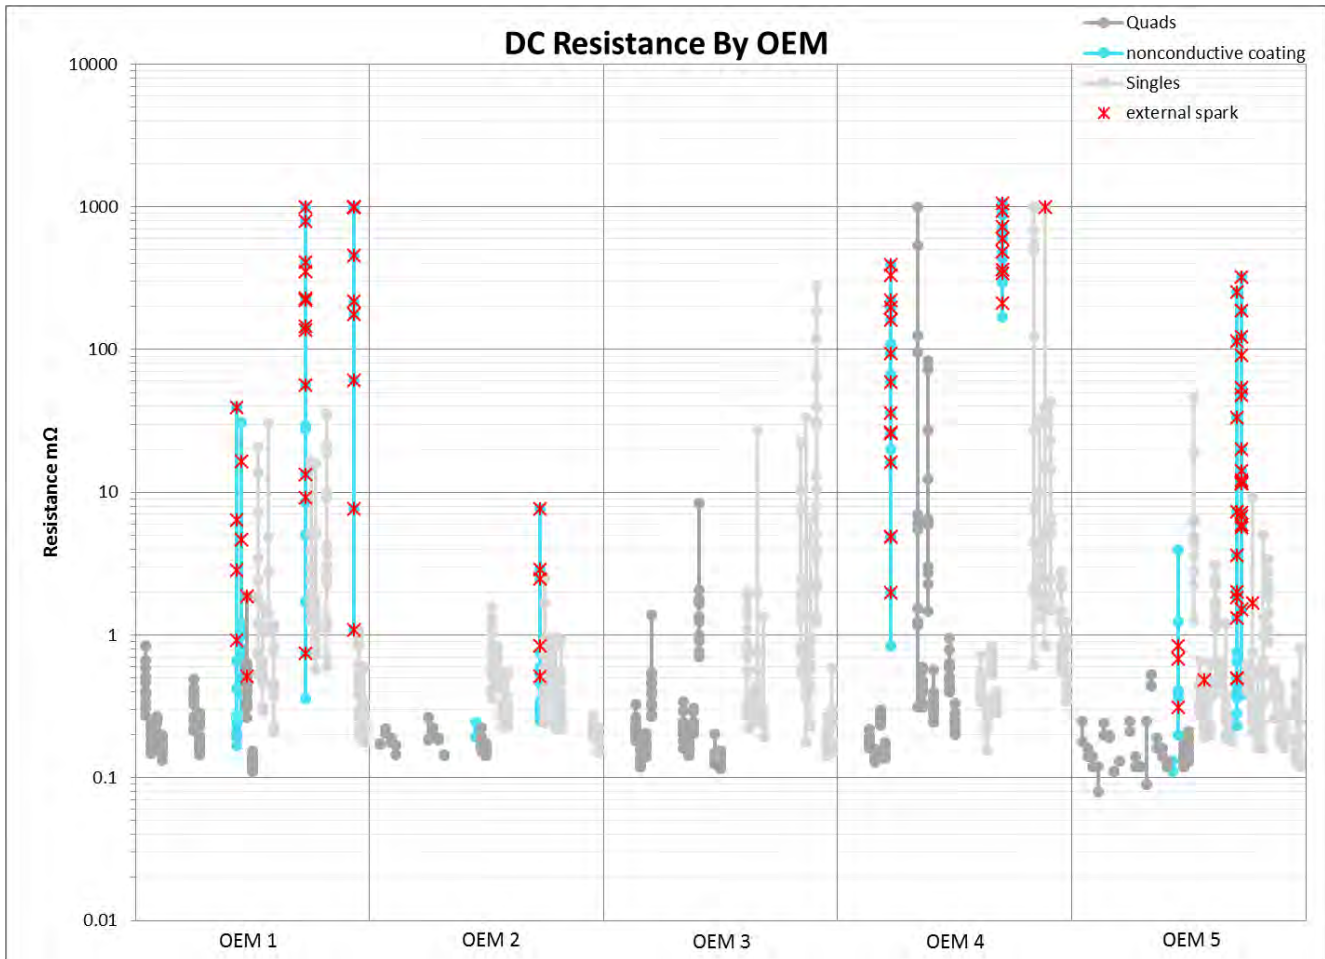
It can also be seen in Figure 63 that some of the low DC resistance values sparked while some of the high DC resistance values did not spark. The main cause of external sparks in this data was the nonconductive coating on the fasteners which disabled the conductive path. This says that sparking is a more complicated event that cannot be explained with a single variable.

Figure 63: DC Resistance of Nominal Test Articles by OEM

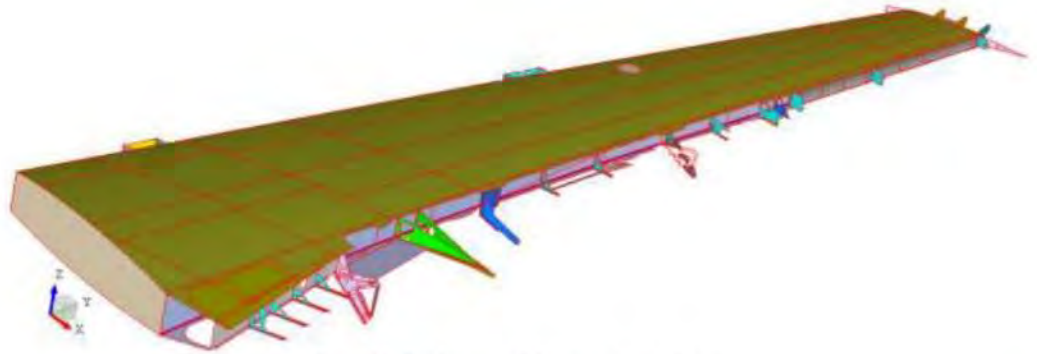
The wing model geometry was directly imported from CATIA CAD files. The geometry was appropriately modified to have the necessary component mesh and connectivity. The final wing geometry is shown in Figures 11-13. The wing considered in this analysis was missing some very important components that should typically be considered when performing this type of validation effort. Primarily this would include system components inside the fuel region like fuel pipes, couplers, hydraulic pipes and electrical components like FQIS. Additional aircraft components outside of the fuel tanks could affect current distributions or certain interfaces that may need to be considered. Some of these additional components may include:

Figure 11: Final wing model geometry, top-aft view.

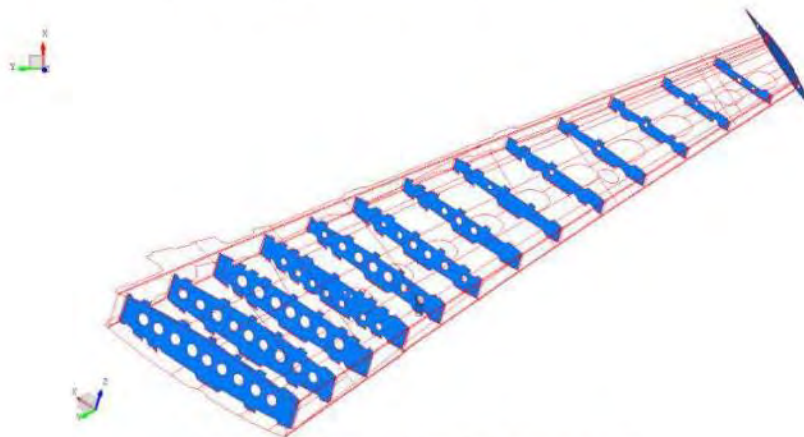
Figure 13: Final wing model geometry, interior rib view.

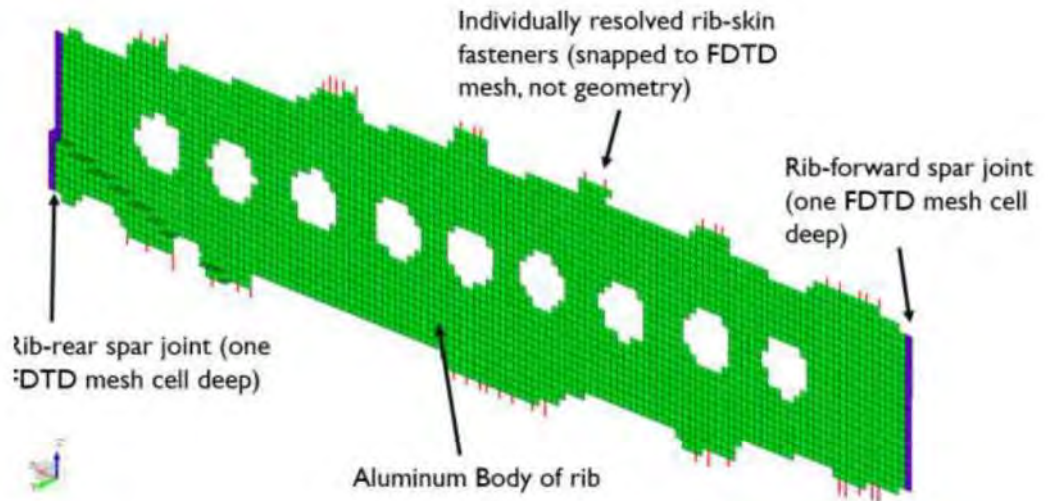
Figure 16: FDTD Mesh result for rib 5.

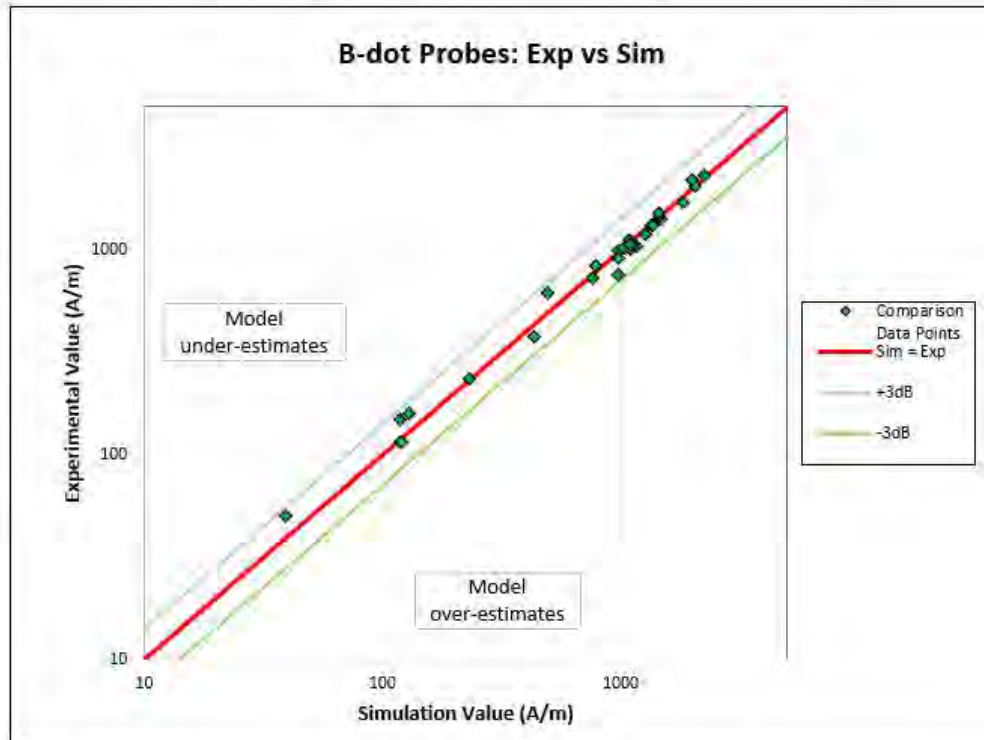
Figure 20: Full data summary scatter plot for B-dot probes. 3 dB lines added to help quantify margins.

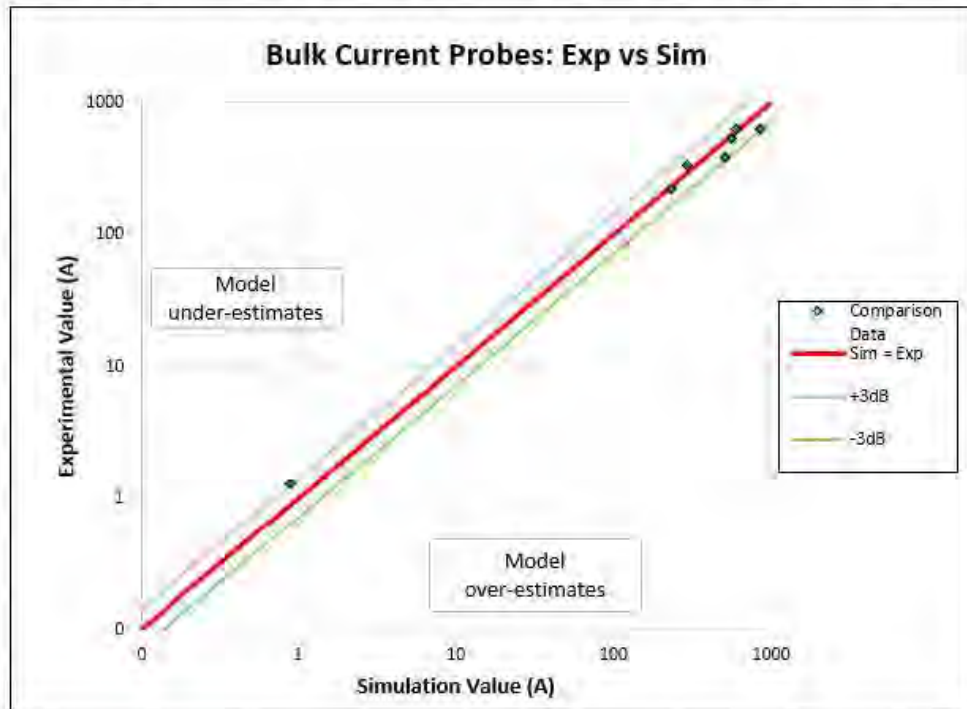
Figure 23: Bulk Current Probe Scatter Plot

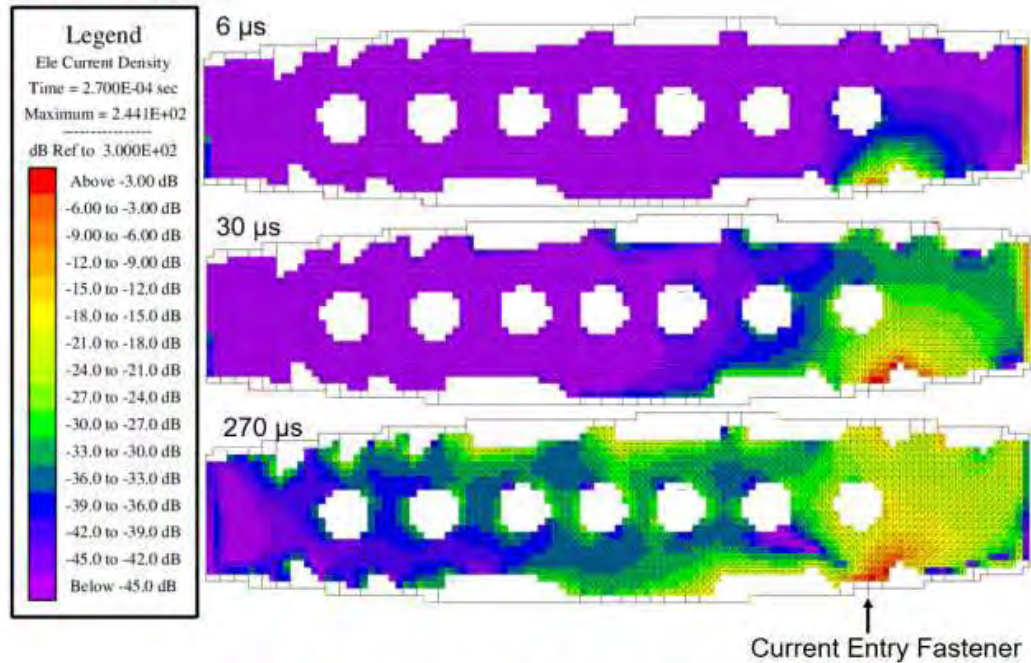
Figure 27: Rib 7 Current Density at 6, 30 and 270 us for Configuration 3.

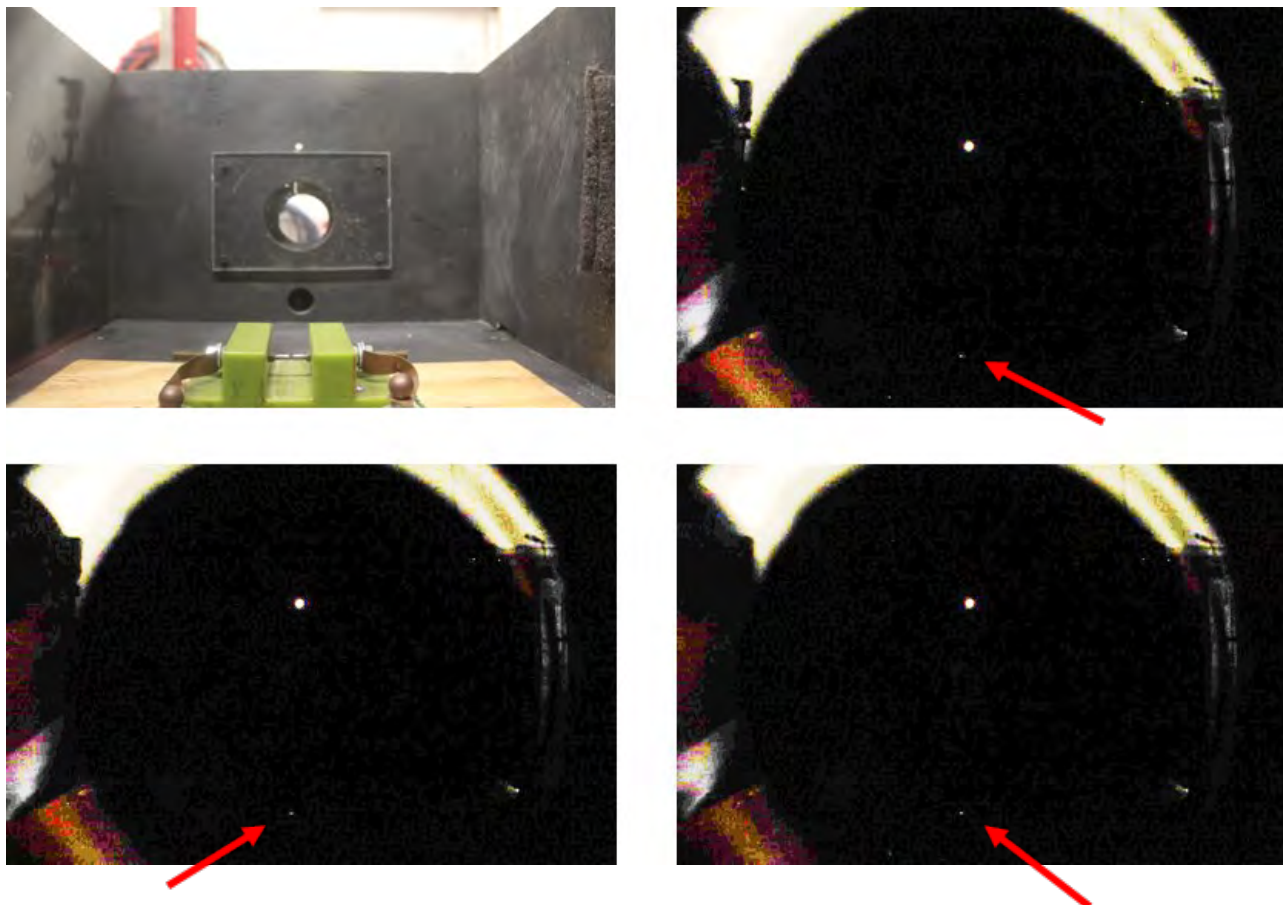
Figure 1: Calibration Photographs for Camera 1

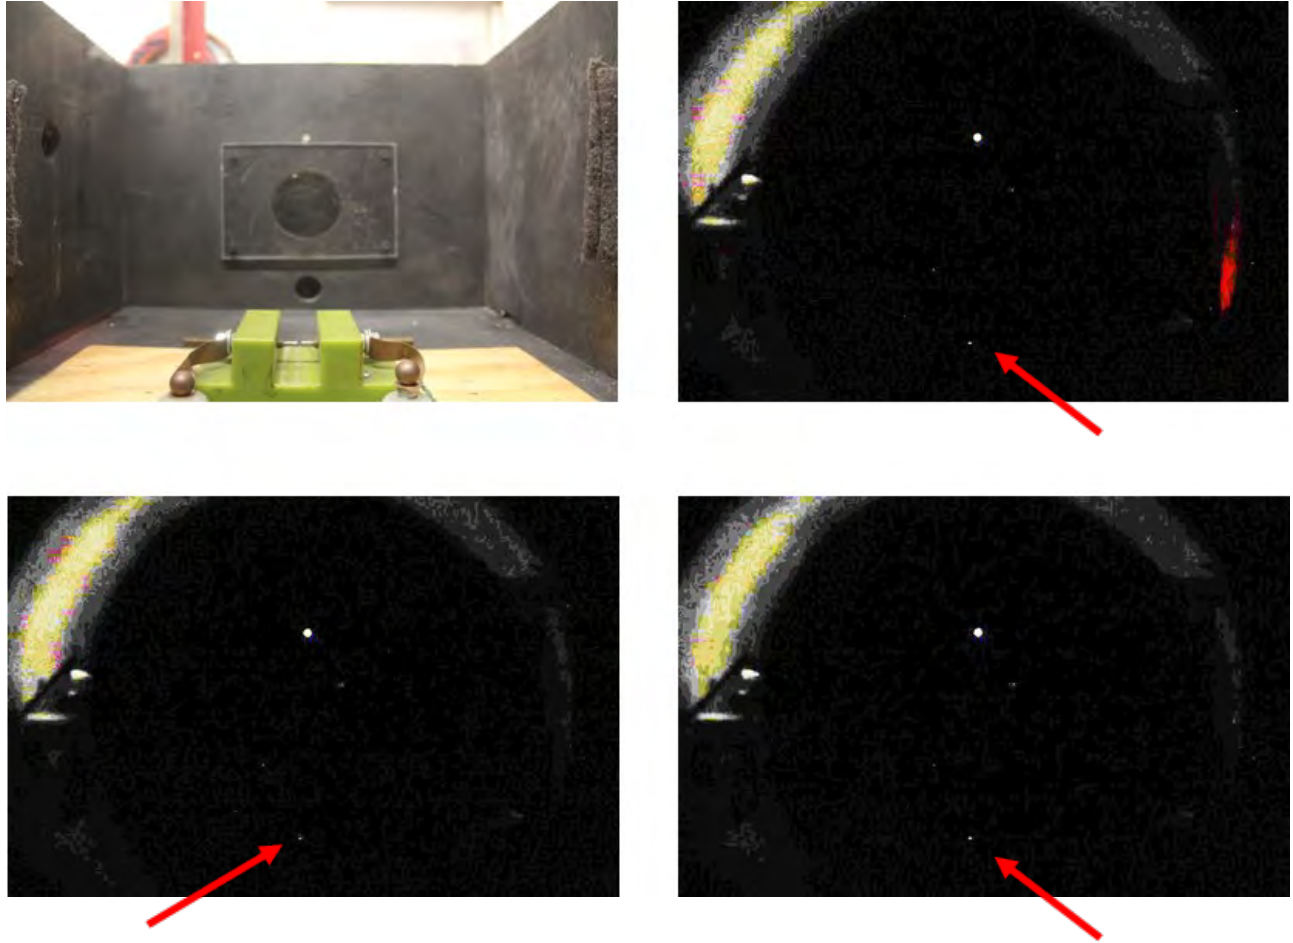
Figure 2: Calibration Photographs for Camera 2

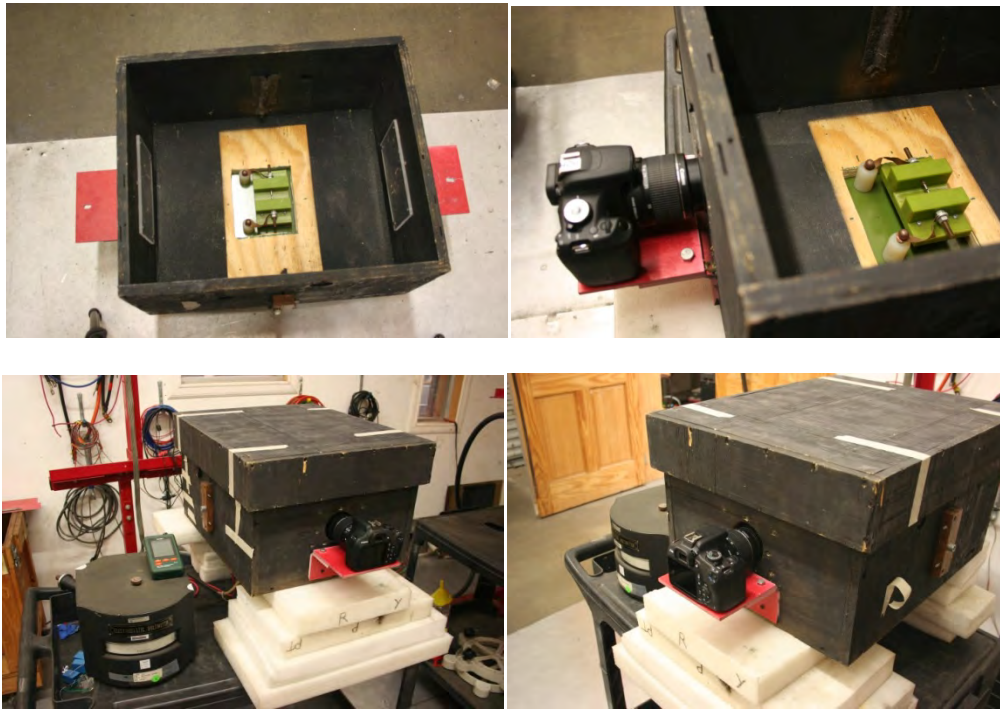
Figure 3: Camera Calibration Test Setup at DNB Engineering, Inc.
