Non-destructive Evaluation Methods for Detecting Major Damage in Internal Composite Structures

**New Project Title: *Impact Damage
Tolerance Guidelines for Stiffened
Composite Panels***

Francesco Lanza di Scalea
Professor, Dept. of Structural Engineering
University of California San Diego

2019 JAMS Technical Review
May 22-23, 2019

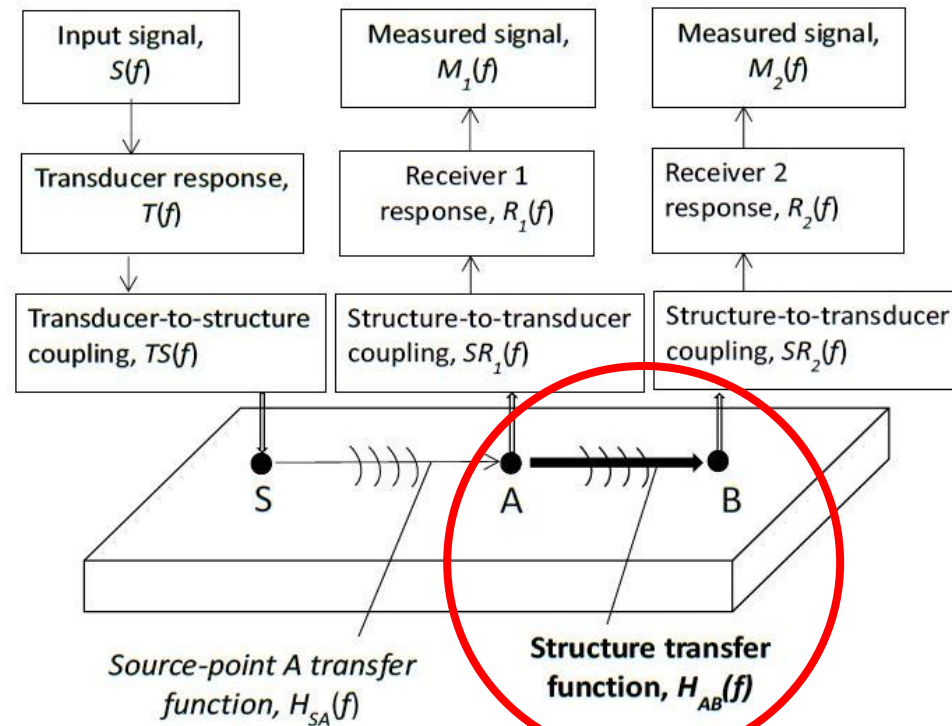
Guided-Wave Transfer Function: Single-Input-Dual-Output Scheme (SIDO)

Receiver 1: $M_1(f) = S(f) \cdot T(f) \cdot TS(f) \cdot H_{SA}(f) \cdot SR_1(f) \cdot R_1(f)$

Receiver 2: $M_2(f) = S(f) \cdot T(f) \cdot TS(f) \cdot H_{SA}(f) \cdot H_{AB}(f) \cdot SR_2(f) \cdot R_2(f)$

~~$$Deconv = \frac{M_2(f)}{M_1(f)} = H_{AB}(f) \cdot \frac{SR_2(f)}{SR_1(f)} \cdot \frac{R_2(f)}{R_1(f)}$$~~

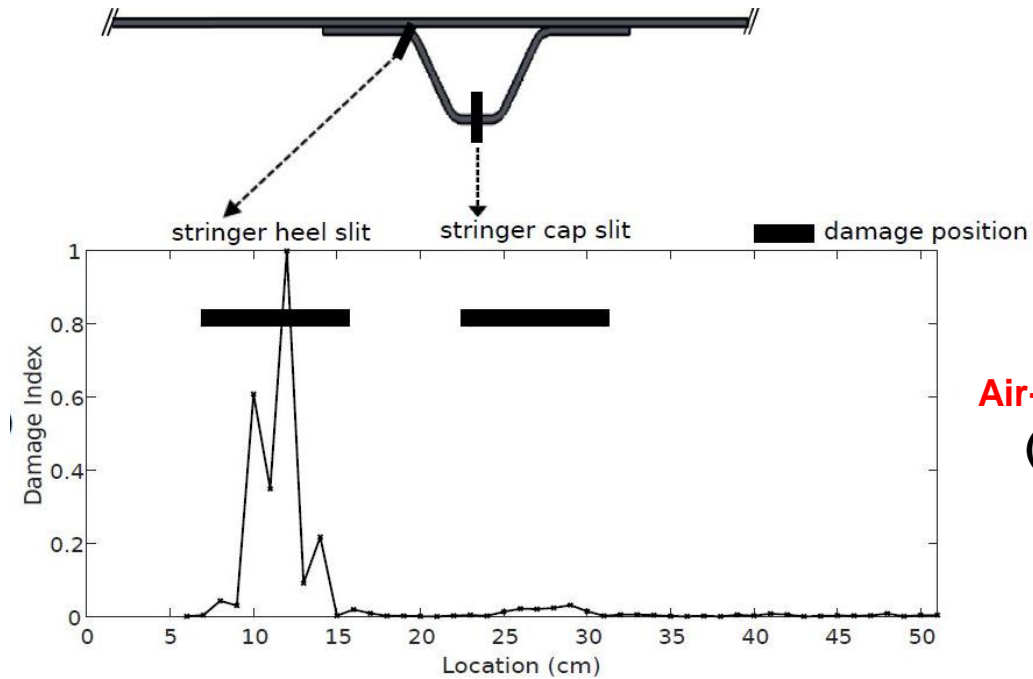
Results: stringer heel slit and stringer cap slit

Air-coupled scanner
(110 – 210 kHz)

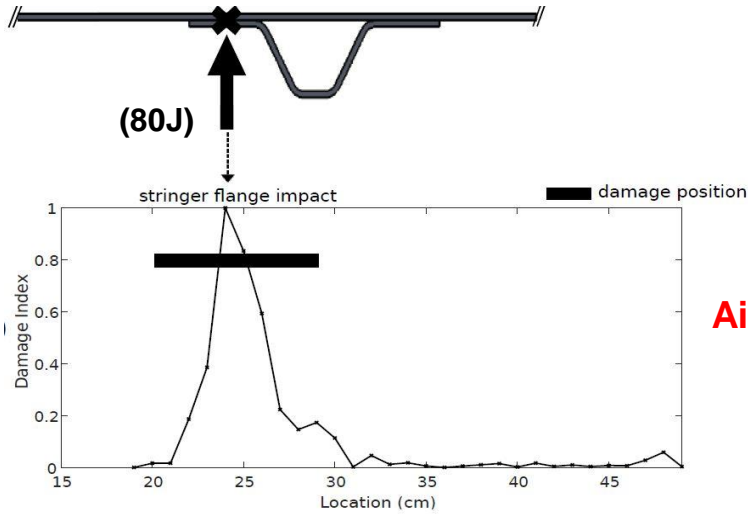
Results: stringer flange impact

Air-coupled scanner
(110 – 210 kHz)

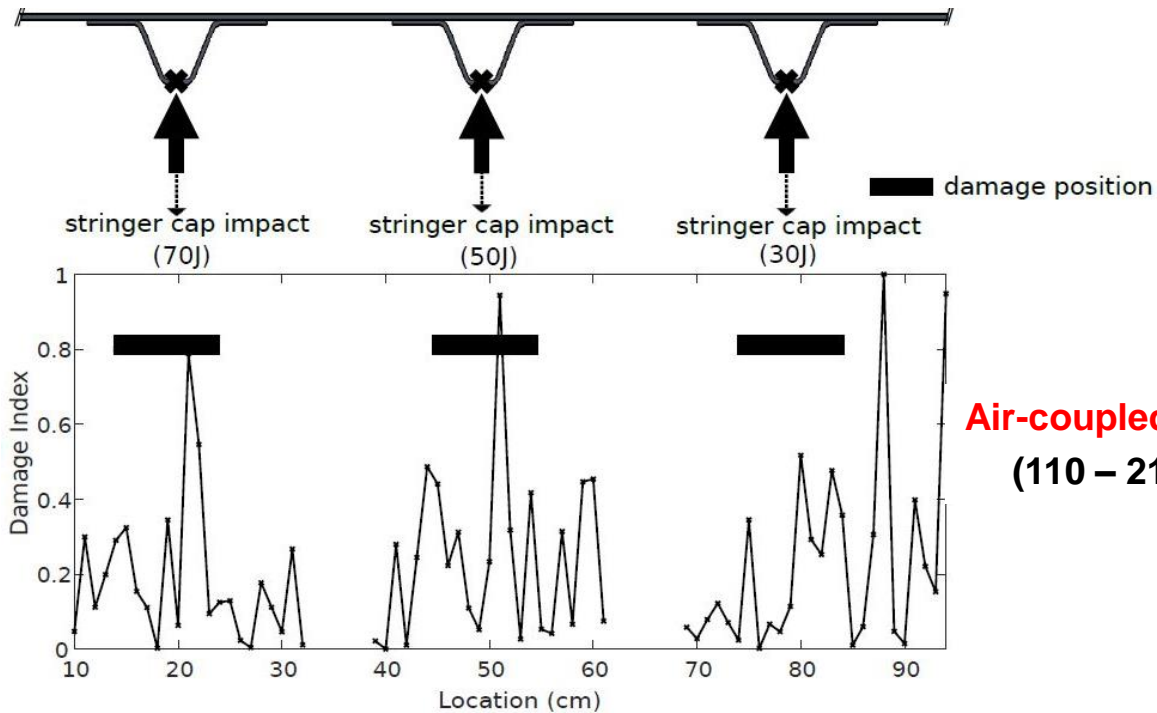
Results: stringer cap impacts

Air-coupled scanner
(110 – 210 kHz)

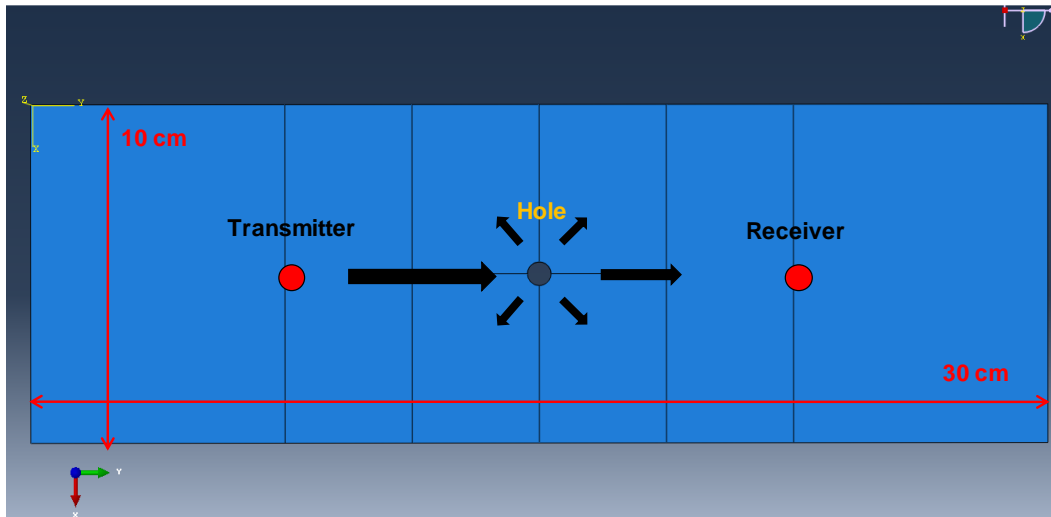
Finite Element Analysis

(isotropic plate. Holes from 0.05 mm to 50 mm dia, 150 kHz freq)

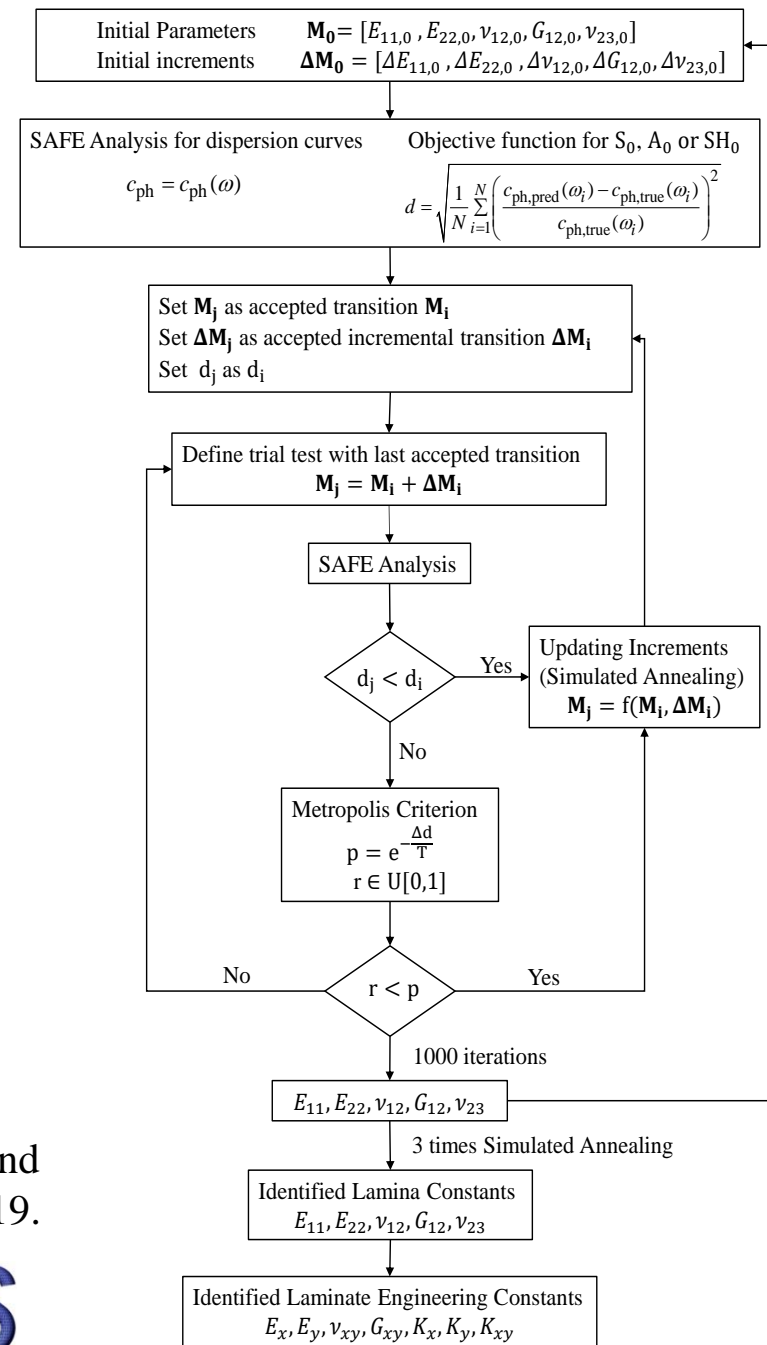
Constants Identification Flowchart

Objective function to minimize:
mismatch of phase velocity dispersion curves

$$d = \sqrt{\frac{1}{N} \sum_{i=1}^N \left(\frac{c_{\text{ph,pred}}(\omega_i) - c_{\text{ph,true}}(\omega_i)}{c_{\text{ph,true}}(\omega_i)} \right)^2}$$

for S_0 , A_0 and/or SH_0

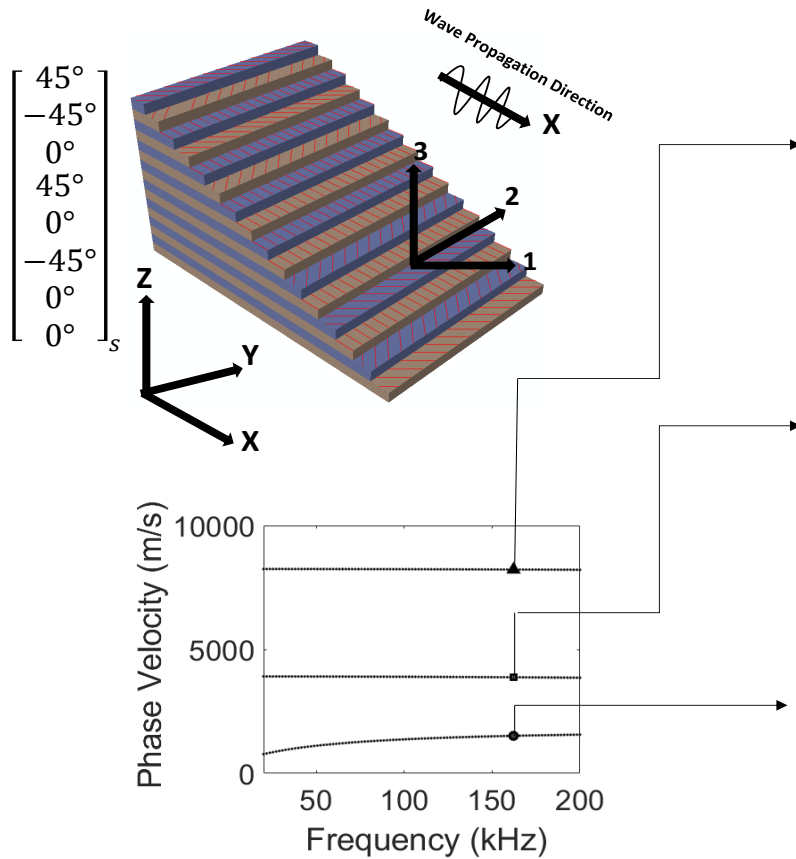
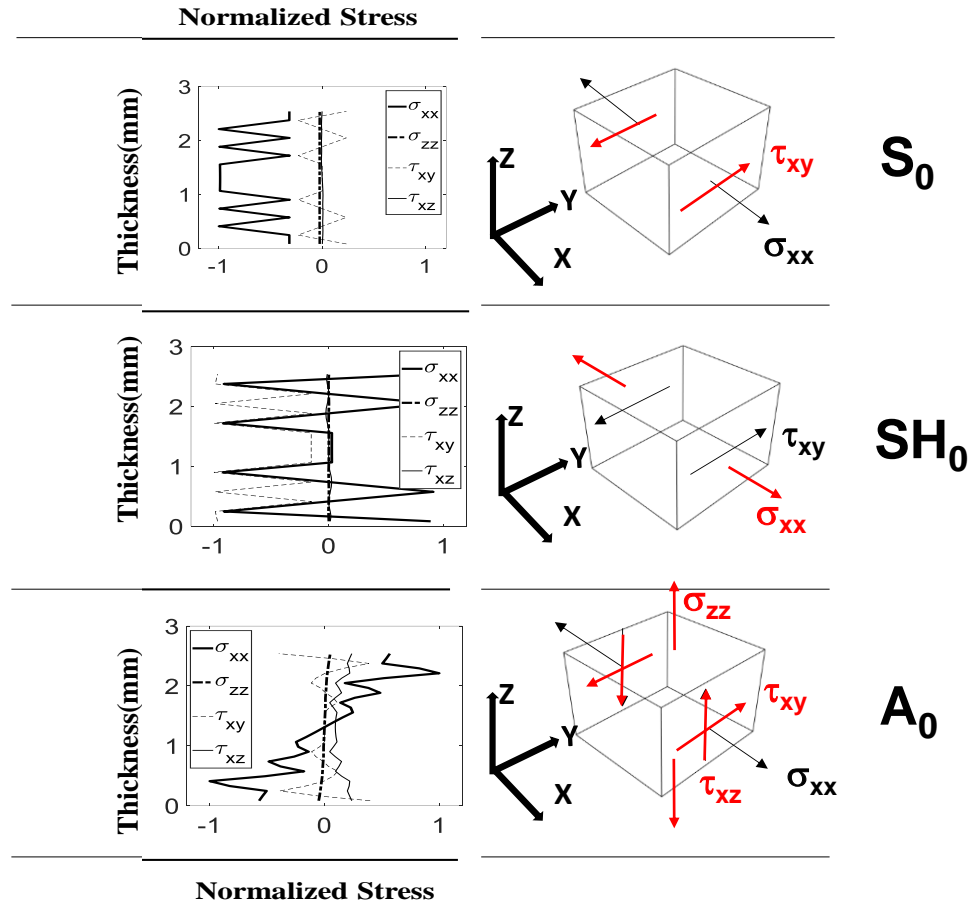
Constants Identification Results: anisotropic laminate

SAFE analysis

*“normal - shear” coupling and
“longitudinal - transverse” coupling !!*

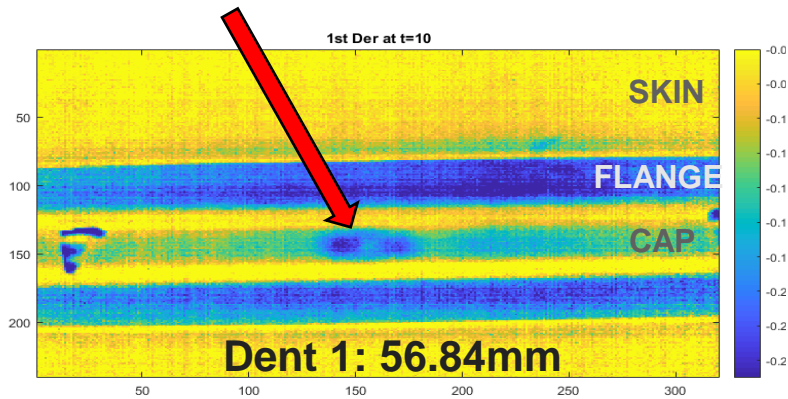
Thermography for Independent Damage Survey

Thermography (TSR): ground truth of damage for quantitative damage survey

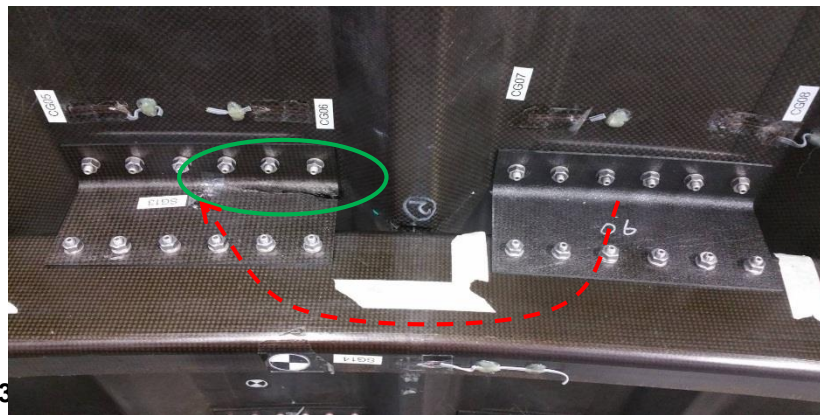
Mini Impactor on Built-up Panel

- Internal shear tie damage detection using mini-impactor excitation

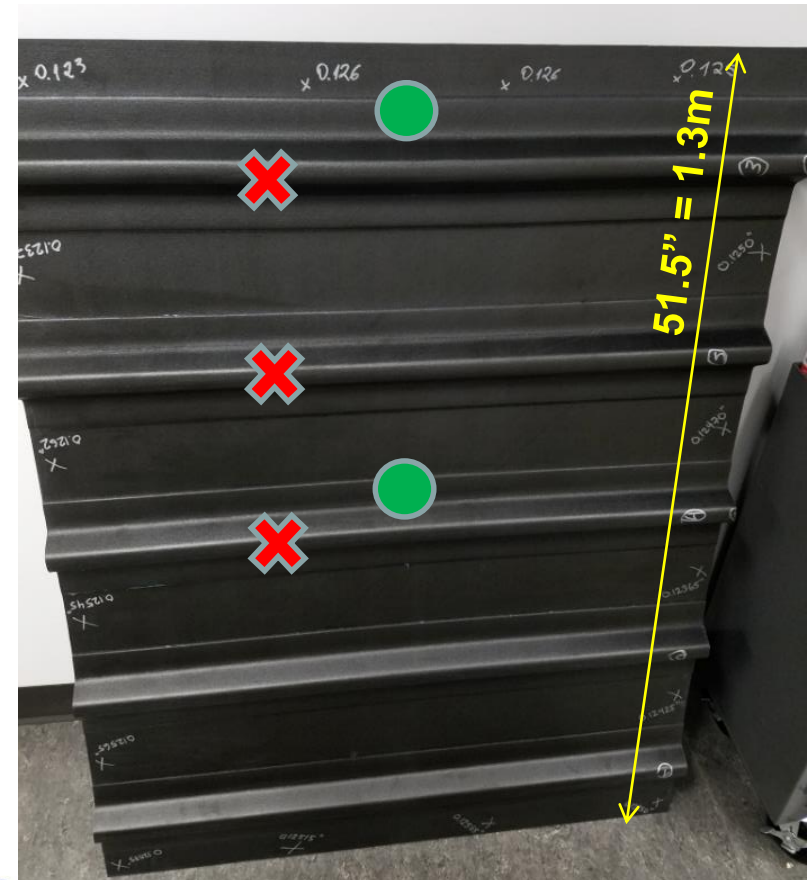
Impact Locations

- Three new stringer panels fabricated
 - T800/3900-2 uni-directional tape plies. Skin thickness = 3.175mm
 - Panel dimensions: 1m x 1.3m
 - Five stringers with 0.26m spacing
 - Various impact energy levels

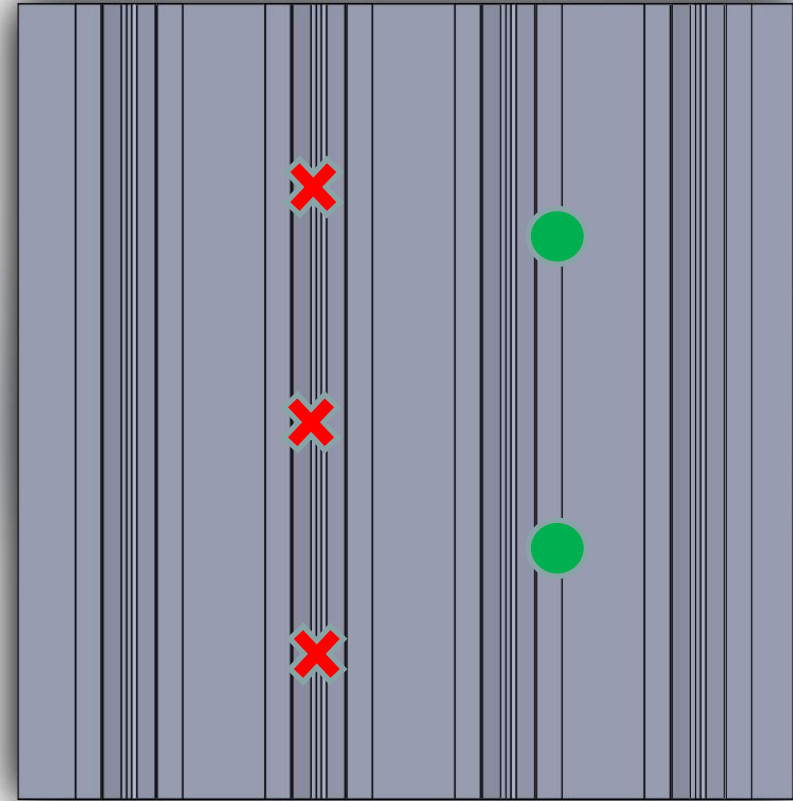
Flat Stringer Panel Impact Plan

- Stringer cap impacted portion will be trimmed into 0.3m specimens for compression w/o buckling
- Stringer flange impacted portion will be trimmed into 0.48m specimens for compression w/ buckling
