# Lightning Direct Effects Handbook

Revision Letter	Date Released	Report Number	Author	Additional Notes
Initial Release	11/03/2022	22-51512-RTR52865	Rebeka Khajehpour & Alyssa Gonzalez	NIAR KART R52865 Spliced Lightning Strike Protection on Thermoplastic Composites

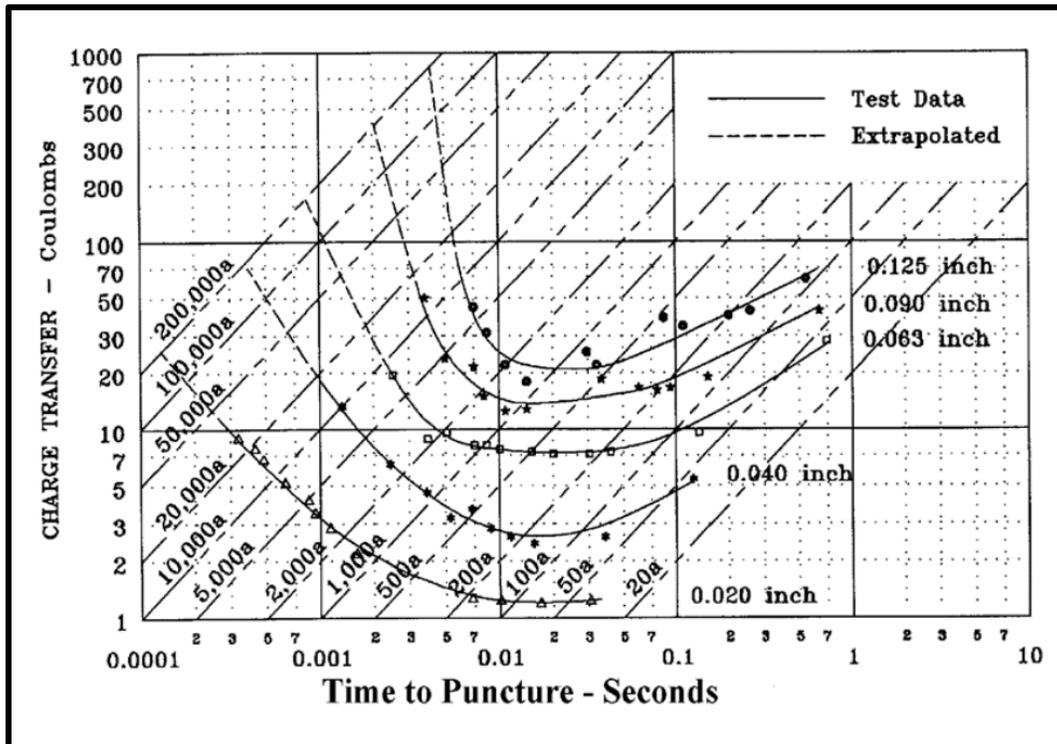
Figure 6-1: Time to melt-through on aluminum skins

Figure 6-1 provides guidance on the amount of coulombs and time required to melt through an aluminum skin, which may be considered to be the time at which fuel vapor ignition may occur as the hot lightning arc may then be presumed to be in contact with fuel vapor.

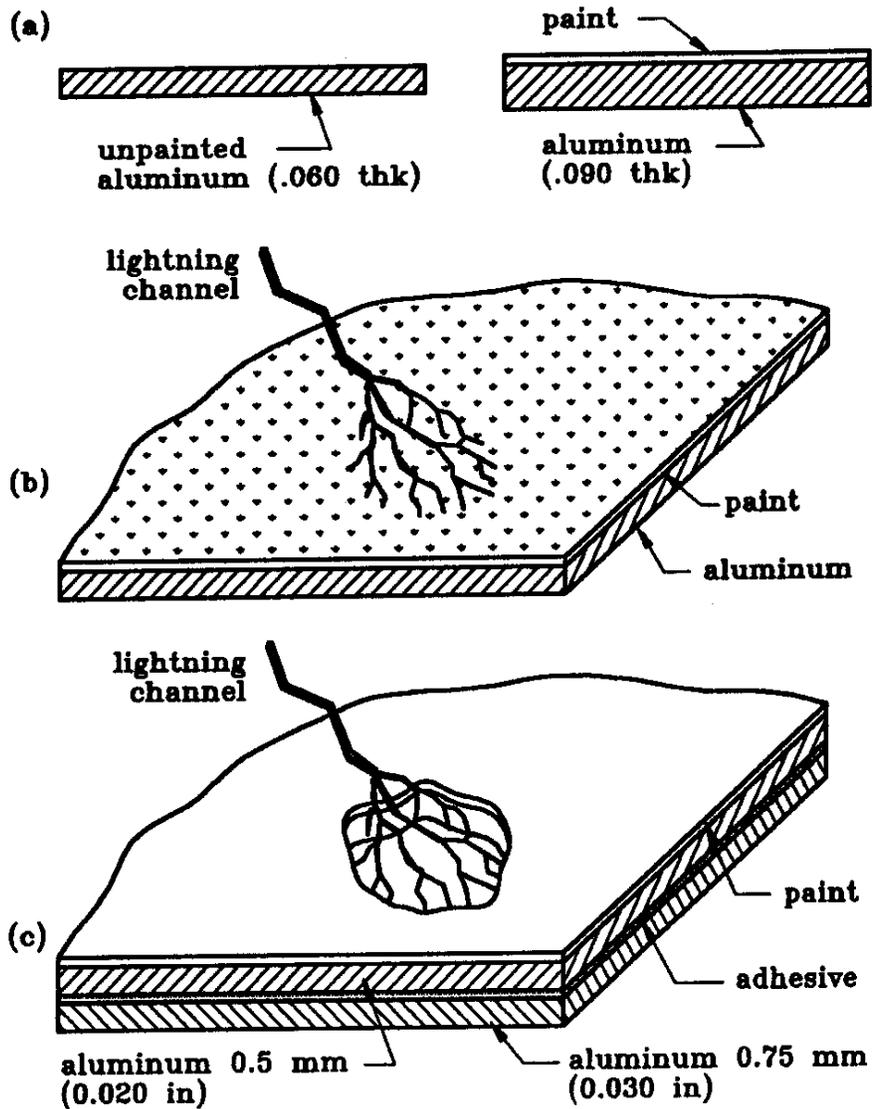
Figure 6-3: Methods for protecting against melt-through  
 a) Increasing skin thickness  
 b) Arc root dispersion / Decreasing dwell time  
 c) Laminated skins

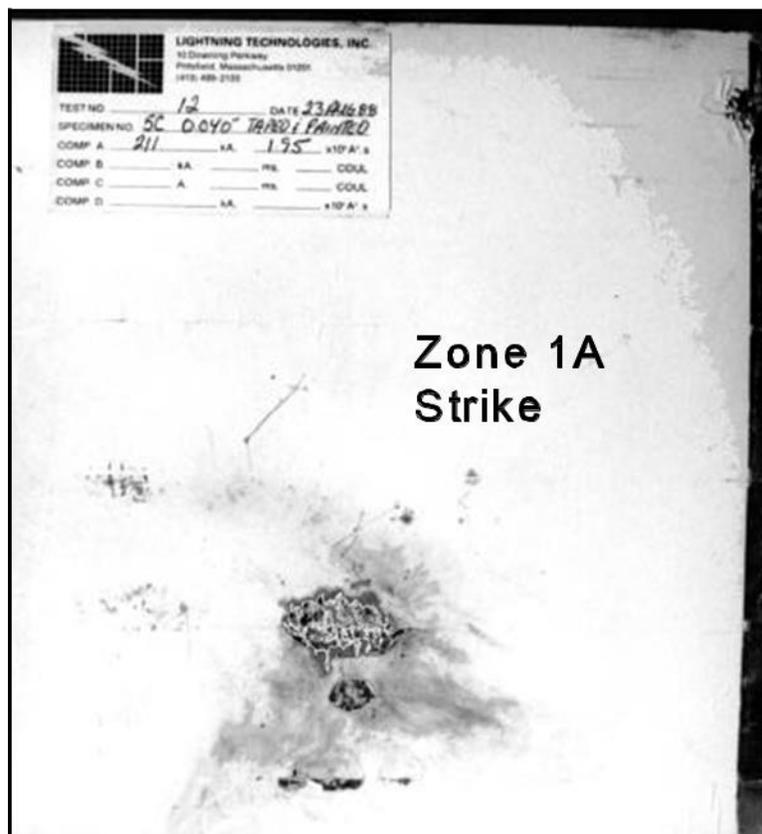
Figure 6-5: 0.040" painted aluminum panel with aluminum tape  
 Melted hole 0.2" through panel, foil loss 1" dia. minor indentation

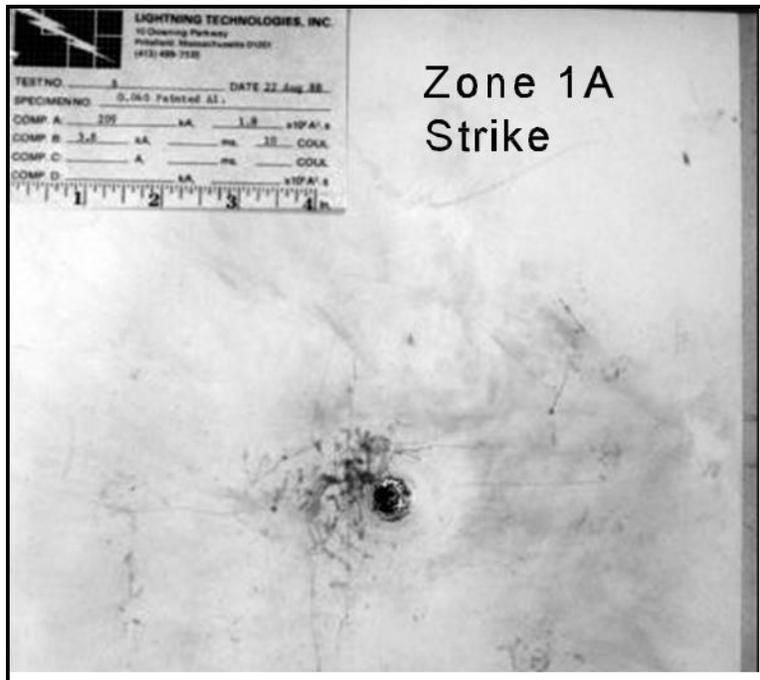
Figure 6-6: 0.040" painted aluminum panel  
Dent, small hole aluminum panel with Zone 1A Strike

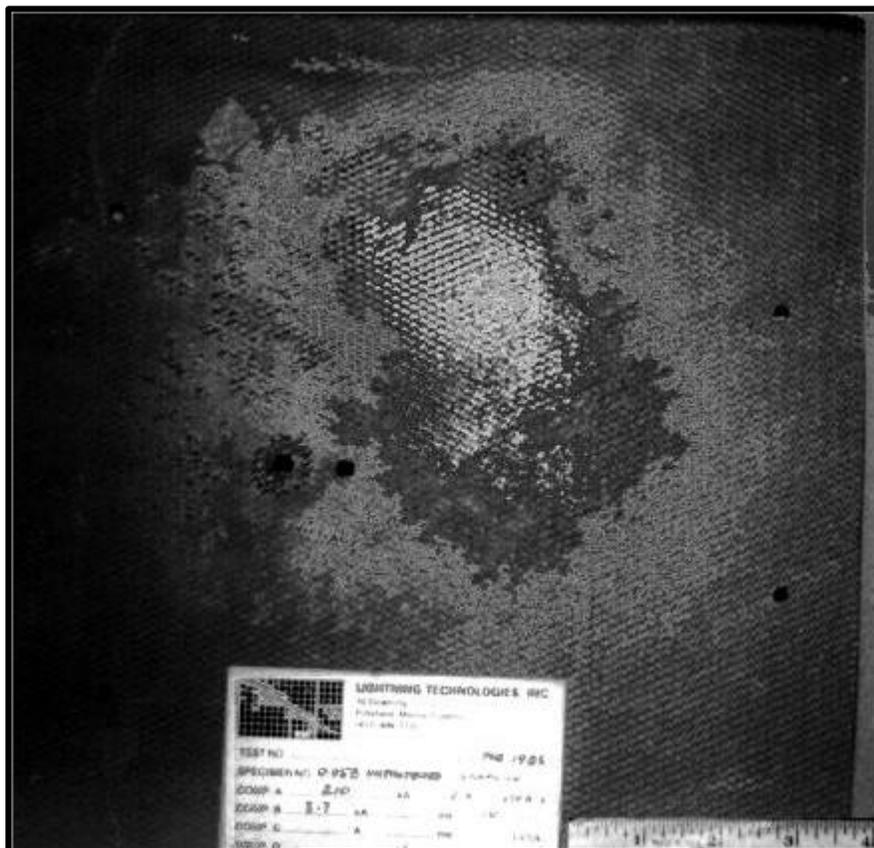
Zone 1A - Unpainted: Figure 6-7 shows that the 0.040 in. thick unpainted CFC panel has very good tolerance to a lightning strike when surface treatments, such as paint, are eliminated. The laminate was undamaged except for minor, cosmetic loss of surface resin. There was no delamination and no puncture.

Figure 6-7: Unprotected and unpainted CFC panel subjected to a Zone 1A strike

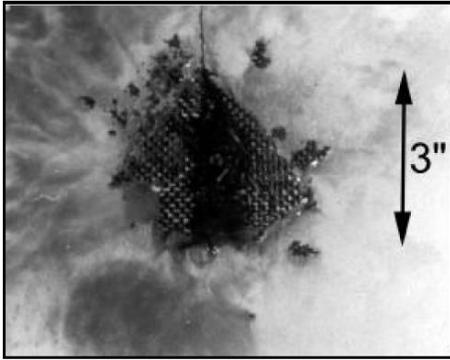
Figure 6-10: Ni CFC Panel Zone 2A Reference b, Test No. 4

**Analysis:** Expanded copper foil demonstrated the best protection for both zones, being marginally better than expanded aluminum foil. Nickel coated carbon fiber permitted puncture in both zones.

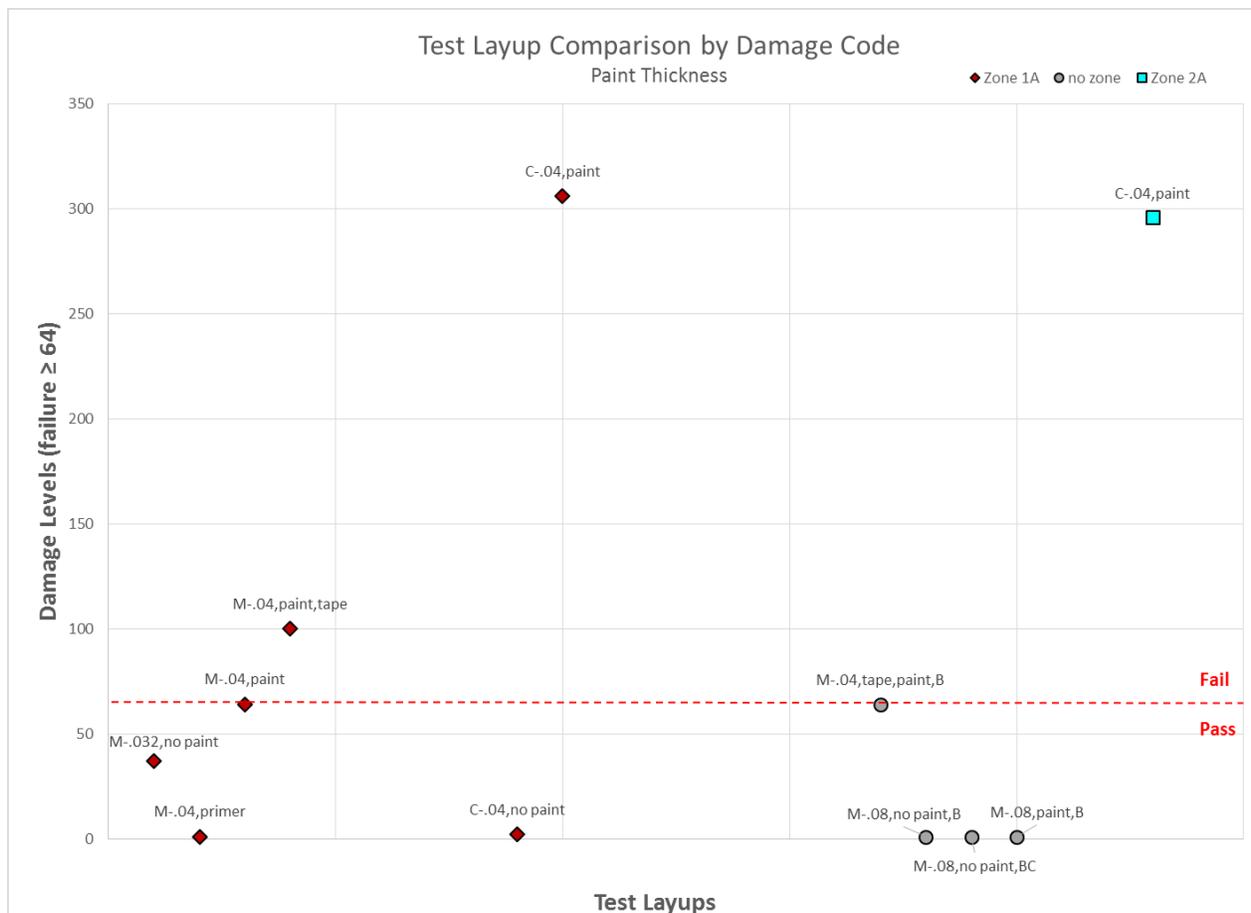
Figure 6-34: AGATE Data Graph by Paint Thickness

**Analysis:** adding paint is a detriment.

- 0.04” thick carbon fiber panel with no paint passes but with paint fails definitively in both zones.
- The results for primer on the zone 1A metal panels were very different than the results for paint. The 0.04” metal panel with primer had very little damage but the 0.04” panels with paint and/or tape failed.
- Even though the 0.032” metal panel has no paint, it still sustains more damage than the 0.04” metal panel with primer because it is thinner.
- For the no zone metal panels, the 0.08” thick panels are basically not affected.
- The no zone metal panel that is 0.04” thick fails with a hole even with just Component B (10 coulombs of charge transfer, 2 kA amplitude, and ≤5 milliseconds of time duration).

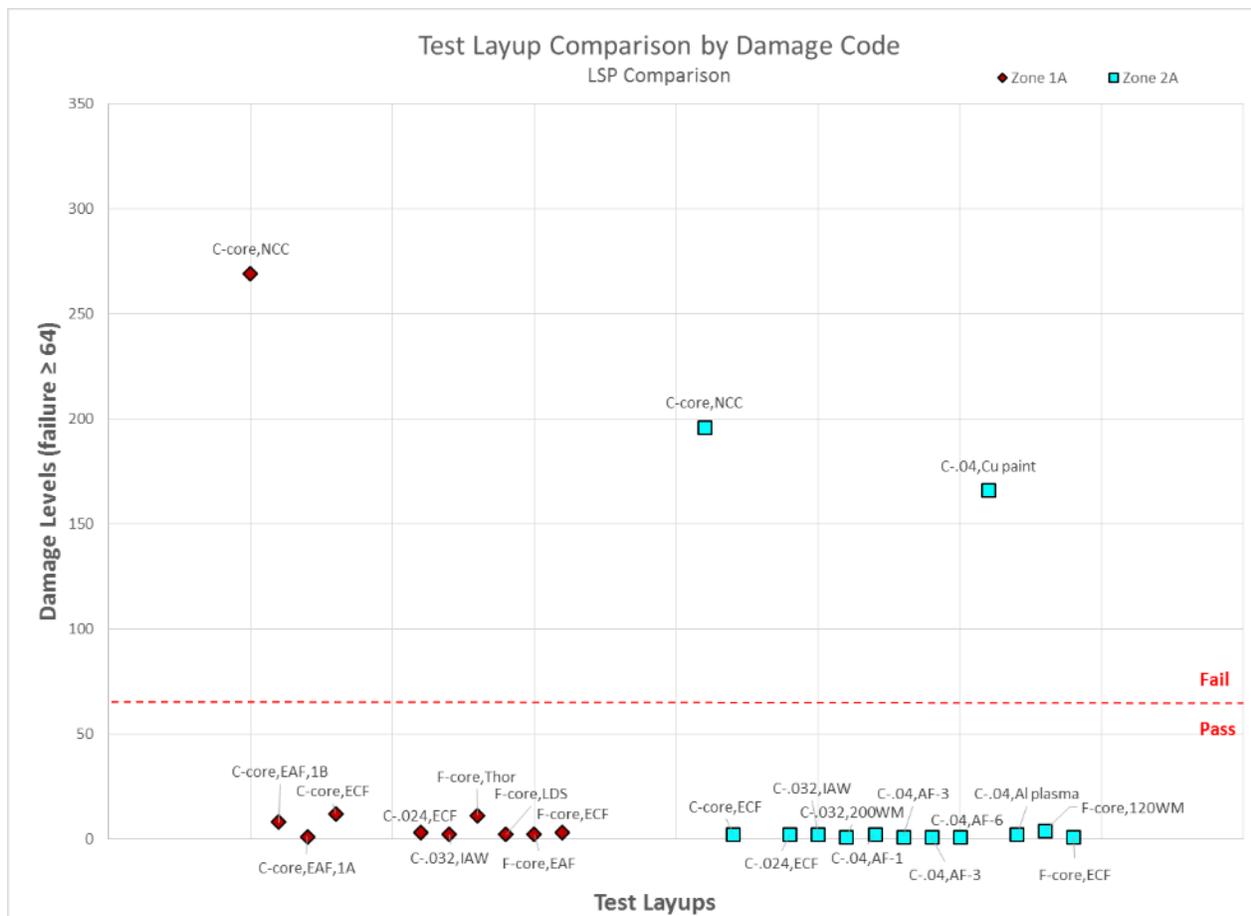
Figure 6-35: AGATE Data Graph by Lightning Strike Protection

**Analysis:** The Nickel Coated carbon fiber and the copper paint failed as effective lightning strike protection materials. All the other lightning strike protection materials appear to be equally good because they all passed at almost the same levels. The expanded copper foil may have an advantage because it passed on a much thinner panel (0.024”).

- The panels with Nickel Coated carbon fiber as the lightning protection failed in both zones.
- The copper paint failed on 0.04” thick carbon fiber in zone 2A but the aluminum plasma and three thicknesses of aluminum foil passed on 0.04” thick carbon fiber.

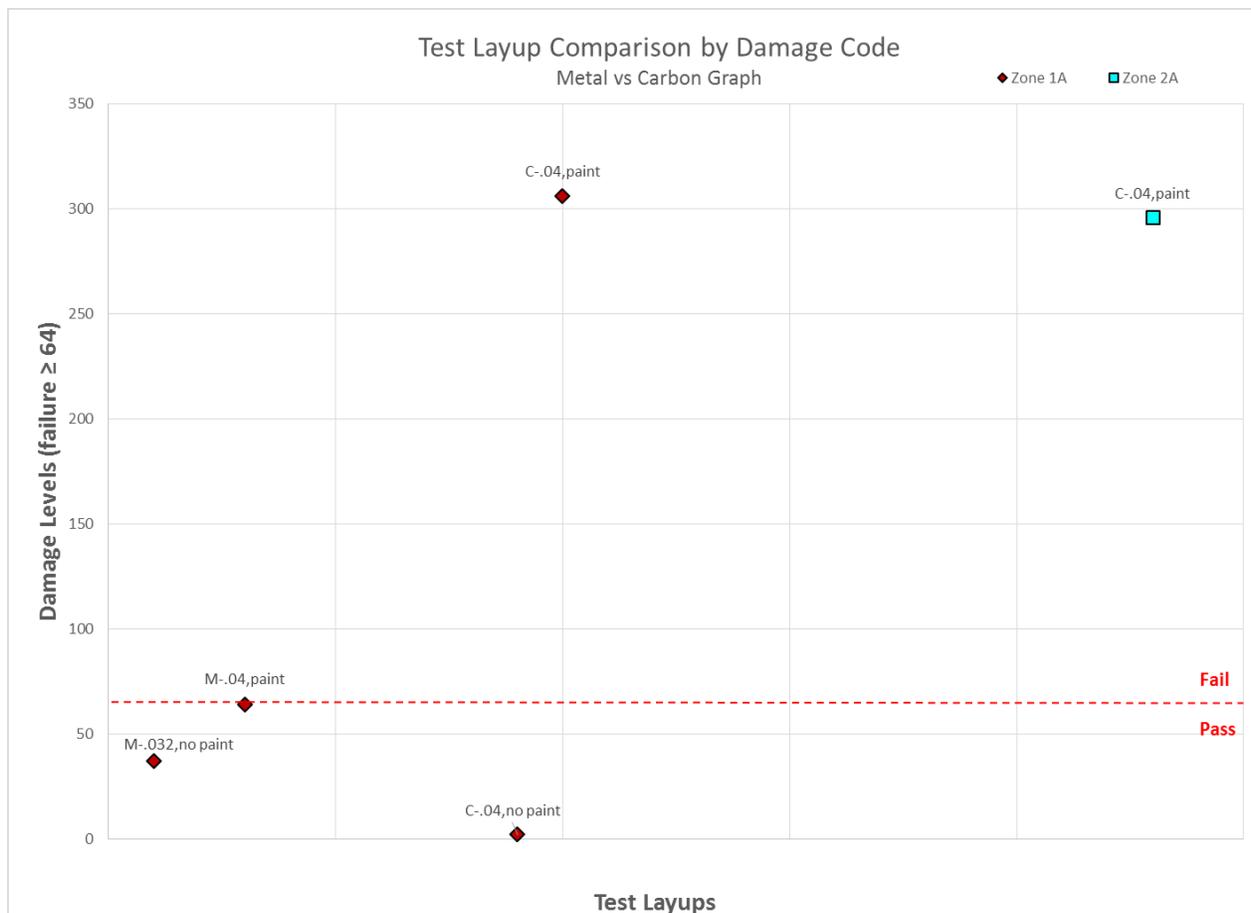
Figure 6-36: AGATE Data Graph by Panel Material

**Analysis:** Metal panels with paint withstand lightning strike much better than carbon fiber panels with paint.

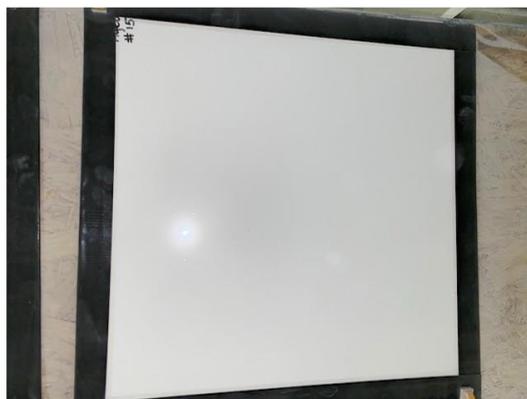
Figure 6-98: Taped panel ready for sand testing

This first step in the aging process was sand testing. As called out in DO-160G section 12 category – S, the panels were bombarded at a 90° angle by sand moving at a velocity of 18 m/s at 25 °C for one hour and then again at 55 °C for another hour. As traditional aircraft paint does not adhere well to thermoplastic panels, there was concern that if a small hole was made in the paint due to the velocity of the sand, then larger sections of paint might peel off the panel. This type of paint loss would warrant repainting the panel before lightning strike, which would cancel out any effects of the aging process on the painted panel. To avoid excessive paint loss, the edges of the panels were first taped off with a layer of packing tape and then a layer of duct tape to protect the exposed painted edge of the panels at the unpainted panel border, as seen in Figure 6-98: Taped panel ready for sand testing. After sand testing, this tape was removed and the panels were inspected for signs of degradation. Aside from a residual layer of sand that came

off easily and minor nicks in the paint surface only noticeable through touch, there were no signs of damage or degradation. However, there was a small amount of adhesive residue left behind on the edges of the panel from the tape because of the high temperature cycle. This residue was outside of lightning strike locations and was not expected to have any effect on further testing of the panels.

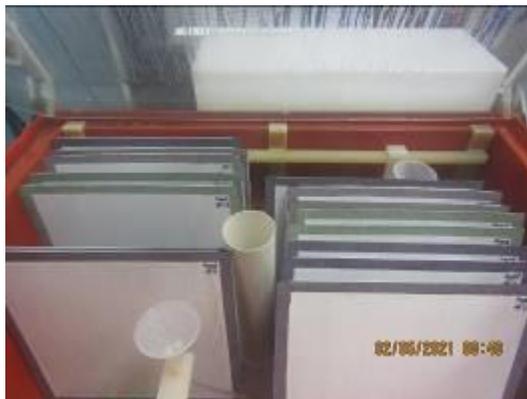
Figure 6-99: Aged panels after the first cycle in the salt-fog chamber

The panels were then subject to the salt-fog stage of the aging process. As seen in Figure 6-99, the panels were placed on racks in a chamber containing a 5% salt-water solution at 35 °C. The solution was then atomized and misted on the panels for 48 hours before being taken out to dry for at least 24 hours. This procedure was repeated one more time before the panels were inspected. After the panels dried for the second time, the residual layer of salt was wiped off and no noticeable damage or degradation to the paint, LSP, or the panel was observed.

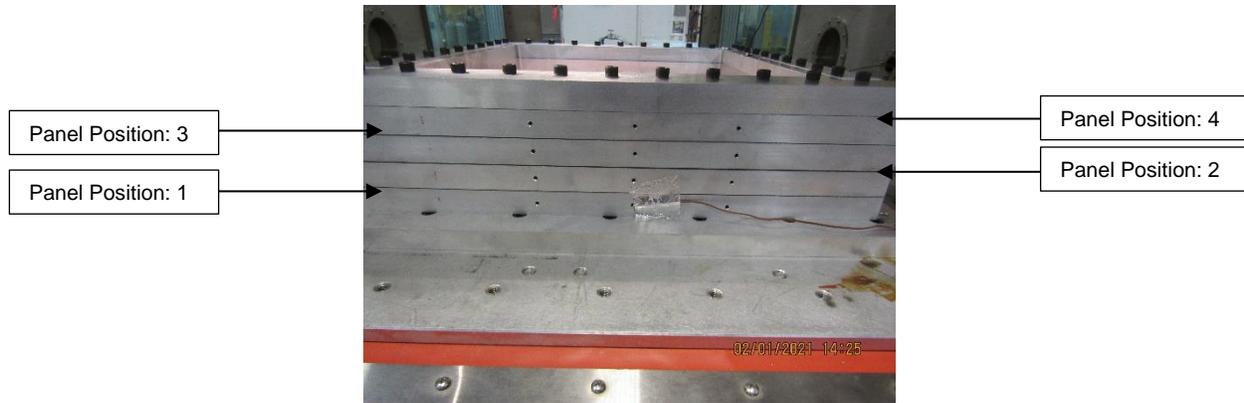
Figure 6-100: HALT fixture assembly

The final step in the aging process was the HALT chamber HASS testing. The panels were placed inside the fixture seen in Figure 6-100 that can hold four panels at a time. The panels were simultaneously subjected to random vibration at 50 GRMS and thermal cycling from -55 to 70 °C for a total of 36 hours. A thermocouple monitored the ambient temperature between the panels. Thermoplastics are excellent thermal insulators and preliminary testing revealed that not all the panels receive the same thermal conditioning at each position in the test fixture, as each layer in the test fixture is subsequently more insulated than the one above it. To counter this, every 8 hours the test was paused and the panels rotated cyclically through each position in

the fixture so that by the end of the 36 total hours, each panel had seen the same thermal condition. Each set of four panels went through one 36-hour HALT. Upon subsequent inspection, no significant visible damage or degradation was seen at the end of this step in the aging process.

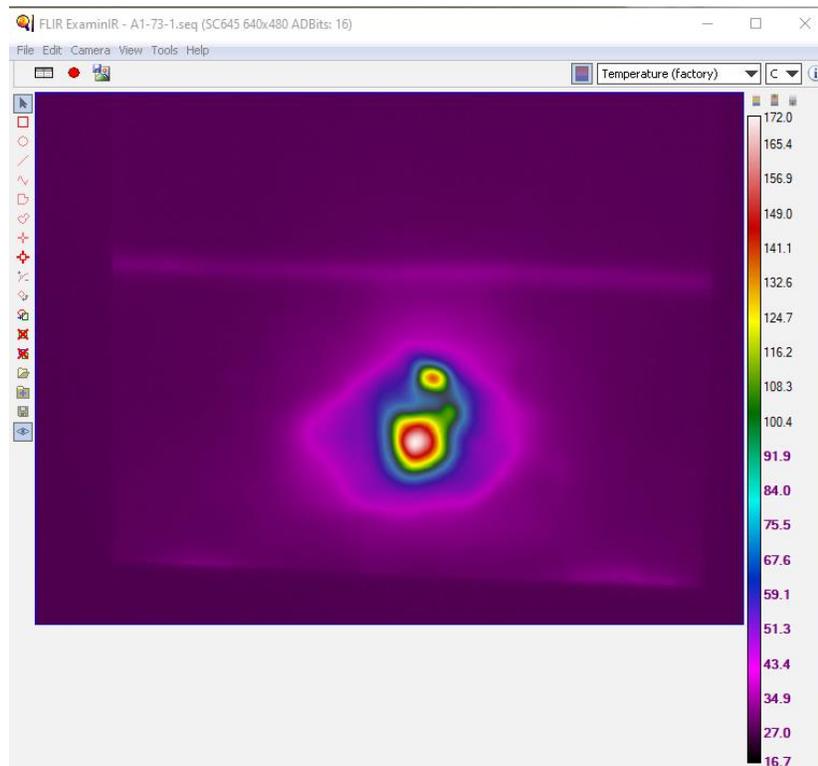
Figure 6-111: Frame from Thermal Imaging of Panel A1-73-1

The aim in this study was to determine whether the presence of a splice in the LSP changes the heat signature compared to panels with continuous LSP. For most splice configurations, the region of the panel immediately beneath the splice did not show signs of heating. Splice heating was evident in A1 and E1 (hand laid butt splice), and A5 (tape laid butt splice) configurations, where the splices reached higher temperatures than other panel configurations did. An example of this is shown in Figure 6-111, and splice temperatures are contained in Table 6-52. It is important to note that due to intermittent failure of the IR camera system, thermal data is missing from 16 of the 34 test points.

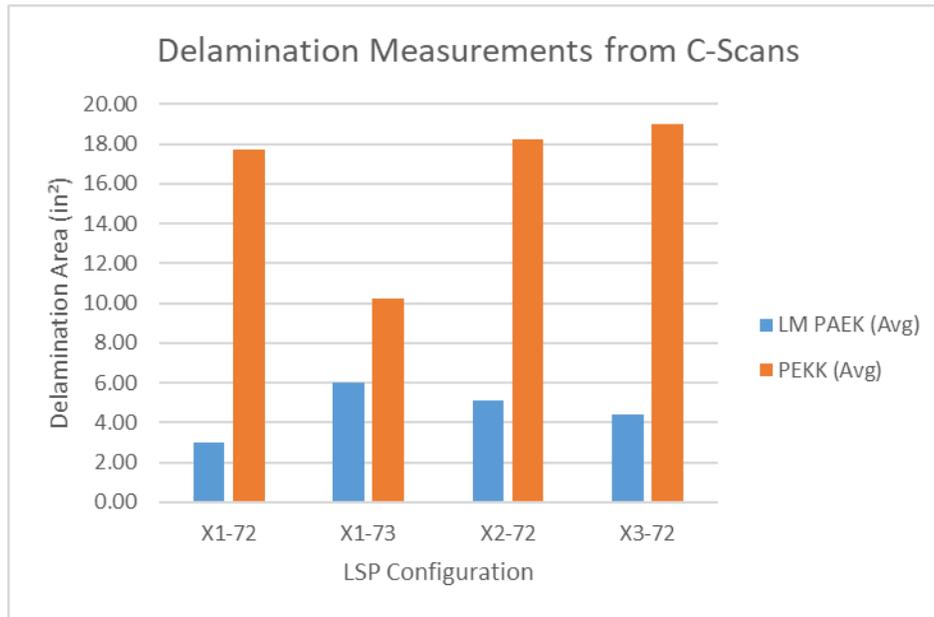
Figure 6-120: Graph of Delamination Measurements from C-Scans - LM PAEK vs PEKK Configuration

For all panels, the damage region recorded on the c-scans was contained to the lightning attachment area. No damage was seen beneath the splices or anywhere outside of the attachment area in any of the configurations. The larger delamination area of the PEKK panels as compared to the LM PAEK panels can be seen in Figure 6-120 below, which graphs the delamination area as measured via c-scan.

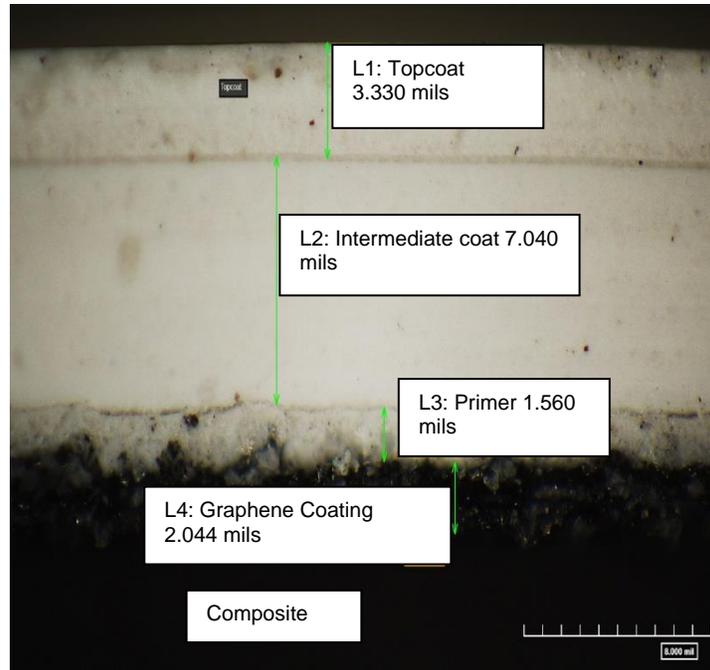
Figure 6-121: Cross Sectional Photomicrograph of Graphene Protected Panels

Graphene Coating: All of the graphene protected panels were 12 ply laminates. The graphene coating on the panels was applied first onto the panels via bar coating and then painted with standard aircraft paint. The graphene coating was brittle and had to be handled with care, thus the standard surface preparation techniques could not be used prior to the application of standard aircraft paint. Figure 6-121 shows a cross sectional schematic of the graphene LSP panels.

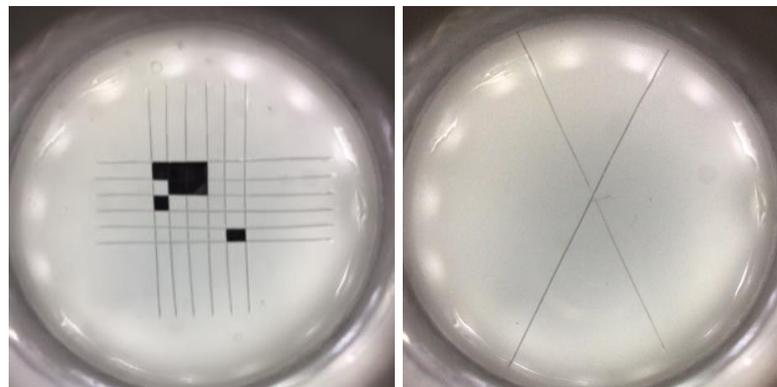
Figure 6-124: Cross-Hatch (left) and X-Cut (right) Paint Adhesion on LGrZ1-K1

The brittle graphene coating required careful handling. The cross-hatch testing showed that in the places that the paint was removed, it was actually the graphene coating that lifted off of the surface of the composite first rather than the paint disbonding from the graphene coating. Taking an average from all 12 cross-hatch data points of the area of paint removed, the overall removal area for the paint adhesion test on the graphene coating protected panels was 22.66%, or a 2B classification. No paint removal was observed in the x-cut method. Figure 6-124 shows representative photos of the cross-hatch and x-cut methods.

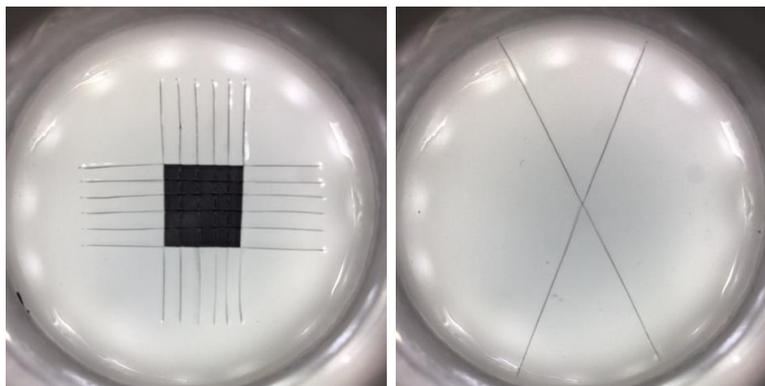
Figure 6-126: Cross-Hatch (left) and X-Cut (right) Paint Adhesion on LNiZ1-K1

The presence of the NNS in the topcoat layer of the standard aircraft paint negatively altered the results on the paint adhesion as compared to the ElectroVeil material. Taking an average from all six cross-hatch data points of the area of paint removed, the overall removal area for the paint adhesion on the NNS protected panels was 99.33%, or a 0B classification. No paint removal was observed in the x-cut method. Figure 6-126 shows representative photos of the cross-hatch and x-cut methods.
