Aging Effects Evaluation of A Beechcraft Starship and a Decommissioned Boeing CRFP 737-200 Horizontal Stabilizer

To evaluate the aging effects of a (RH) graphite-epoxy horizontal stabilizer after 18 years of service (48000 flights, 2/3 of DSO)

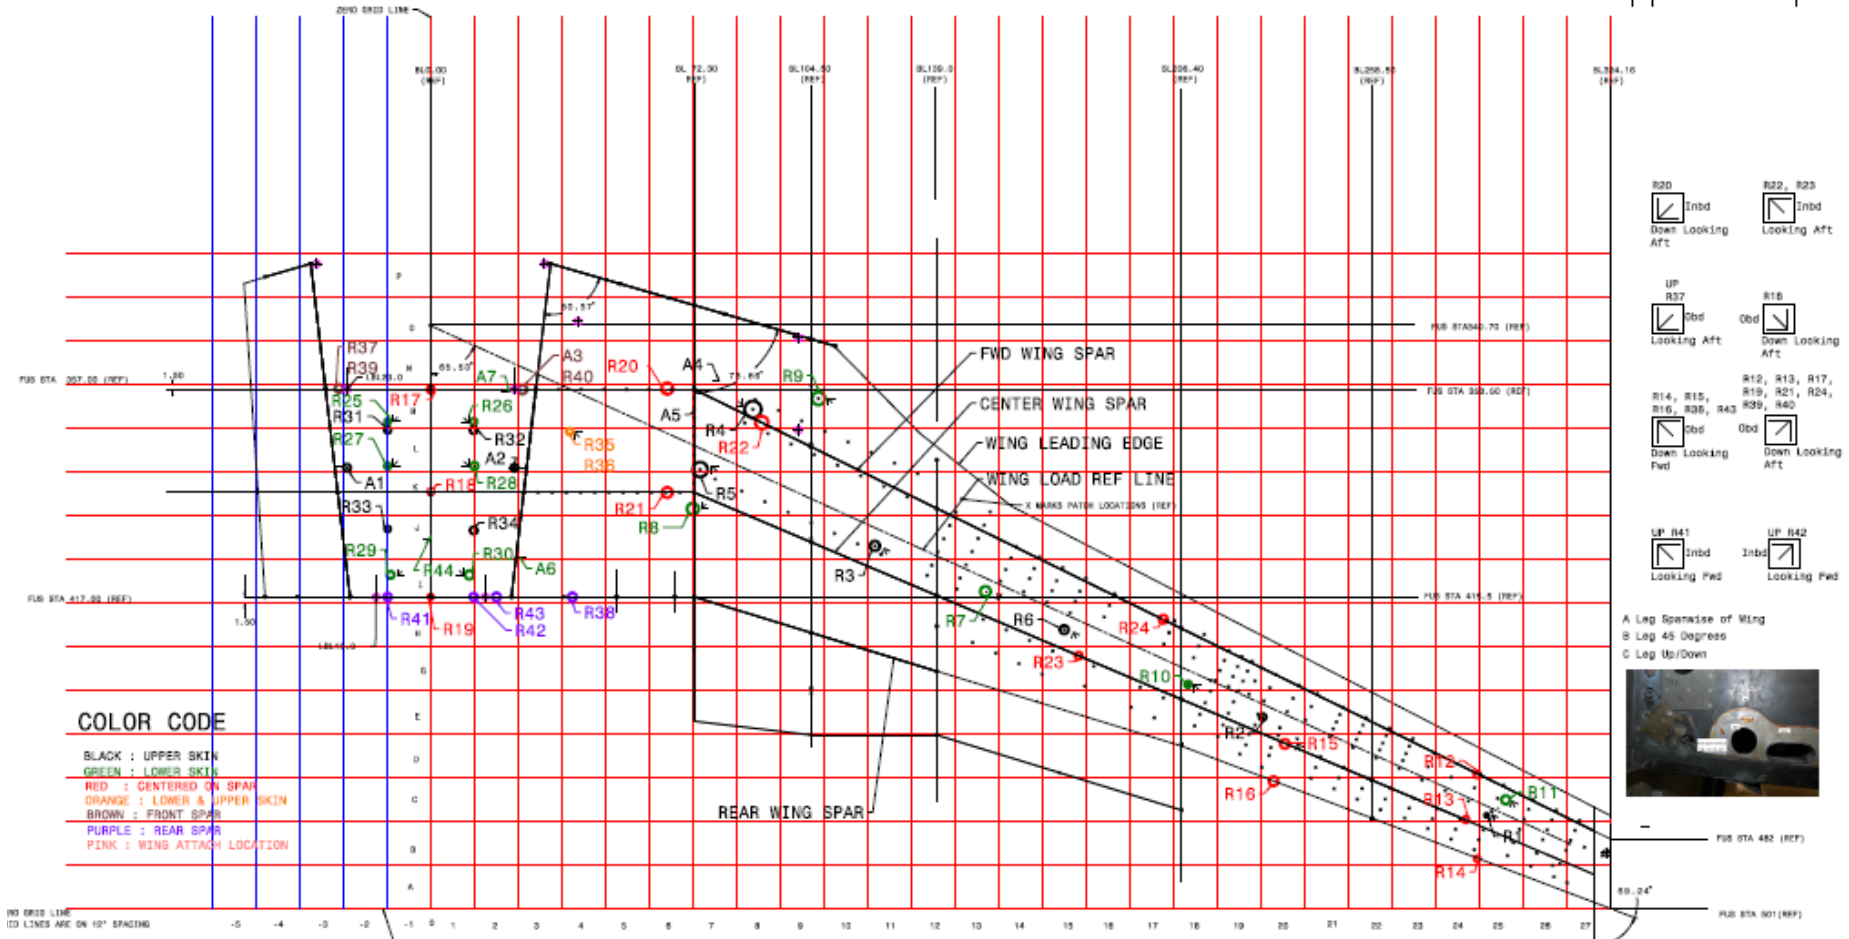
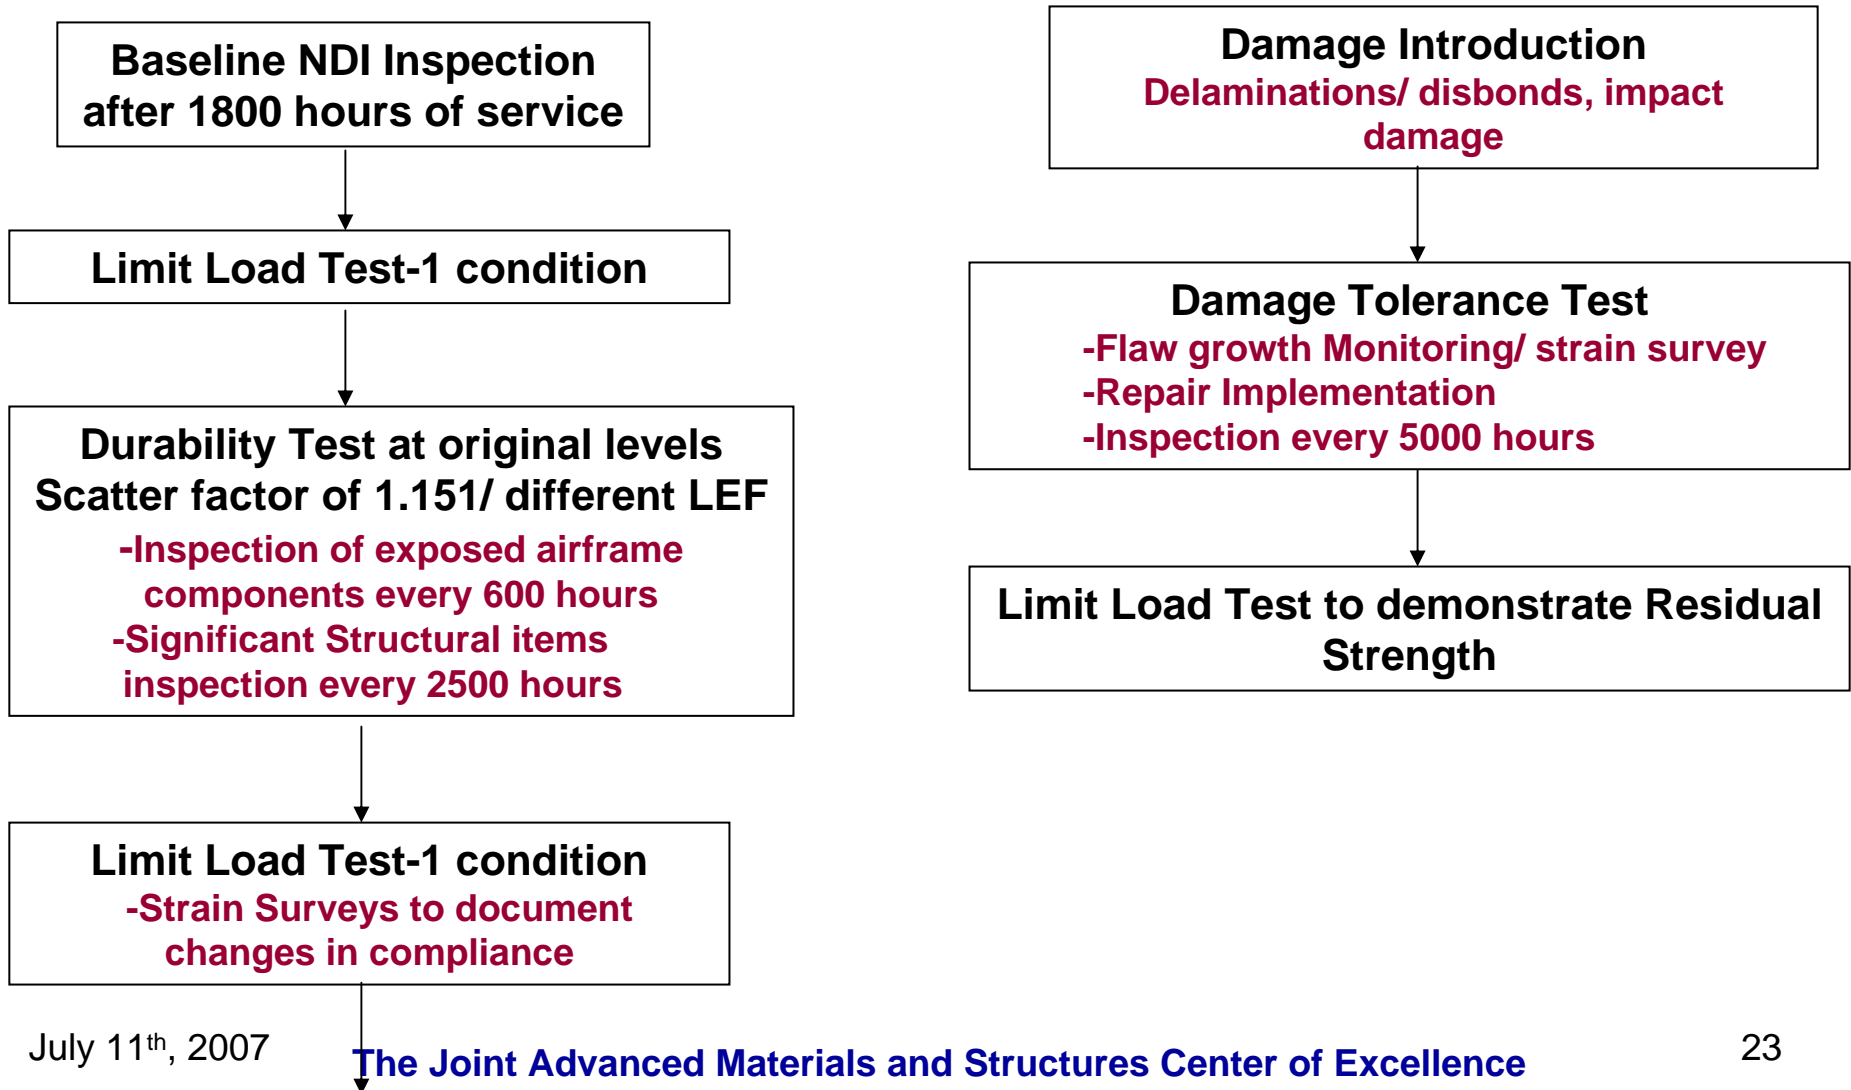
- A baseline Non-Destructive Inspection scan has been conducted prior to conducting the full scale test in order to identify possible manufacturing flaws or defects induced during service
- NDI standards have been built, probes and an NDI grid has been drawn on the structure for ease of inspection and flaw growth monitoring
- The OEM has supplied engineering reports that define the wing load reference line for subsequent full-scale static and fatigue tests.
- A fixture has been built to simulate inertia loads induced by the engines.
- A fixture has been built to simulate rudder tip deflections
- Limit Load full-scale test preparation in progress

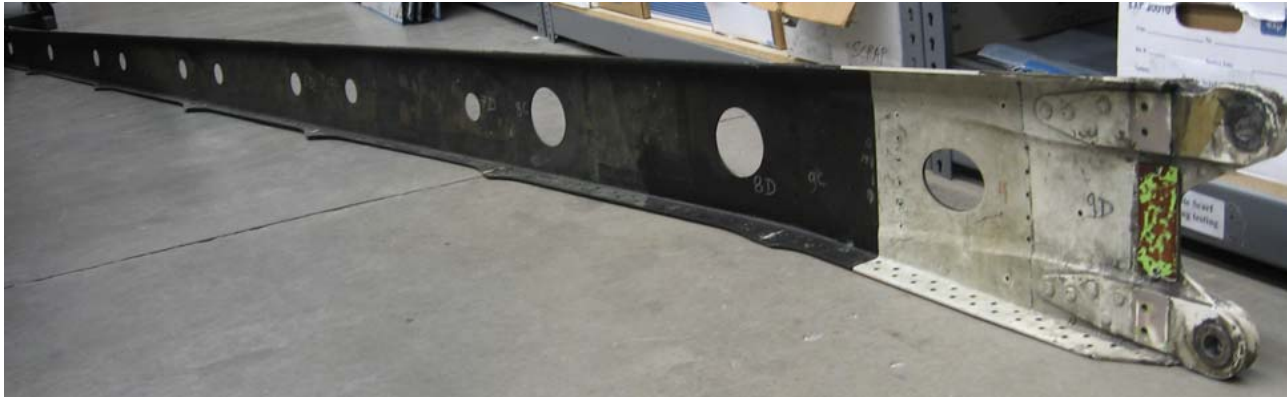
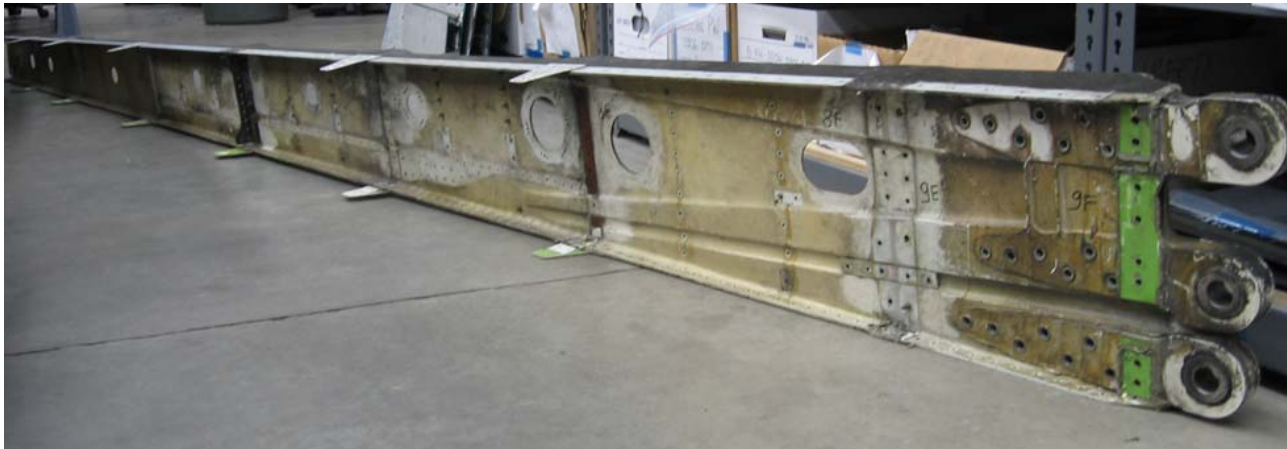
Front and Rear Spars after disassembly

- Structure held very well
- No evidence of pitting or corrosion as would be observed in a metal structure
- No residual strains compared to the LH

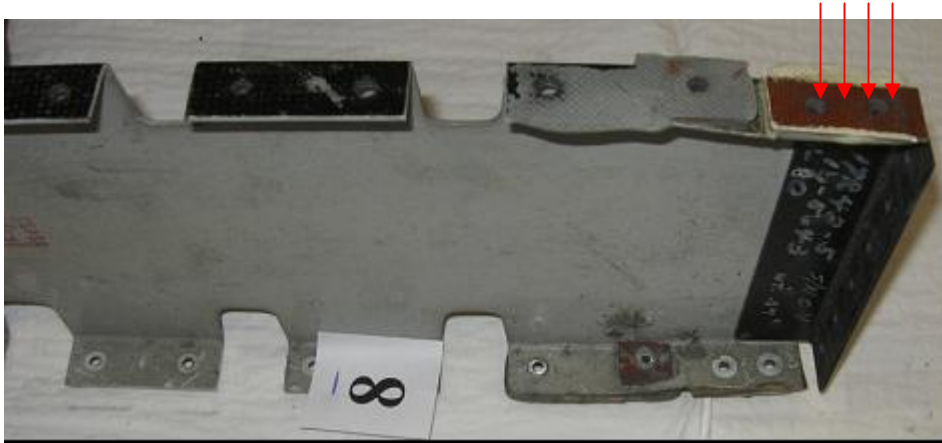
Phenolic shims used to fill gaps between skin and ribs

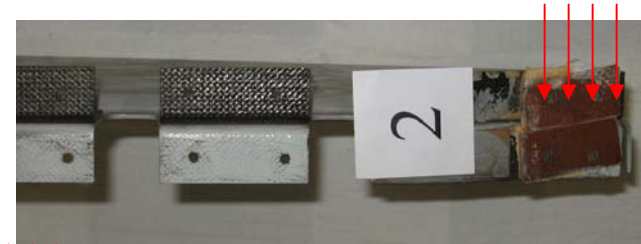
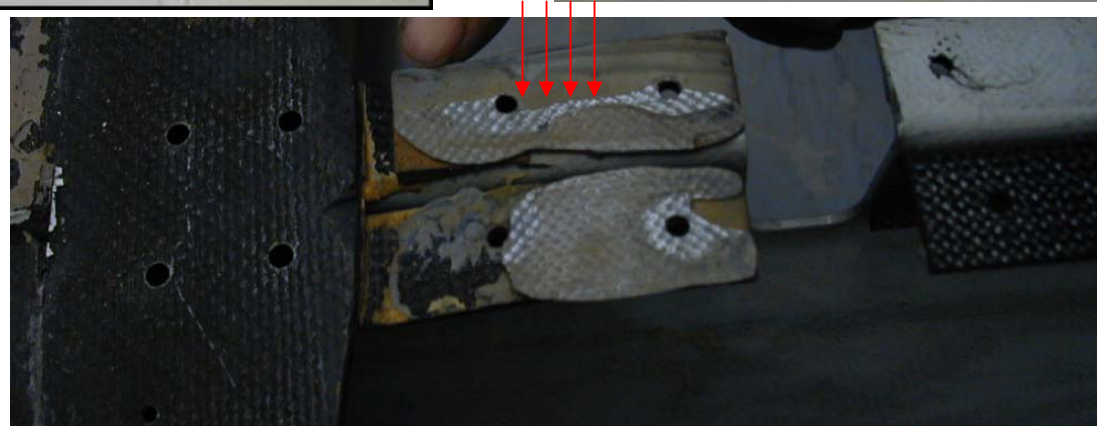
Liquid Shims used to fill gaps between the upper skin and the stabilizer ribs

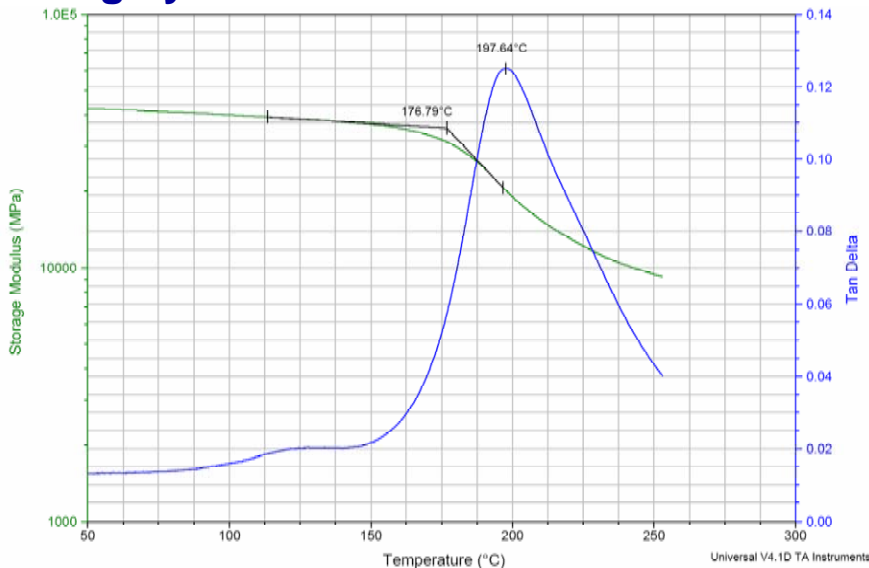
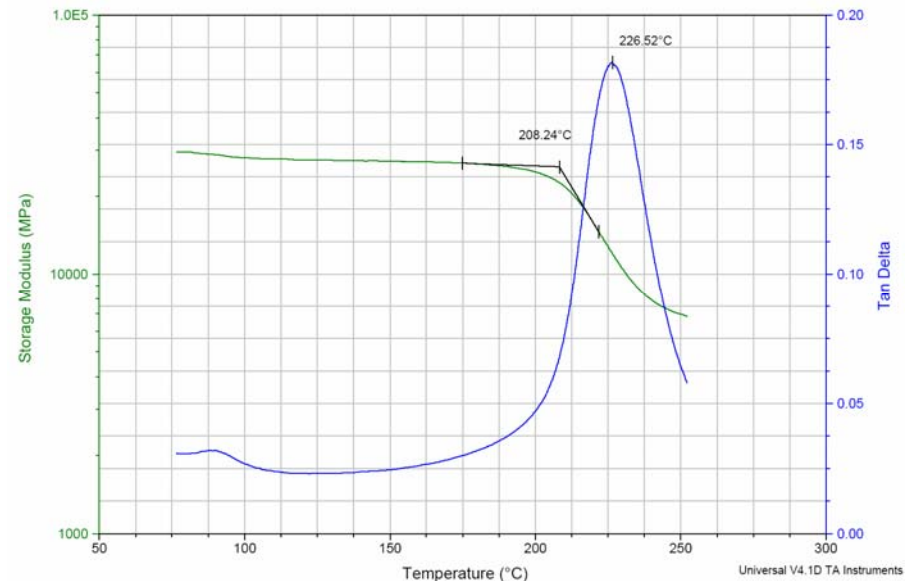
- DMA technique to determine the glass transition temperature of the aged material for coupons extracted from both the upper and lower skins
- Thermal analysis was conducted on coupons with actual in-service moisture content and dried coupons to compare the difference between the in-service T_g with respect to the dry T_g.
- Storage Modulus is an indication of the stiffness of the material, tan δ is a measure of the damping of the material
- DMA curves with a shallow storage modulus transition and a narrow tan δ indicate a highly cross linked material

- Tg values consistent and comparable to LH Results (Courtesy the Boeing Co) average values for RH (201°C/233°C)
- DMA test parameters vary/ Tg obtained is a “wet” Tg (at least 0.69% moisture content)

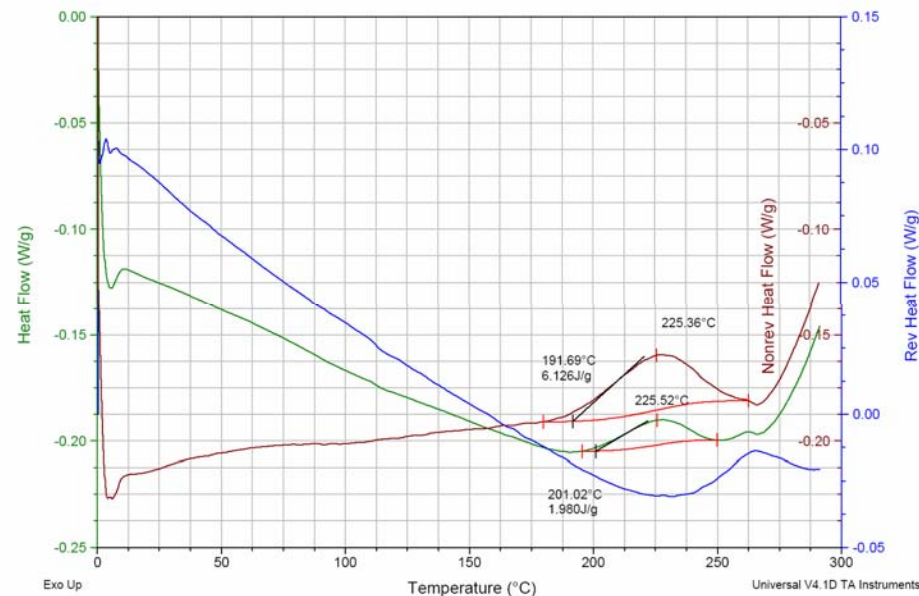
DSC, Rib 7, as extracted

- Non-Reversing heat flow curves reveal exotherms/ chemical reactions
DSC heat of reaction values are extremely small (<6J/g) indicating a highly cross linked material (fully cured)
- Reversing heat flow curves reveal T_g
- Drying the specimen increased the cure onset (water acts as a plasticizer)
- Water content does not affect the degree of cure
