Inspection and Teardown of Aged In-Service Bonded Repairs

JAMS 2019 Technical Review – May 23, 2019

Waruna Seneviratne, John Tomblin, and Brandon Saathoff

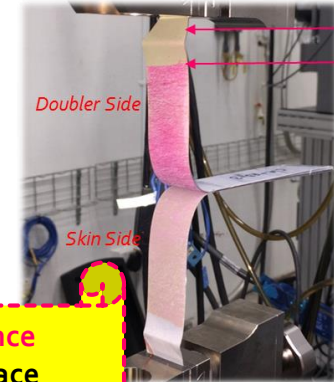
Peel Initiation
Start of Peel Test

- Lab prepared coupons used as “baseline” & compared to repair test results
- Component 14
 - Interfacial anomaly between the film adhesive and parent structure when an external patch was bonded over metallic honeycomb core repairs (witnessed on all 6 bonded repairs)

- Mechanical Testing: Post mechanical test failure analysis showed fracture across interfacial anomaly in all specimens
 - Repair Peel Strength: **≈64% of BL panels**

• Poor bond performance related to repair surface preparation (not aging)

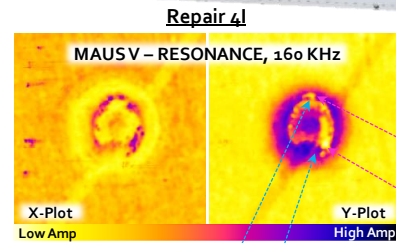
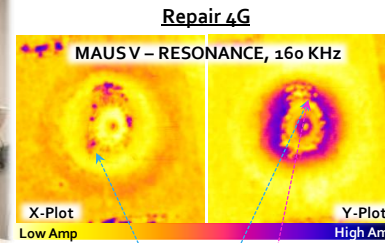
- 6 of 41 repairs contained indications isolated within the repair region

- 4 of these 6 repairs were noted within structural level inspections for containing indications within the bond region

- 2 repairs contained indications missed at structural level inspections due to limitations of the methods applied to detect sub-surface features (9B & 9K)

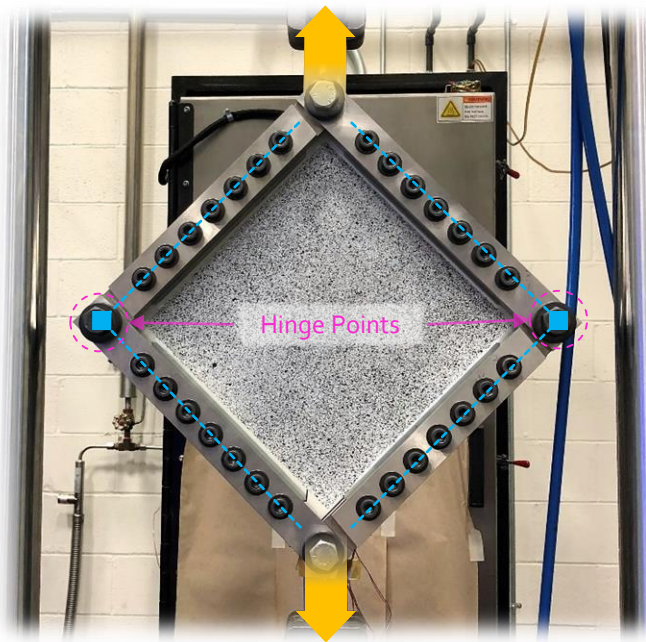
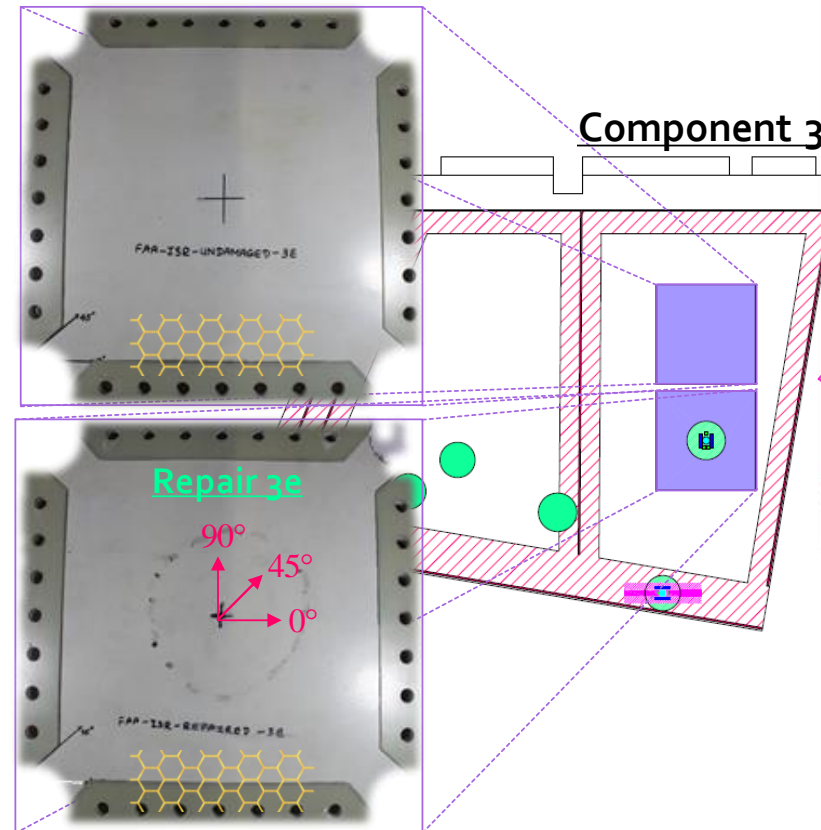
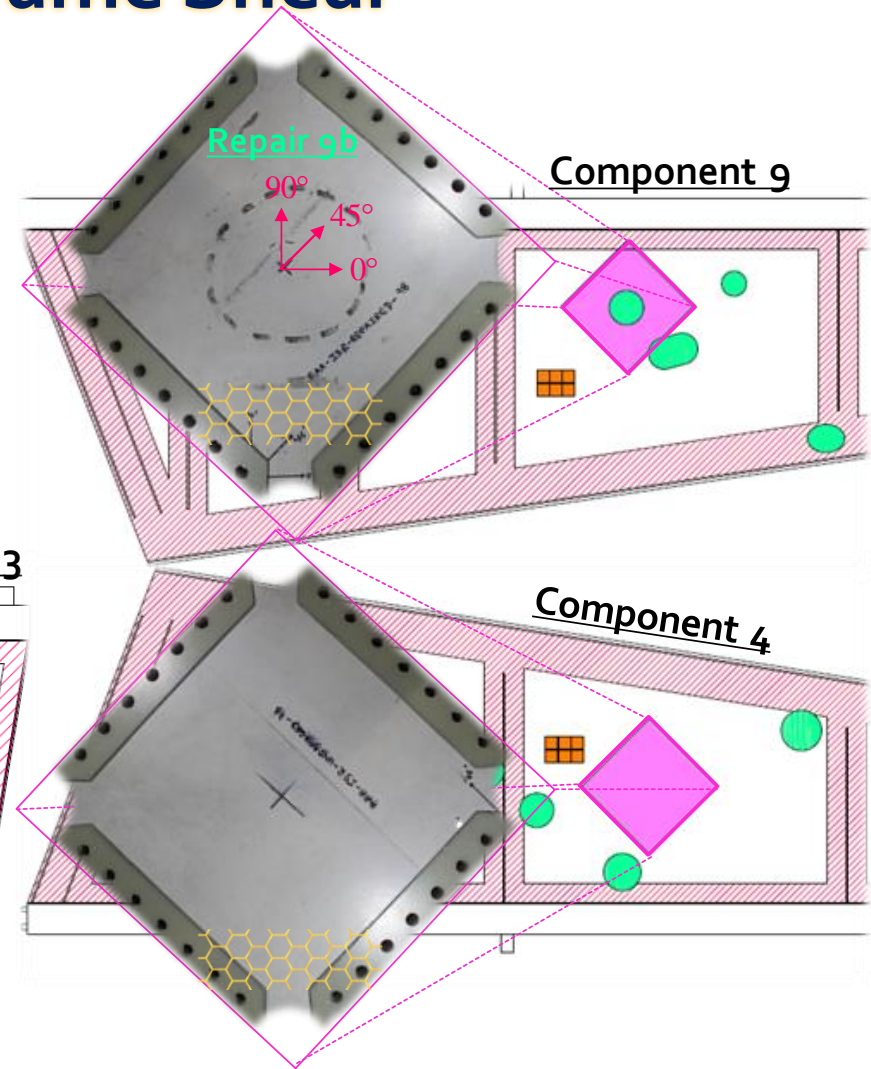
Mechanical Testing – Picture Frame Shear

- Picture Frame Shear (PFS) Testing
- 15.375" x 15.375" element
- Repaired element compared to un-damaged "baseline" element performance
 - Performed on repair 3e and 9b (Pre-Test X-ray CT Inspections)
 - Full-field strain (ARAMIS)

- No significant loss in strength witnessed
- Repair 9b popped away from parent material with no failure through patch material
- Repair 3e failed through repair patch material

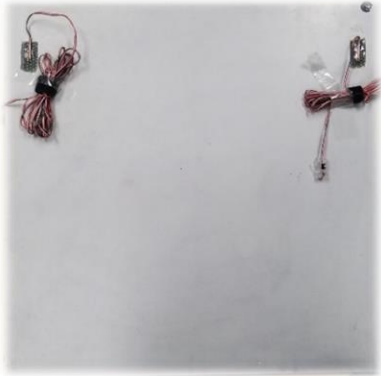
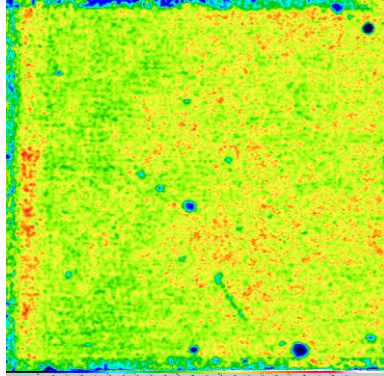
Repair 9j/9k (Multiple Repairs)

Repair 9j & 9k TTU C-scan

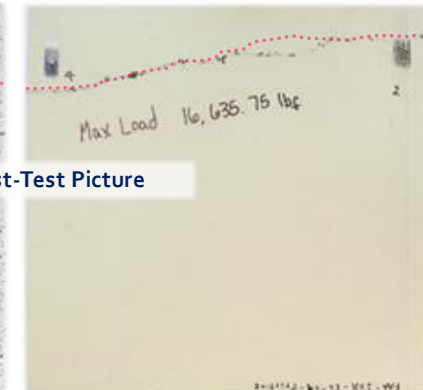
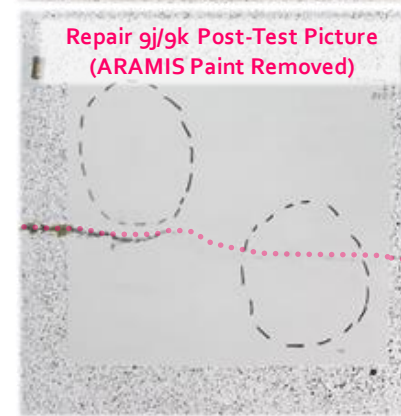
Repair gJ/gK Post-Test Picture (ARAMIS Paint Removed)

- No significant loss in strength witnessed (repair failure loads **within 3.2%** of pristine failure load)
- Failure witnessed through repairs
 - Failure was not witnessed through any of the indications noted in the pre-test inspections for repair gk

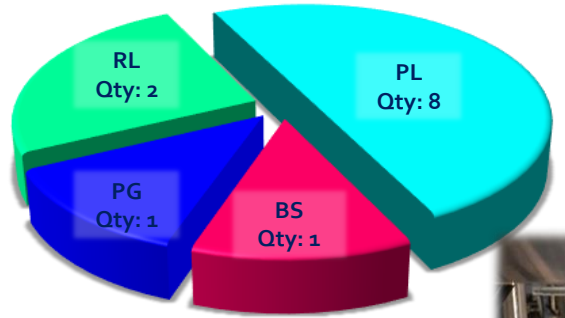
- High variation in results
- Only 1 bondline shear failure

Specimen Name	Failure Load [lbf]	PL Failure Stress [ksi]	RL Failure Stress [ksi]	Failure Mode
C3-RC-2	1010.601	23.216	20.458	RL
C3-RD-2	1394.197	43.031	26.287	BS
C4-RC-2	1293.195	34.513	25.947	RL
C4-RG-2	736.913	43.708	36.427	PL
C4-RI-2	1041.473	40.057	33.063	PL
C9-RD-2	332.520	32.066	11.791	PL
C9-RE-2	1084.178	30.116	27.448	PG
C12-RC-2	1594.913	35.978	25.249	PL

Failure Stress [ksi]	37.067	26.602
Standard Deviation	6.944	7.500
% Coefficient of Variation	18.733	28.194

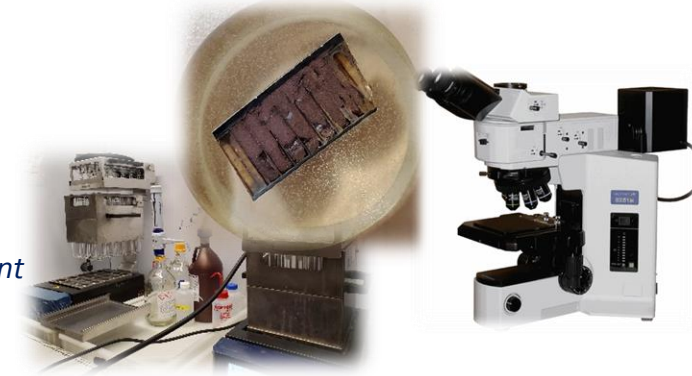
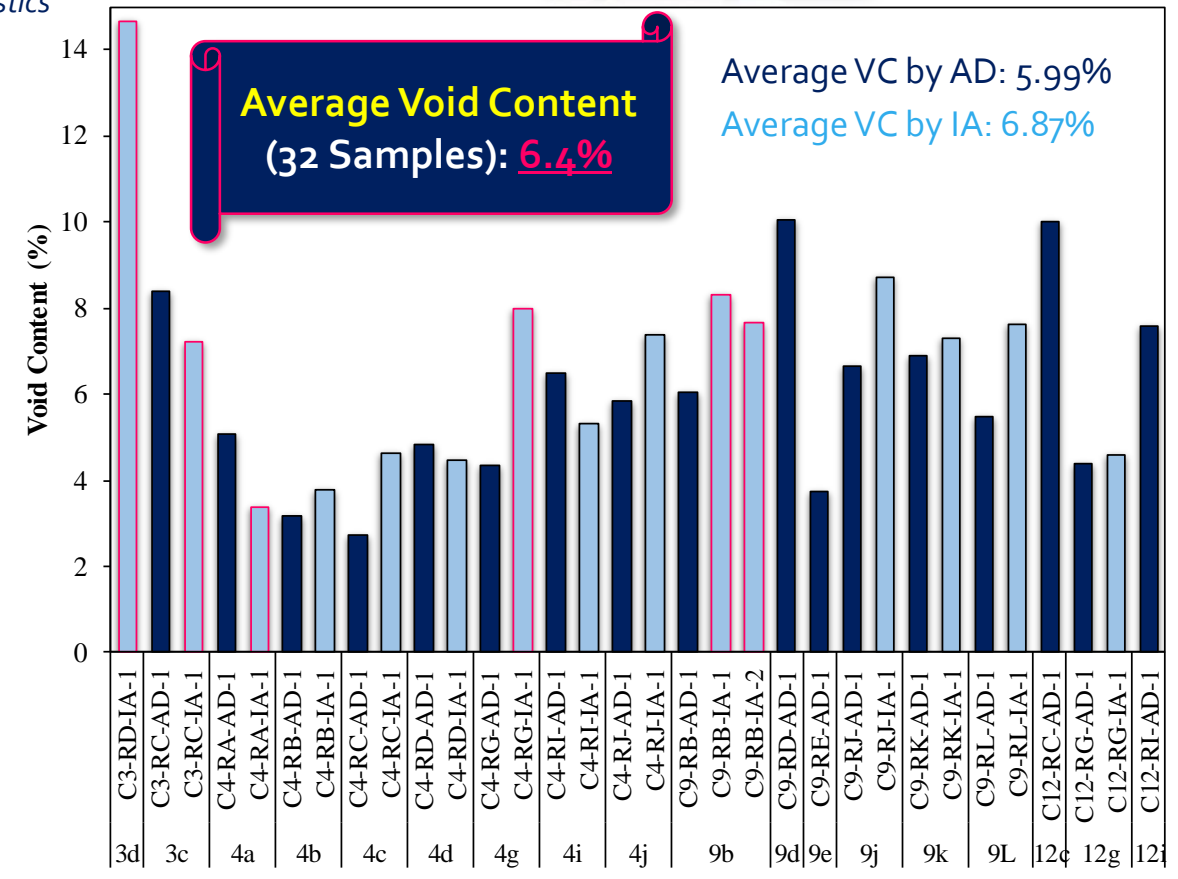
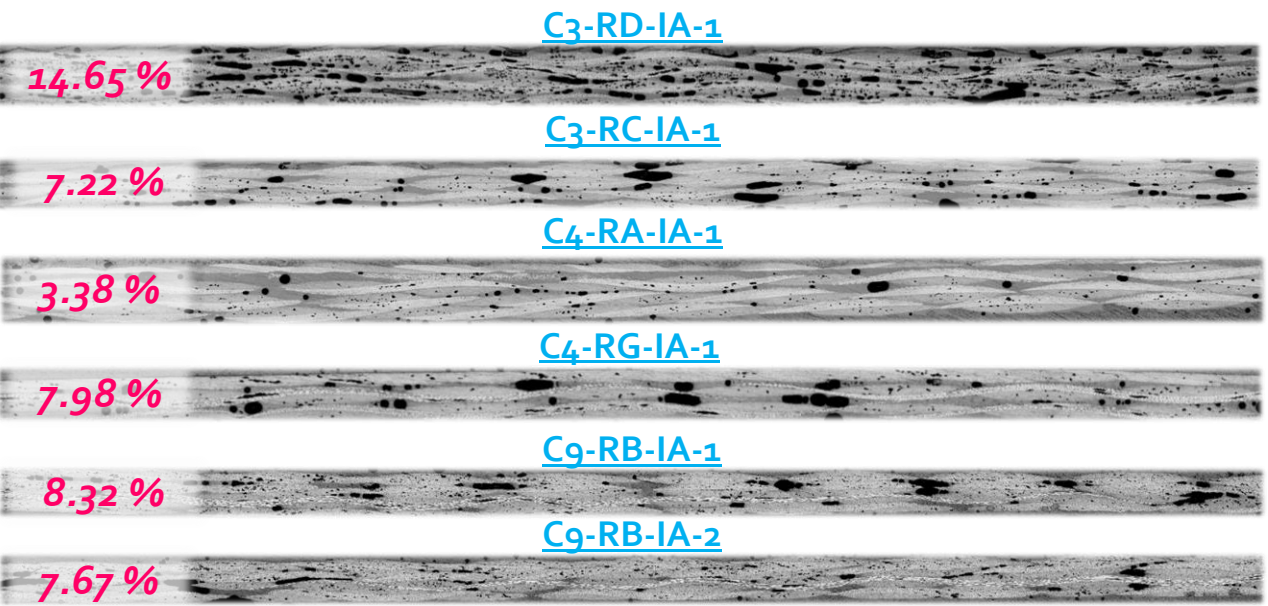
Physical Testing – Void Content

- Acid Digestion (AD)
 - Requires 1" x 1" extraction and known fiber/resin densities
 - ASTM D792-13 – Standard Test Methods for Density and Specific Gravity (Relative Density) of Plastics by Displacement
 - ASTM D3171-15 – Standard Test Methods for Constituent Content of Composite Materials
 - ASTM D2734-16 – Standard Test Methods for Void Content of Reinforced Plastics
- Image Analysis (IA)
 - Performed when a 1" x 1" extraction was not feasible
 - Compared to AD results on select repairs

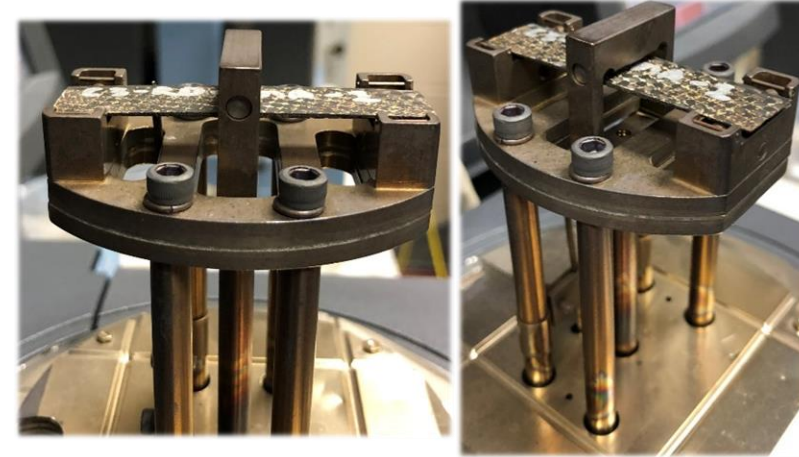
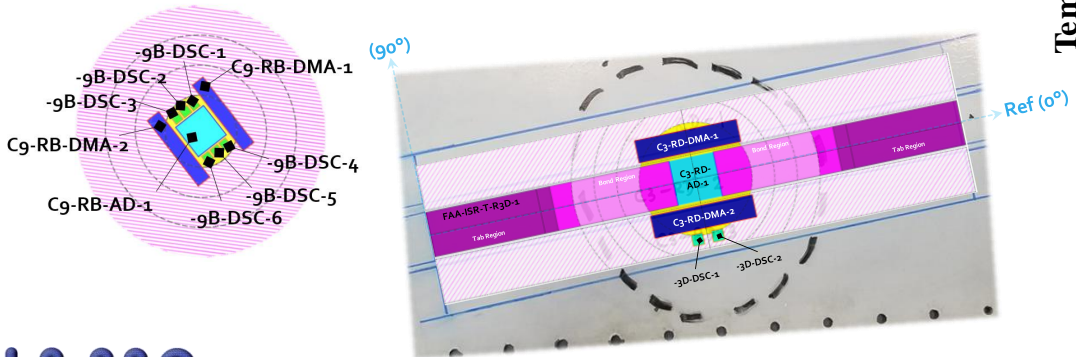
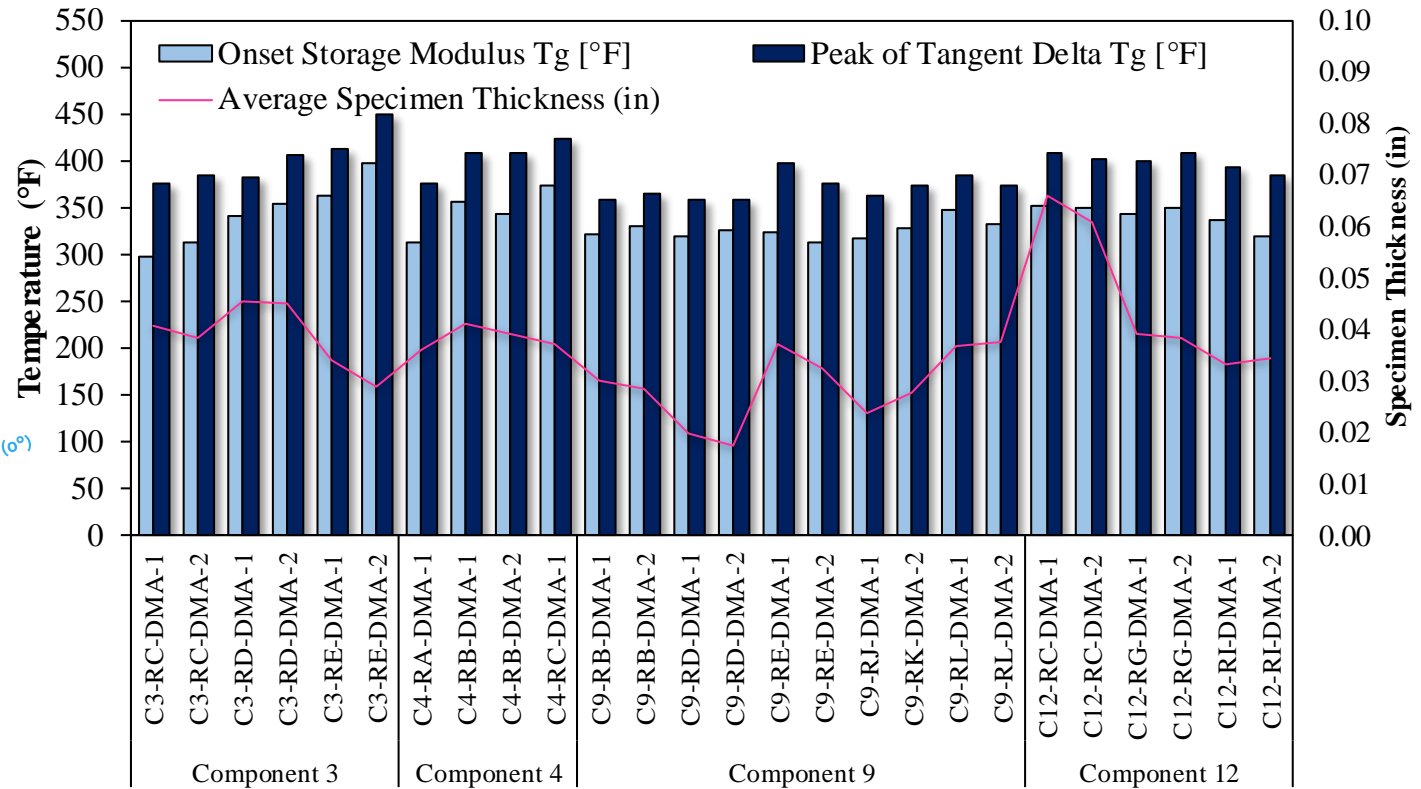
- Evaluation of glass transition temperature (T_g)
- 2.3" x 0.5" specimen used for 50 mm 3-point bend (repair patch material separated from parent material)
 - ASTM D7028-07** – Standard Test Method for Glass Transition Temperature (DMA T_g) of Polymer Matrix Composites by Dynamic Mechanical Analysis (DMA)
- Tested in as-extracted moisture configuration

Average Onset Storage Modulus T_g : **338.16°F** (6.48% COV)
 Average Peak of Tangent Delta T_g : **389.70°F** (5.80% COV)
EA9390 TDS:

- Dry T_g : 345°F
- Wet T_g : 302°F

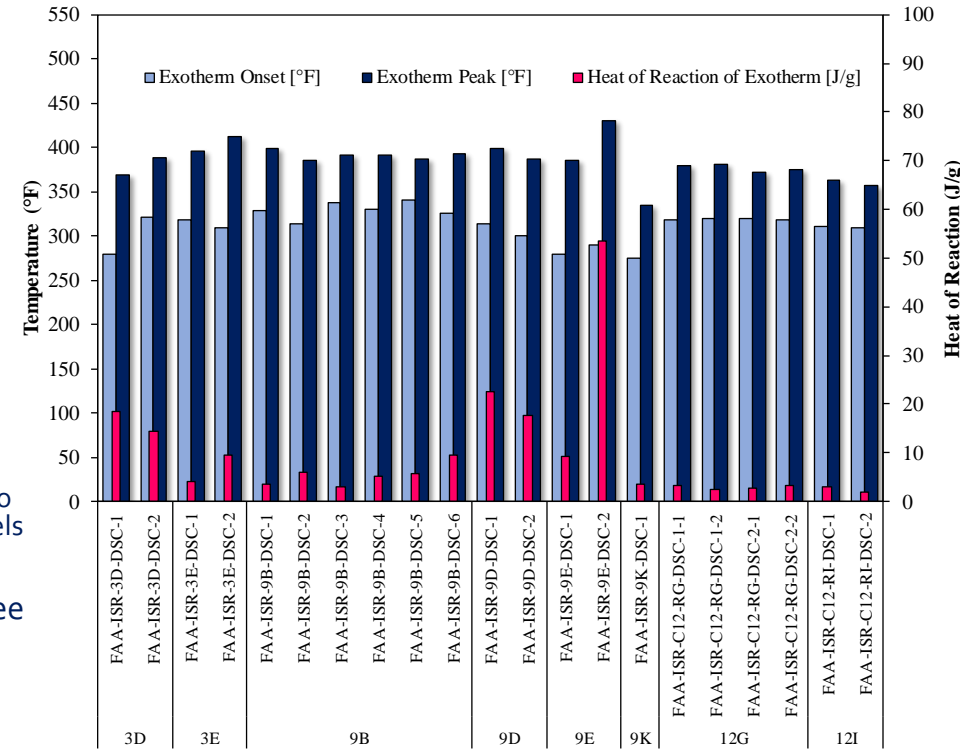
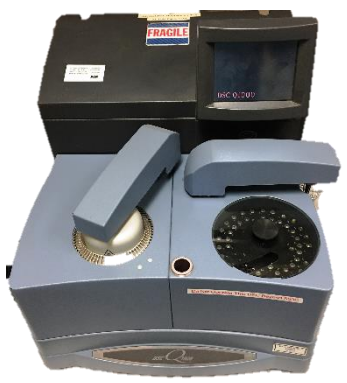
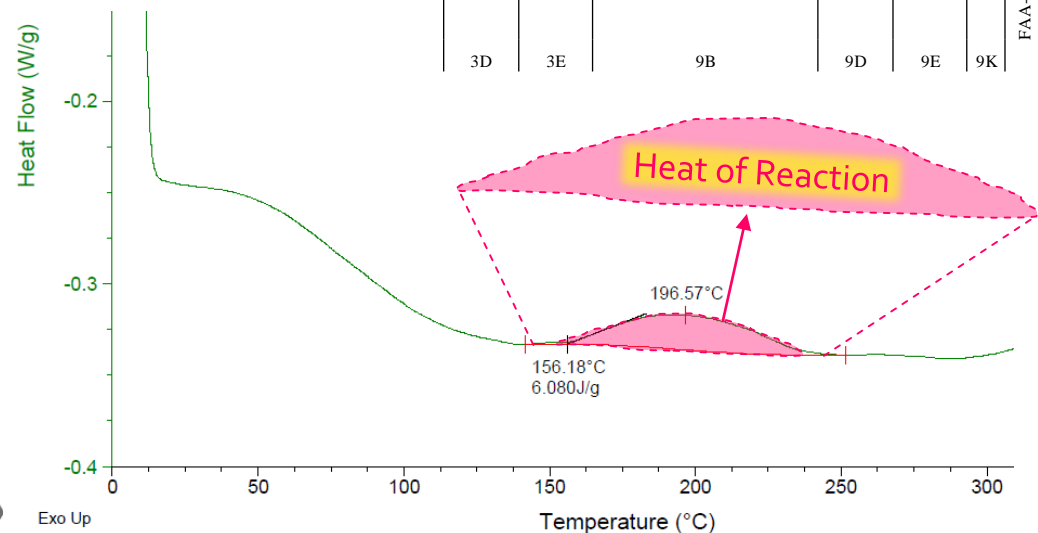
Differential Scanning Calorimetry (DSC)

- Evaluation of degree of cure
- 5-10 mg samples
 - ASTM D3418-15 – Standard Test Method for Transition Temperatures and Enthalpies of Fusion and Crystallization of Polymers by Differential Scanning Calorimetry
- Extracted repair material was used as an indicator for the degree of cure
 - Average heat of reaction of **9.66 J/g**
 - High amounts of variation can be attributed to low sample weight (thin repairs) and high levels of porosity
- T_g increases linearly with respect to the degree of cure

Repair	Specimen	Exotherm Onset [°F]	Exotherm Peak [°F]	Heat of Reaction of Exotherm [J/g]
3C	FAA-ISR-C3-RC-1	-	-	-
	FAA-ISR-C3-RC-2	-	-	-
	FAA-ISR-C3-RC-3	-	-	-
3D	FAA-ISR-3D-DSC-1	278.58	369.14	18.60
	FAA-ISR-3D-DSC-2	321.17	389.05	14.32
3E	FAA-ISR-3E-DSC-1	318.76	395.67	4.11
	FAA-ISR-3E-DSC-2	309.61	411.78	9.42
4A	FAA-ISR-4A-DSC-1	-	-	-
	FAA-ISR-4A-DSC-2	-	-	-
4B	FAA-ISR-4B-DSC-1	-	-	-
	FAA-ISR-4B-DSC-2	-	-	-
4C	FAA-ISR-4C-DSC-1	-	-	-
	FAA-ISR-4C-DSC-2	-	-	-
4D	FAA-ISR-4D-DSC-1	-	-	-
	FAA-ISR-4D-DSC-2	-	-	-
4I	FAA-ISR-4I-DSC-1	-	-	-
	FAA-ISR-4I-DSC-2	-	-	-
4J	FAA-ISR-4J-DSC-1	-	-	-
	FAA-ISR-4J-DSC-2	-	-	-
9B	FAA-ISR-9B-DSC-1	329.00	398.80	3.67
	FAA-ISR-9B-DSC-2	313.12	385.83	6.08
	FAA-ISR-9B-DSC-3	338.04	391.64	3.08
	FAA-ISR-9B-DSC-4	330.75	391.64	5.06
	FAA-ISR-9B-DSC-5	340.18	386.08	5.70
	FAA-ISR-9B-DSC-6	325.58	392.38	9.39
9D	FAA-ISR-9D-DSC-1	313.54	398.75	22.67
	FAA-ISR-9D-DSC-2	300.24	386.47	17.71
9E	FAA-ISR-9E-DSC-1	279.28	384.76	9.19

FAA-ISR-9E-DSC-2	289.69	430.50	53.63
9J	FAA-ISR-9J-DSC-1	-	-	-
	FAA-ISR-9J-DSC-2	-	-	-
9K	FAA-ISR-9K-DSC-1	274.24	333.84	3.61
	FAA-ISR-9K-DSC-2	-	-	-
12C	FAA-ISR-C12-RC-DSC-1	-	-	-
	FAA-ISR-C12-RC-DSC-2	-	-	-
12G	FAA-ISR-C12-RG-DSC-1-1	318.60	378.82	3.22
	FAA-ISR-C12-RG-DSC-1-2	319.60	380.23	2.52
	FAA-ISR-C12-RG-DSC-2-1	319.77	372.45	2.70
	FAA-ISR-C12-RG-DSC-2-2	318.04	374.86	3.35
12I	FAA-ISR-C12-RI-DSC-1	311.29	362.62	2.98
	FAA-ISR-C12-RI-DSC-2	308.88	356.56	1.90
